## ROAD SAFETY AUDIT: A CASE STUDY ON (NH-326)

*“NH-326 from Km 212.700 to Km 253.700 Km and Km 281.700 to Km 311.700 (Old chainage 0/000 to Km 30/000 and from Km 58/0 to Km 99/0)”*

*Table 2 : Design Aspects and General Observations*

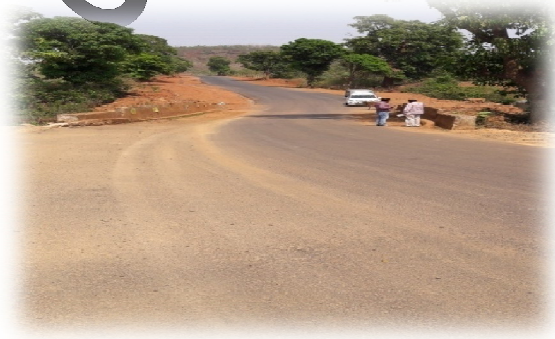
Sl.No	Observation	Measures	Priority
<b>1</b>	<b>Under-construction stage</b> At chainage: 11/500Km, The road alignment is not safe for moving vehicles on design speed, because there is an “S” curve. As the culvert to be retained and the alignment is finalized. Both the entry and exit point of culvert should properly match with the transition of S curve.	➤ All the relevant sign boards, road marking, lighting, both side ( <b>entry and exit of curves must provide ramblers</b> ), delineator, Hazard marker at CD and etc. should be provided as per guide line.	<b>Very much Essential</b>
<b>1</b>

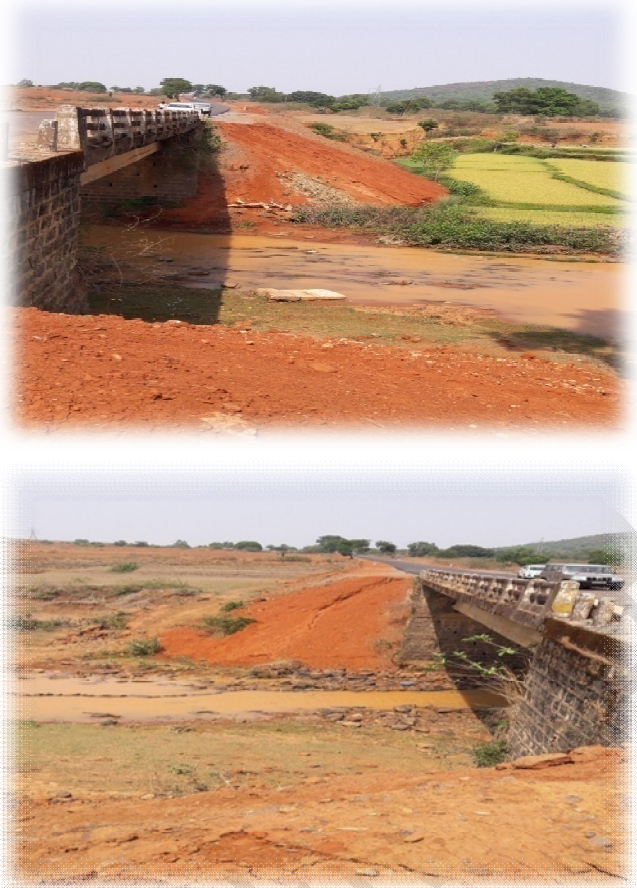
Sl.No	Observation	Measures	Priority
2	<p>At chainage: 14/100km -14/200km, Bridge approach embankment slope is not the standard 2:1, embankment is not safe, soil erosion take places.</p>

<p>(Left Side View)</p> <p><i>(Right Side View)</i></p>	<p>➤ There need protection wall at both side, the nallah bed sours present, so need 'D' wall for floor protection and nallah water way protection.</p>	<p><b><i>Very much Essential</i></b></p>
3	<p>At chainage km(21/800 -21/850), the road is constructed by cutting the road ways, the cutting is not maintaining slope 1:1, both side slope are vertical, so the embankment may falls at any time, both side edge bears trees it may fell down at any time.</p>	<p>➤ The slope should be maintained proper and check the stability of embankment, trees should be cut immediately. Breast wall on LHS around 50m length and RHS around 100m length need to be provided.</p>	<p><b><i>Very much Essential</i></b></p>

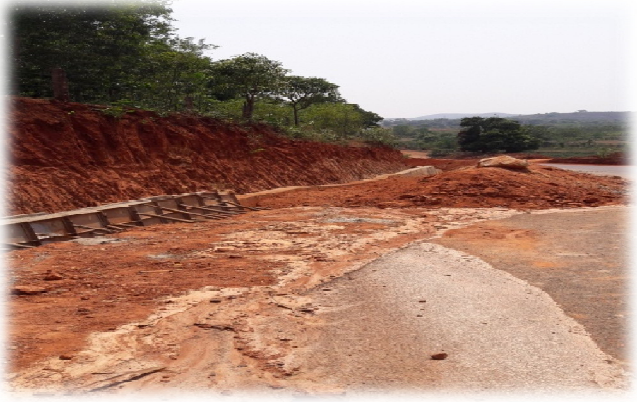
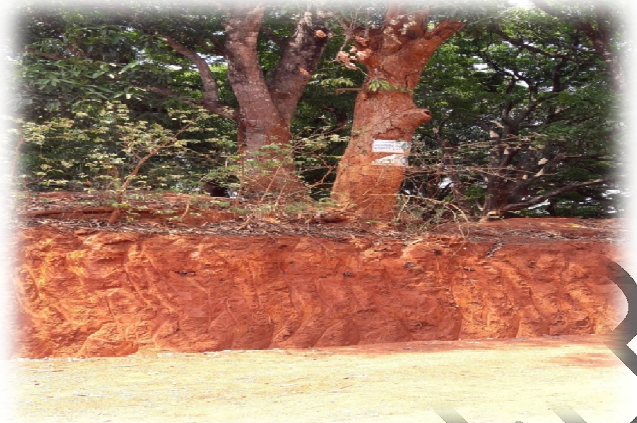
<p><i>(Right Side View)</i></p>		
4	At chainage 29/530km, Left side cutting slope is not maintained, it is almost vertical, Right side village road crossing, which is connects with a steeper gradient, and site distance is very poor.	➤ The junction need to develop properly and the cutting slope should be rectified	<b><i>Very much Very much Essential</i></b>
5	At chainage: 58/0km Laxmipur junction & At chainage: 78/0km Rukuna junction There needs to install overhead signboards and all other road furniture for junction improvement.	➤ Laxmipur junction should be developed immediately	<b><i>Very much Essential</i></b>
6	At chainage: 58/500km 7x1200mm dia Hume pipe, both side approach needs safety barrier.	➤ Both side approach needs to provide safety barrier by using guard post or metal beam crash barrier	<b><i>Very much Essential</i></b>

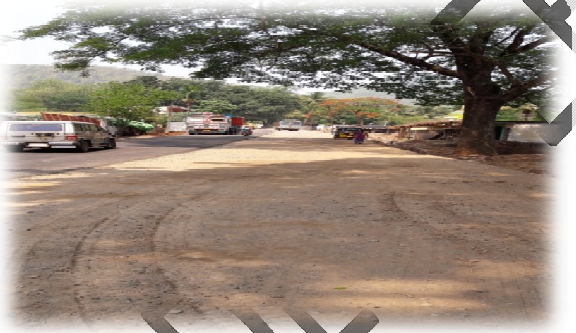
<b>Sl.No</b>	<b>Observation</b>	<b>Measures</b>	<b>Priority</b>
8	At chainage: 61/440km, MB 1x8x8m, High embankment both side approaches need to provide safety barrier and protection to the embankment.	➤ Both side approach needs to provide safety barrier by using guard post or metal beam crash barrier, the high embankment should be protected with PCC/RCC concrete wall.	<b>Very much Essential</b>
9	At chainage: 62/262 – 62/400km High embankment need to provide safety barrier	➤ Both side of road edge need safety barrier by using guard post or metal beam crash barrier.	<b>Very much Essential</b>
10	At chainage: 68/496km, Habitation area and School LHS precaution and safety information mandatory sign boards etc. are to be provided.	➤ All the relevant sign boards, road marking, lighting and rumbles as per guide line should be provided	<b>Very much Essential</b>
11	At chainage: 75/600km, Habitation area Potali and School precaution and safety information mandatory sign boards etc. are to be provided. Here also horizontal curve site distance is obstructed.

➤ All the relevant sign boards, road marking, lighting, rumbles, reflector should be provided as per guide line.	<b>Very much Essential</b>

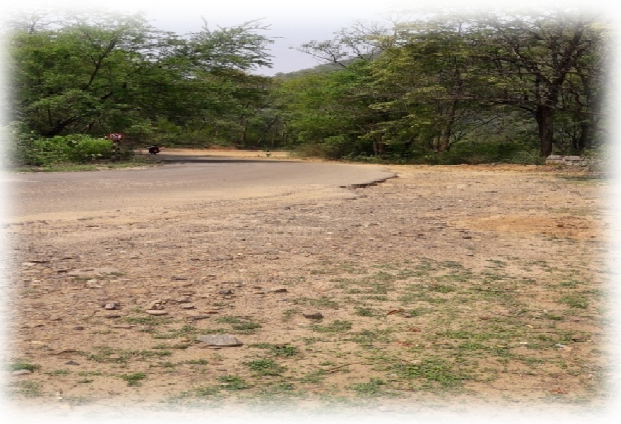
12	At chainage: km (88/5-88/800) 2hair pin bends and from km(90/0-91/0) 3hair pin bends and steeper gradient, informatory signboards, safety barrier and guard wall, beast wall need to provide	➤ All the relevant sign boards for hair pin bend, steeper gradient incline/decline, curve sign, wild animal crossing, road marking, lighting, rumbles, reflector should be provided as per guide line.	<b>Very much Essential</b>

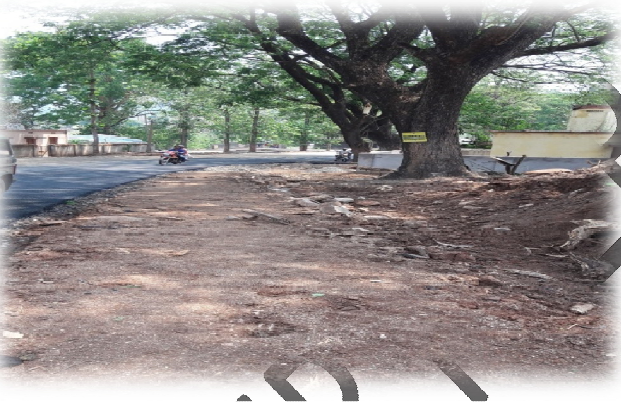
13	<p>At chainage: 93/985km, Habitation area, R.I office, Hospital, 5 big trees at curve location, horizontal site distance site distance is obstructed.</p>

<p>➤ All the relevant sign boards, road marking, lighting, rumbles, reflector less ribbons should be provided. Tree should be marked properly for alerting drivers.</p>	<i>Very much Essential</i>
14	<p>At chainage: 94/273km, Habitation Guma School (RHS) precaution and safety information mandatory sign boards etc. are to be provided.</p>

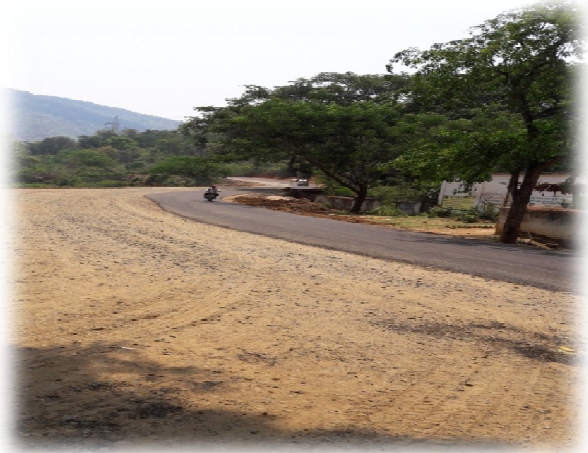
<i>Sl.No</i>	<i>Observation</i>	<i>Measures</i>	<i>Priority</i>
	zones	etc. to be provided	
16	<p>At chainage: km (95/990), 'S' CURVE</p>

<p>➤ Curve sign, no overtaking zone sign and road marking, lighting etc. to be provided, super elevation, extra widening, safety barrier at LHS to be provided</p>	<i>Very much Essential</i>
17	<p>At chainage: 96/790, Bridge 3x34.5, High embankment both side approaches need to provide safety barrier.</p>

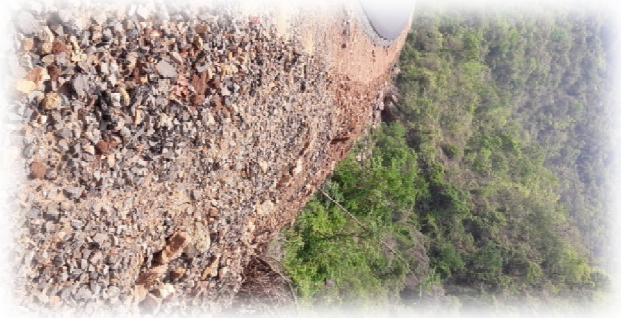
<i>Sl.No</i>	<i>Observation</i>	<i>Measures</i>	<i>Priority</i>
20	<p>At chainage: km 98/468 horizontal curve, vegetation affected the site distance.</p>

<p>➤ Curve sign, road marking, lighting etc. to be provided, site distance affected by the vegetation need to be clear.</p>	<p><b>Very much Essential</b></p>

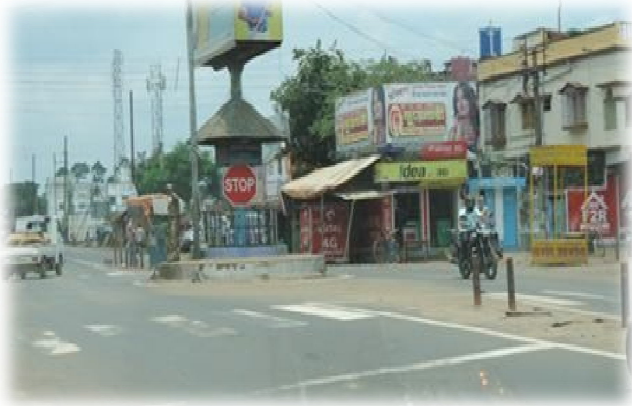
Sl.No	Observation	Measures	Priority
4.1	<p><b>*Built up area</b>  School/Aganawadi / Hospital/ Bank  Km. 1/0-1/2 , 2/080, 2/830 , 58/0 -58/300, 58/550 – 58/880, 60/500 – 60/700, 60/800-61/000, 62/600-62/880, 69/200 – 69/500, 75/600 – 75/800, 82/700 – 82/800, 83/100-83/300, 93/900 -94/300</p>

<ul style="list-style-type: none"> <li>➤ Pedestrian crossing and side walk facilities at the intersection need to be created. Also consider painting the Road markings on all minor roads indicating the pedestrian crossings and road openings with dotted line coupled with the provision of STOP line marking on the intersecting road.</li> <li>➤ Proper signage is to be erected at least 100 mtr ahead of the these area</li> <li>➤ road marking, Zebra crossing</li> <li>➤ Rambler strip and delineator to be provided</li> </ul>	Essential

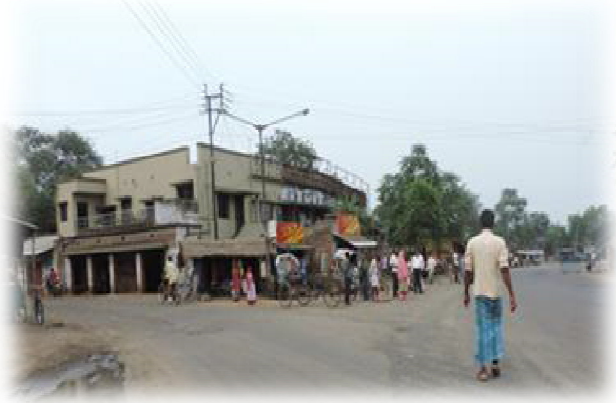
<i>Sl.No</i>	<i>Observation</i>	<i>Measures</i>	<i>Priority</i>
	<p><b>*Rail Over Bridge</b> At chainage: 1/890km</p>	<ul style="list-style-type: none"> <li>➤ Informatory sign board to be provided.</li> </ul>	<b>Essential</b>
	<p><b>*Major Junctions</b> 0/0km, 0/330, 77/800</p>

<ul style="list-style-type: none"> <li>➤ Pedestrian crossing and side walk facilities at the intersection need to be created. Also consider painting the Road markings on all minor/major roads indicating the pedestrian crossings and road openings with dotted line coupled with the provision of STOP line marking on the intersecting road.</li> <li>➤ Junction need to develop properly and the grades of the junctions and merging point should be as per code provision.</li> <li>➤ Proper signage is to be erected at least 100mtr ahead of the these area</li> <li>➤ road marking, Rambler strip and delineator to be provided</li> </ul>
