**EROSION RATE IN POST-COAL MINING RECLAMATION AREA
IN KUTAI KARTANEGARA DISTRICT, INDONESIA**

The research aims to determine the magnitude of the rate of erosion and the class of erosion hazard that occurs in the reclamation area so that a precaution can be taken to preserve the soil.

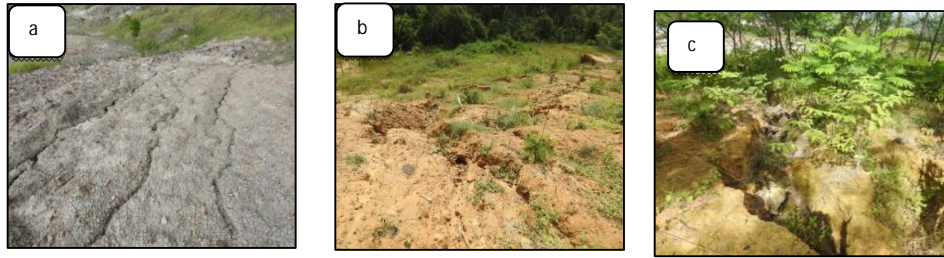
The amount of soil eroded in one year in the Disposal area is due to the absence of vegetation growth. It has too steep slopes, even though the soil permeability class in the Disposal area at PT ABE and PT JMB is moderate. Land slope and length are topographical elements that significantly affect runoff and erosion. The steeper the slope, the higher the erosion potential caused by the soil surface splashing to the bottom of the slope caused by the collision of more and more raindrops [14]. Land or vegetation cover benefits the soil because it can protect the soil from rainwater so that it does not hit the ground surface directly. High rain intensity will cause surface runoff and transport the soil particles to a lower place [14].

The magnitude of eroded soil is low due to land cover at the Stock Soil research location and the 2019 Reclamation research location. However, the Stock Soil research location has less vegetation than the 2019 Reclamation research location. Thick and dense vegetation is magnificent for reducing the influence of rainfall and topography on erosion, while less vegetation will be more easily eroded and transported by runoff [15].

Based on the Erosion Hazard Class in the Jembayan Muarabara Group, Kutai Kartanegara Regency (Table 8), it is generally included in class V, which is very high. PT ABE in the Disposal area (558.55 tons/ha/year) and Stock Soil (552.39 tons/ha/year) fall into class V, while at the 2019 Reclamation research location (189.51 tons/ha/year) entered into class IV, namely high. At PT JMB, in the Disposal area (1341.94 tons/ha/year) and 2019 Reclamation (673.88 tons/ha/year), it is included in class V which is very high, while in the Stock Soil area (471.79 tons/ha/year) entered into class IV, namely high. PT KRA in the Disposal area (1003.38 tons/ha/year) and Stock Soil (693.51 tons/ha/year) is in class V which is very high, while in the 2019 Reclamation area (369.87 tons/ha/year) entered into class IV, namely high (Table 8). The class of soil erosion hazard from high to very high on the reclamation land is also shown in Figure 3, where groove erosion has formed up to gully erosion.

Figure 3. Condition of Reclamation Land
a) Disposal Area, b) Stock Soils Area, c) Reclamation Area in 2019

The conservation technique in the Jembayan Muarabara Group is making bench terraces (terracing). The bench terrace is very helpful for reducing the erosion rate because it aims to reduce the slope length, retain water to reduce the speed and amount of surface runoff and increase the opportunities for water absorption by the soil. In addition to making bench terraces, there is also the construction of drains in the 2019 Reclamation area, but there are no drains in the Disposal and Stock Soil areas. Taking into account several other factors that affect the magnitude of the erosion rate at the study site in Jembayan Muarabara Group besides rainfall, vegetation cover, slope, volume weight and soil texture, namely at the Disposal location, there is no management of ground cover, there is no drainage around the barrier, especially at Disposal and Stock Soil locations.

1. Stockpiling and arranging cover soil according to the type of soil because this type of soil is prone to erosion and landslides and is also a type of loose soil.
2. Increase the types of vegetation that cover the ground so that rainwater does not directly hit the ground surface.
3. Construction of bench terraces accompanied by drains on the landfill, shortening the length of the slope and the slope angle of the barrier, which increases water absorption, reduces the flow rate of the soil surface and can regulate water so that it can flow in certain places.
