Evaluating the Impact of River Bank Erosion on Environmental Stream Morphology for the Mini Piti Stream, Obio-Akpor, Rivers State, Nigeria

Key Words: Impact, River Bank, Erosion, Channel, Morphology, Mini-Piti stream

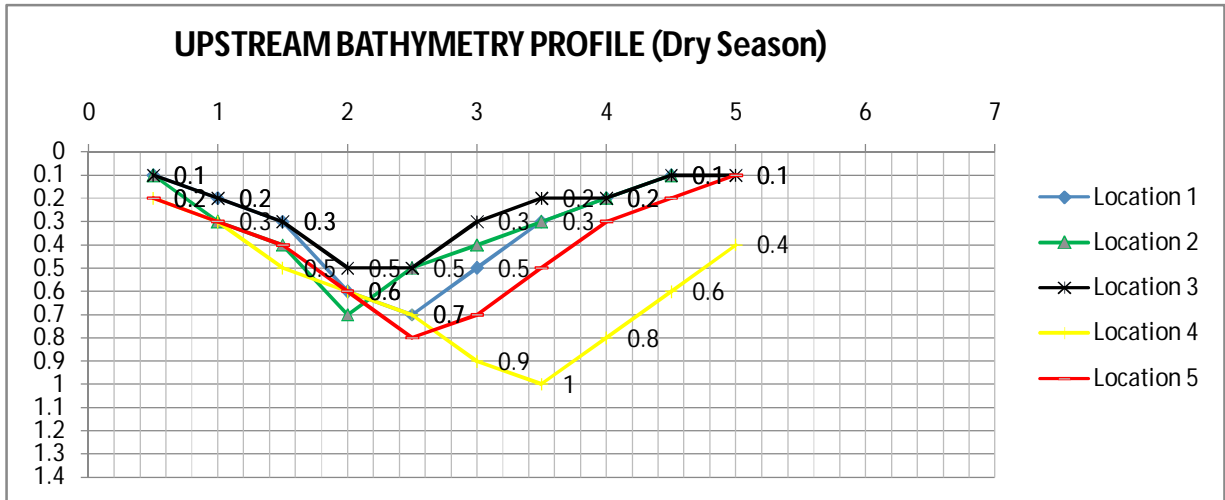
Figure 3: Graphical interpretation of upstream dry season bathymetry profile

The chart in Figure 3 shows the cross sectional depth profile of the upstream of the study area during the dry season where a total of five stations were surveyed across the channel. Maximum depth of 1m was recorded at location 5 indicated in the graph as red line and 0.5m depth observed at location 3. Observation at field indicated an average of 1.4m of water regression from the bank full stage and point bar. No serious bank erosion was recorded at the upstream of the study area, and is highly vegetated with farmland and distance built houses. The profile shows a well-defined, uniform and undisturbed channel basin.

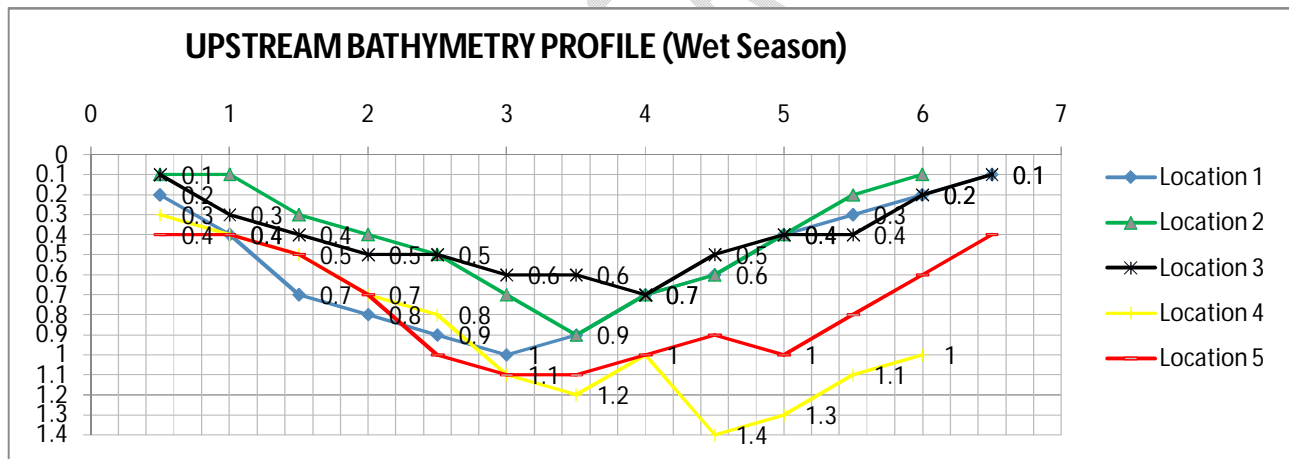
Figure 4: Graphical interpretations of wet season upstream bathymetry profile

There were significant changes in the depth and width of the upstream of the study area during the wet season as shown in Figure 4, the maximum width of the stream was 6.5m at location 5 and maximum depth of 1.4m at location 5. The changes in depth and width of the channel is as the result of input from the rain and runoff from the watershed which is between 1.2m and 1.4m depth. There was deposition of about 0.2m height of sediment in the stream bottom and bed erosion at location 5.

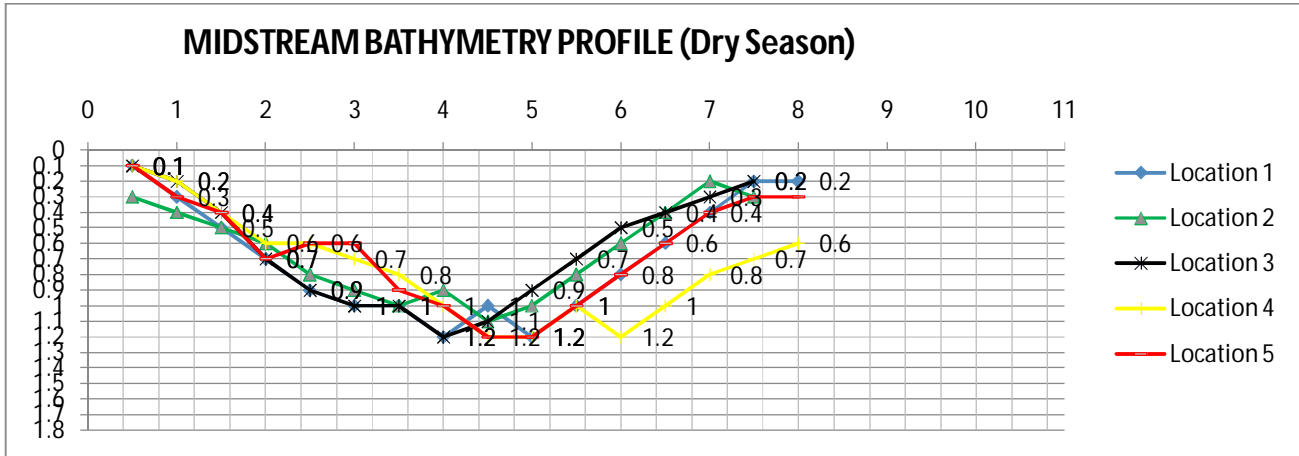
Figure 5: Graphical interpretations of dry season midstream bathymetry profile

The midstream of the study area covered five sample locations. The eroded zone of the bank was well exposed during the dry season as waste and debris dumped along the bank extended about 1.5m into the water channel, scarp, and bank full dimension was observed during the study (Figure 5). The maximum depth of the stream was 1.2m at location 2, 3, 4 and 5 and maximum width of 8.5m during the dry season.

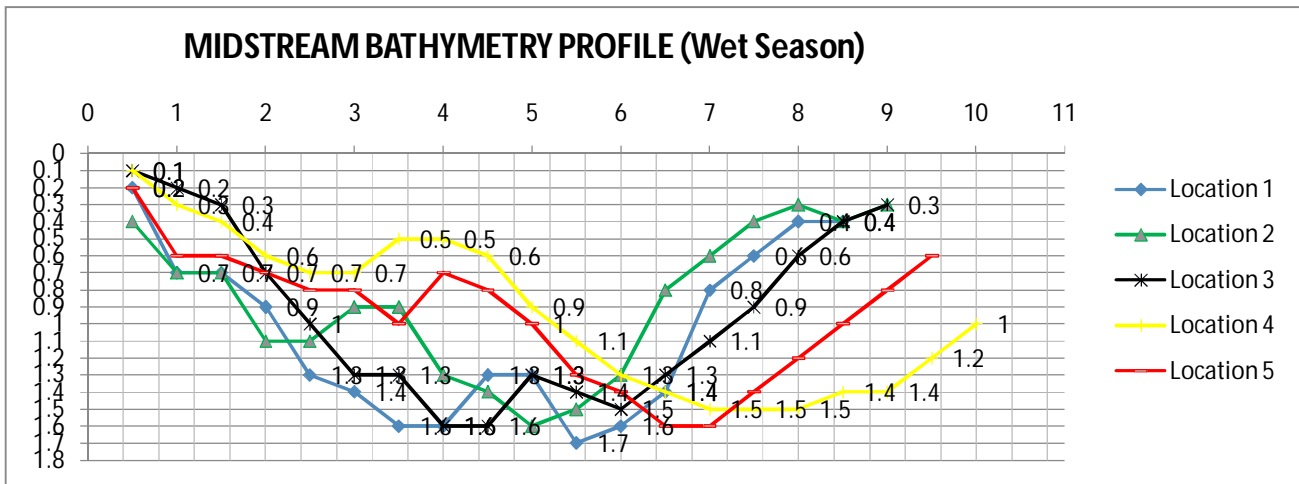
Figure 6: Graphical interpretation of midstream wet season bathymetry profile

The horizontal distance of about 2m from the floodplain which was exposed during the dry season was completely covered at the wet season as shown in Figure 6. The width distance of 0 -2m at 0.2 -0.6m depth shows bank erosion across the five locations of the midstream at the right bank. The scarp that was visible at the dry season was completely submerged during the wet season and for locations 1 and 3 at 1.3m depth, there was sediment accumulation on the bed of the stream and bed erosion at 1.6m depth and at location 1 and 1.7m depth at location 2. The maximum depth of the midstream during the wet season was recorded at location 1 and the width of 10.5m at location 4. From the field observation, the midstream was characterized by sharp sand.

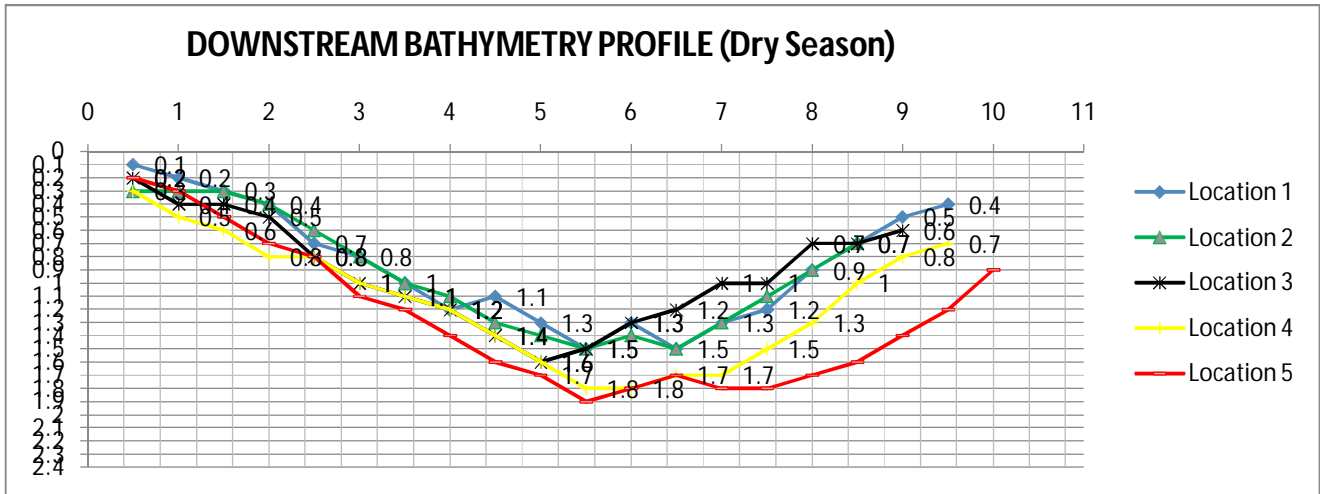
Figure 7: Graphical interpretation of downstream dry season bathymetry profile

The downstream bed characterization is the reflection of the processes that occurred along the upstream and midstream of the study area as shown in Figure 7. Locations 1 and 2 have an average depth of 1.5m and location 3 depth of 1.6m which is relatively shallow due to high rate of sediment deposition compared to the midstream of the study area. There was sand dredging activities along Location 4 and 5 which affected the depth profile at that point. The maximum depth of location 4 and 5 was 1.9m with maximum width of 10m.

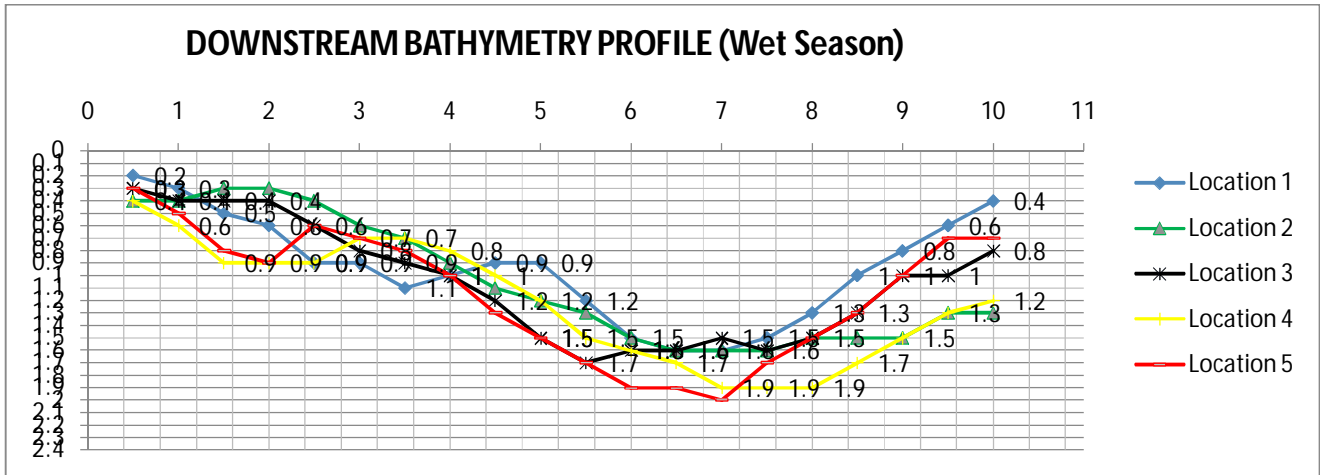
Figure 8: Graphical interpretation of downstream wet season of bathymetry profile

During the wet season, the eroded part of the bank that was exposed at dry season was covered with water as shown in Figures 7 and 8. The width length between 0.1m and 1.1m was covered with water as the result of increased rainfall and storm water impacts from the watershed. Maximum depth of 1.9m was recorded at locations 4 and location 5 of the right bank. The stream showed increase in depth towards the left bank with maximum width of 11m and at locations 4 and location 5 where there were sand minding activities.

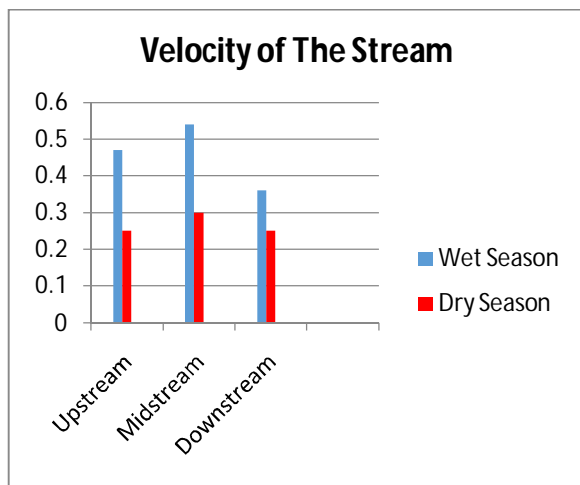
Fig. 9: Wet & dry season velocity

High velocity and discharge was recorded at midstream station of the study area during the wet season.

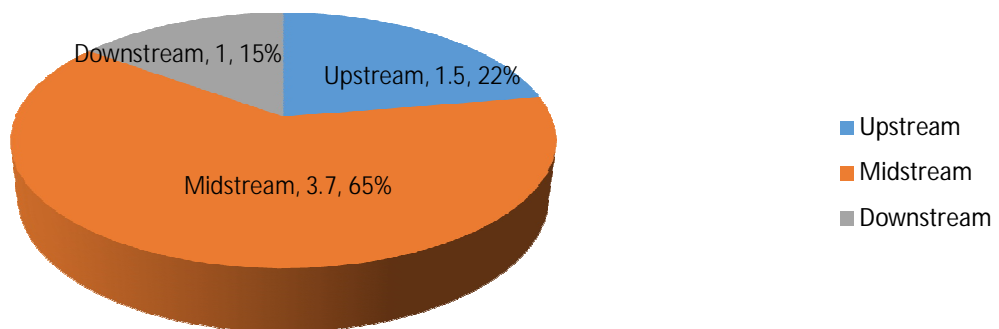
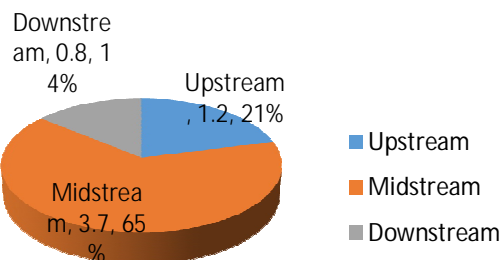
Fig.11: Average Bank Height

The height of the bank and slope are the critical factors responsible for erosion of the bank along the midstream station of the stream with average height of 4.5m and upstream of 0.9m.
