# GOOD BUILDING DESIGN AND CONSTRUCTION PRACTICES IN BARANGAY BAYBAY, CATARMAN, NORTERN SAMAR

The Extension program conducted entitled “Good Building Design and Construction Practices” an adopt a Barangay program was undertaken in Barangay Baybay, Catarman, Northern Samar. It aimed to provide a series of training to the skilled workers and administered consultancy services on civil engineering practices. It undertakes a campaign information drive for safe building construction practices. There were 40 participants in attendance mostly composed of skilled workers. The module presented focuses on design construction, materials principles, and safety construction principles. Pre-tests and post-tests were given before and after the training program. From the administered pre-test, the lowest score was 7 and the highest score was 14 out of 15 items conducted, while from the post-test examination they got a perfect score and obtained a lowest 10 points score. The result on the House Building Checklist as to the type of house building structures was derived; there was 3.66 percent on concrete houses, 43.09 percent on mixed concrete and timber house, 46.74 percent were made of steel, conc

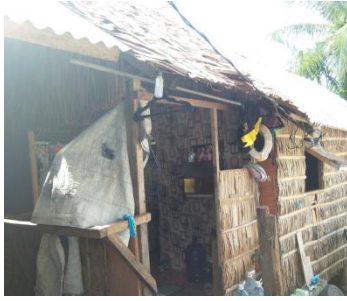
1. Indigenous House

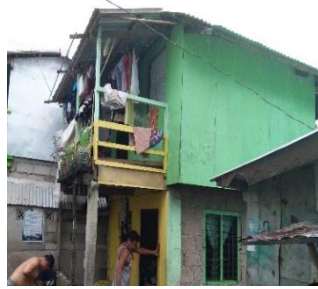
2. Mixed Concrete & Lumber

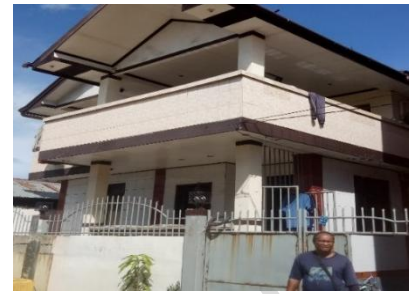
3. Concrete, Steel & Lumber

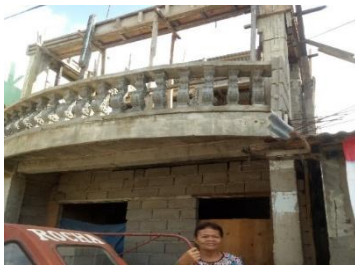
Unfinished construction

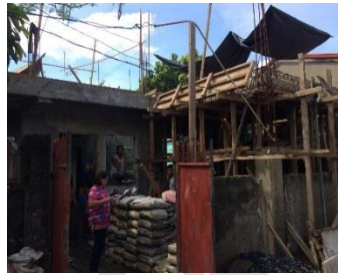
House built on mixed concrete

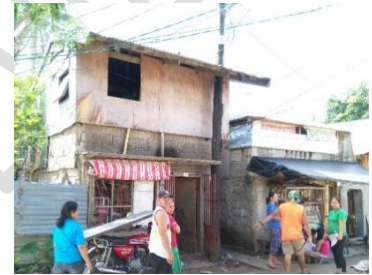
Poor building design

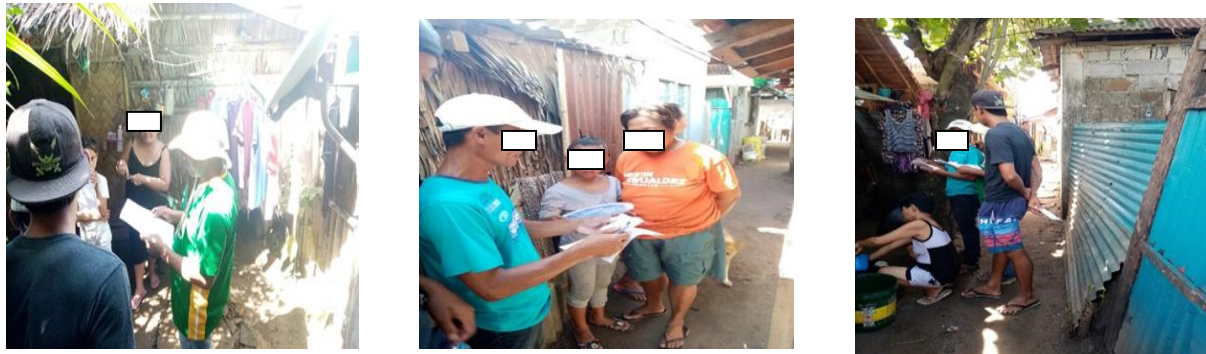
**Figure 1.** Before the onslaught of Typhoon Tisoy photo taken on November 22, 2019

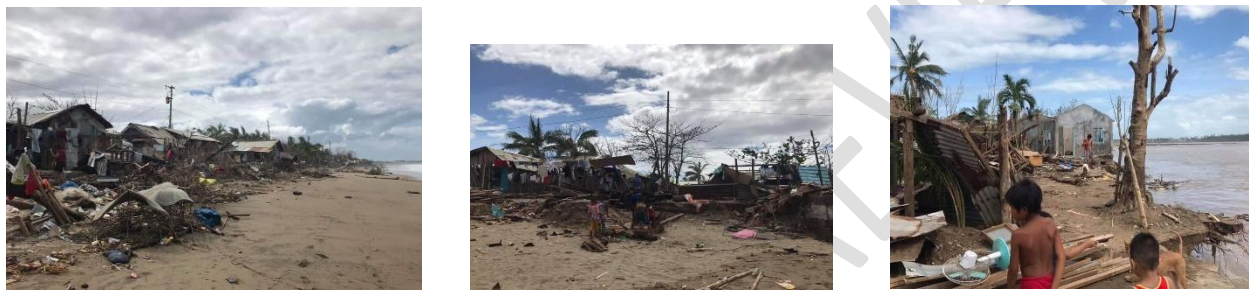
**Figure 2.** After the Typhoon Tisoy photo taken on December 11, 2019

The onslaught of typhoon Tisoy brought about 100 houses that were washed out to the shores of Barangay Baybay this is according to the interview of one of the members of the Catarman Municipal Disaster Risk Management Office. The structures are made of nipa hut, coco lumber, and bamboo pole materials.
