GOOD BUILDING DESIGN AND CONSTRUCTION PRACTICES IN BARANGAY BAYBAY, CATARMAN, NORTERN SAMAR

A SURVEY ON HOUSE STRUCTURES IN BARANGAY BAYBAY

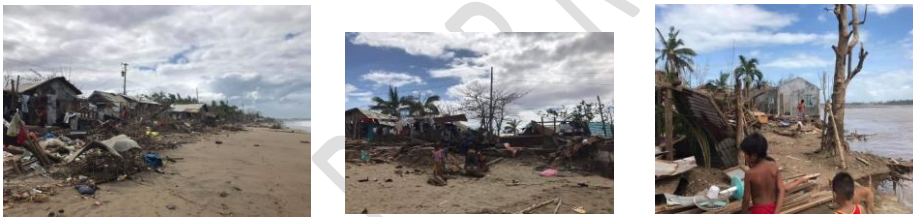
Figure 2. After the Typhoon Tisoy photo taken on December 11, 2019

The onslaught of typhoon Tisoy brought about 100 houses that were washed out to the shores of Barangay Baybay this is according to the interview of one of the members of the Catarman Municipal Disaster Risk Management Office. The structures are made of nipa hut, coco lumber, and bamboo pole materials.
