GOOD BUILDING DESIGN AND CONSTRUCTION PRACTICES IN BARANGAY BAYBAY, CATARMAN, NORTHERN SAMAR

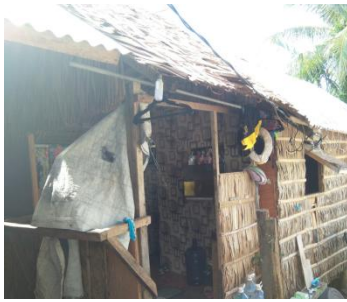
a. Indigenous House

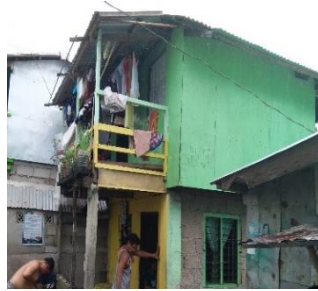
b. Mixed Concrete & Lumber

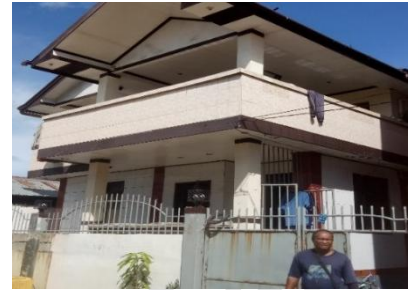
c. Concrete, Steel & Lumber

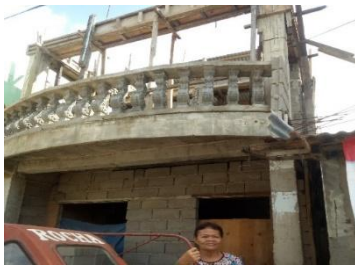
a. Unfinished construction design

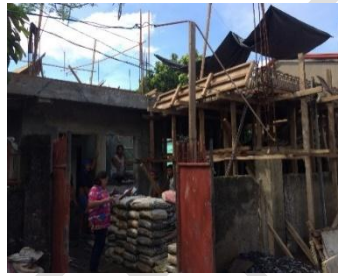
b. House built on mixed concrete

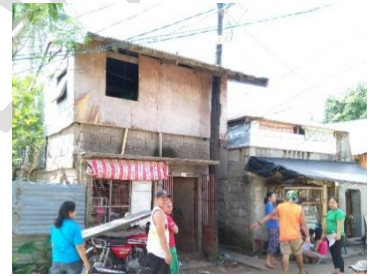
c. Poor building

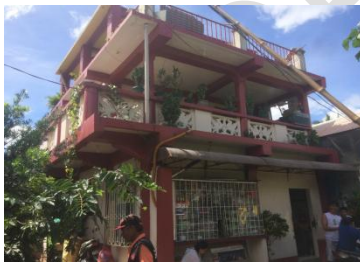
Image 3 : A GOOD BUILDING DESIGN STRUCTURES IN BARANGAY BAYBAY

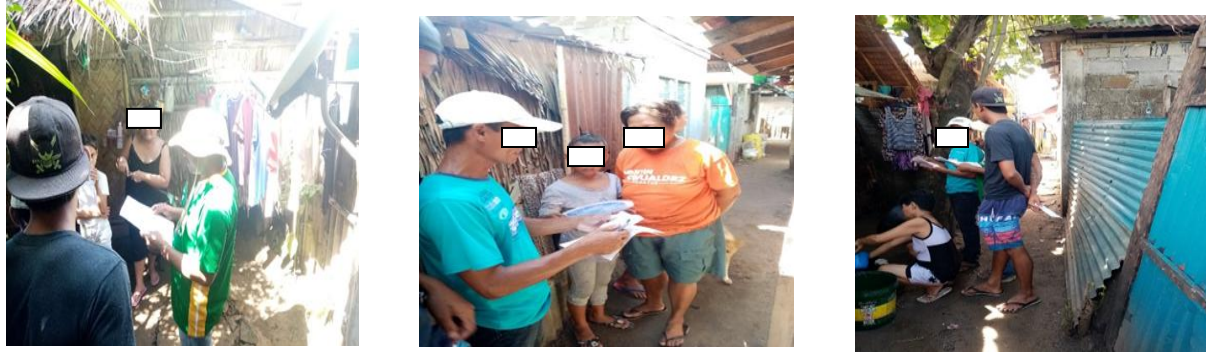
Figure 1. Before the onslaught of Typhoon Tisoy photo taken on November 22, 2019

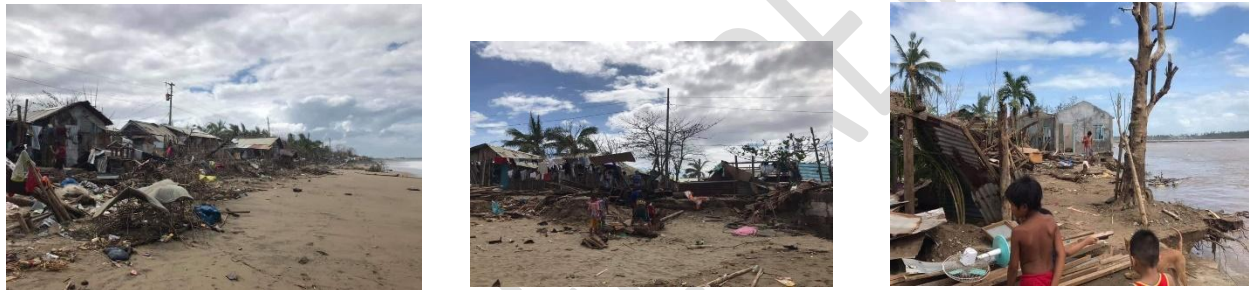
Figure 2. After the Typhoon Tisoy photo taken on December 11, 2019

The onslaught of typhoon Tisoy brought about 100 houses that were washed out to the shores of Barangay Baybay this is according to the interview of one of the members of the Catarman Municipal Disaster Risk Management Office. The structures are made of nipa hut, coco lumber, and bamboo pole materials.
