# ROAD SAFETY AUDIT: A CASE STUDY ON NATIONAL HIGHWAY -326

*“NH-326 from Km 212.700 to Km 253.700 Km and Km 281.700 to Km 311.700 (Old chainage 0/000 to Km 30/000 and from Km 58/0 to Km 99/0)”*

*Table 2:Design Aspects and General Observations*

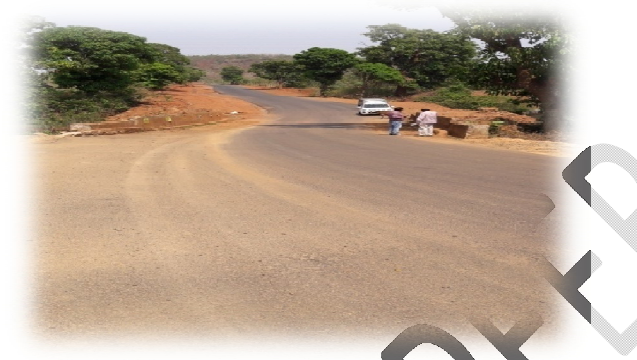
<i>Sl.No</i>	<i>Observation</i>	<i>Measures</i>	<i>Priority</i>
<b>1</b>	<b>Under-construction stage</b>		
<b>Case - I</b>	<p>At chainage: 11/500Km, The road alignment is not safe for moving vehicles on design speed, because there is an “S” curve. As the culvert to be retained and the alignment is finalized. Both the entry and exit point of culvert should properly match with the transition of S curve.</p>

<p>➤ All the relevant sign boards, road marking, lighting, both side (<b>entry and exit of curves must provide rambler</b>s), delineator, Hazard marker at CD and etc. should be provided as per guide line.</p>	<i>Very much Essential</i>
<b>Case-2</b>	<p>At chainage: 14/100km -14/200km, Bridge approach embankment slope is not the standard 2:1, embankment is not safe, soil erosion take places.</p>

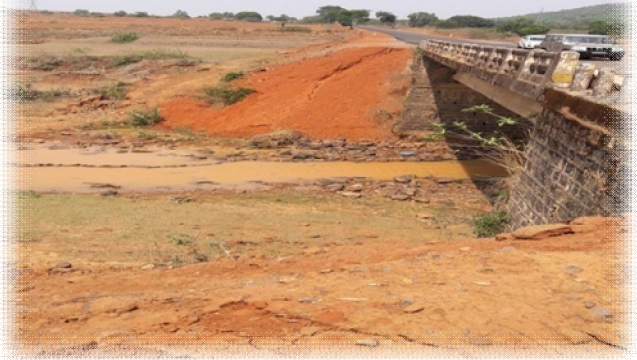
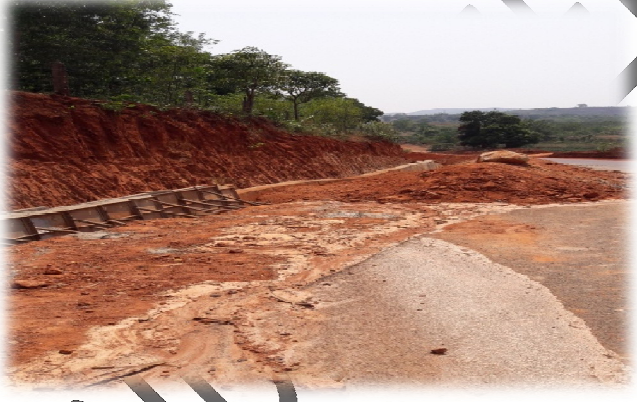
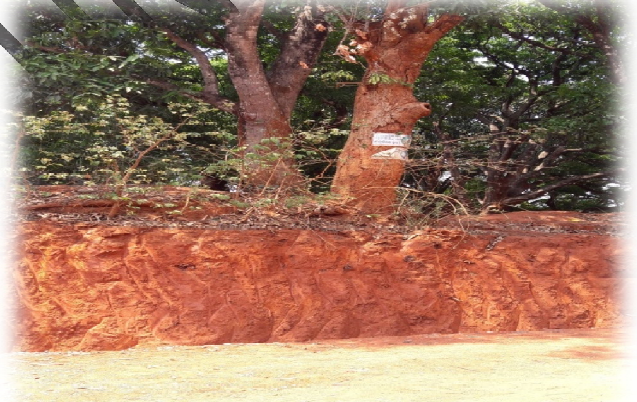
<p>(Left Side View)</p> <p><i>(Right Side View)</i></p>		
<p>Case - 3</p>	<p>At chainage km(21/800 -21/850), the road is constructed by cutting the road ways, the cutting is not maintaining slope 1:1, both side slope are vertical, so the embankment may falls at any time, both side edge bears trees it may fell down at any time.</p>

<p>➤ The slope should be maintained proper and check the stability of embankment, trees should be cut immediately. Breast wall on LHS around 50m length and RHS around 100m length need to be provided.</p>	<p><b><i>Very much Essential</i></b></p>

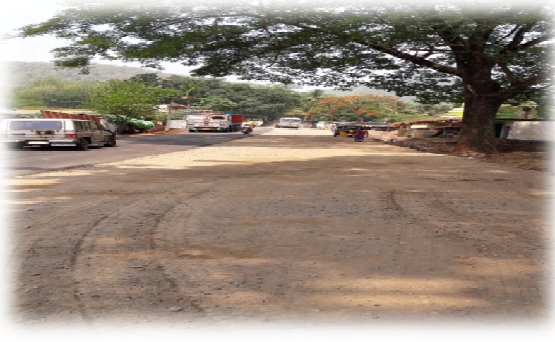
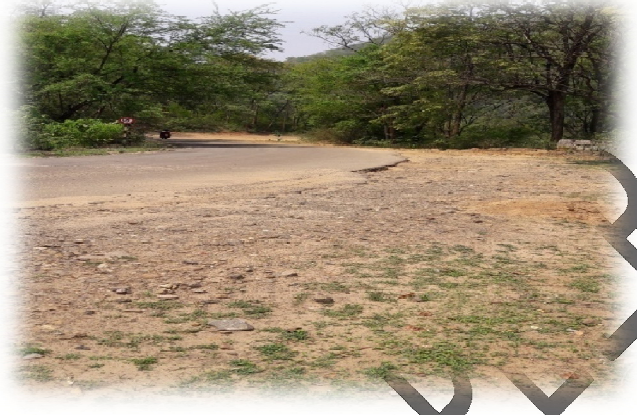
12	<p>At chainage: km (88/5-88/800) 2hair pin bends and from km(90/0-91/0) 3hair pin bends and steeper gradient, informatory signboards, safety barrier and guard wall, beast wall need to provide</p>

<p>➤ All the relevant sign boards for hair pin bend, steeper gradient incline/decline, curve sign, wild animal crossing, road marking, lighting, rumbles, reflector should be provided as per guide line.</p>	<p><b>Very much Essential</b></p>
13	<p>At chainage: 93/985km, Habitation area, R.I office, Hospital, 5 big trees at curve location, horizontal site distance site distance is obstructed.</p>

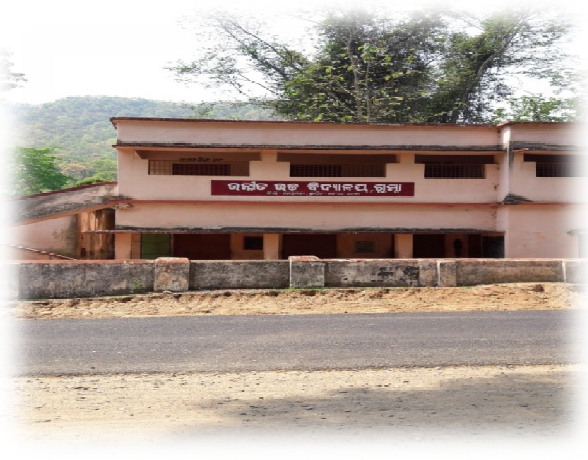
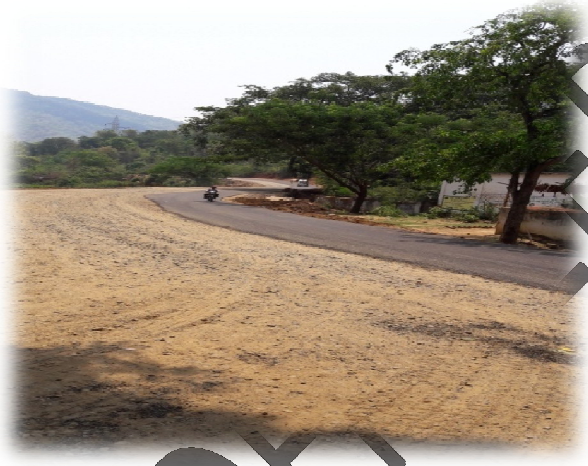
as per guide line.	
15	At Chainage: km (95/435 -95/487), No overtaking zones	<ul style="list-style-type: none"> <li>➤ No overtaking zone sign and road marking, lighting etc. to be provided</li> </ul>	<b>Very much Essential</b>
16	At chainage: km (95/990), 'S' CURVE

<ul style="list-style-type: none"> <li>➤ Curve sign, no overtaking zone sign and road marking, lighting etc. to be provided, super elevation, extra widening , safety barrier at LHS to be provided</li> </ul>	<b>Very much Essential</b>
17	At chainage: 96/790, Bridge 3x34.5, High embankment both side approaches need to provide safety barrier.	<ul style="list-style-type: none"> <li>➤ Few guard post exists, which are quite insufficient for hazards, So both side approach needs to provide safety barrier by using guard post or metal beam crash barrier.</li> </ul>	<b>Very much Essential</b>

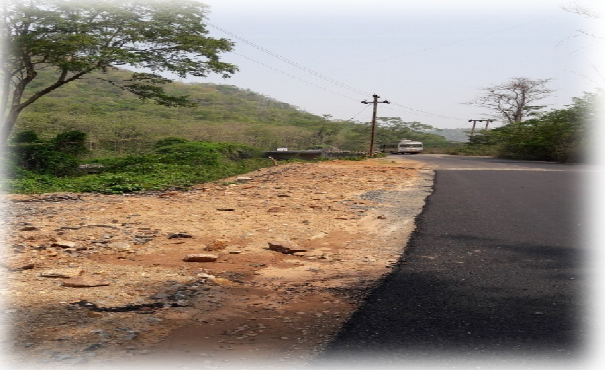
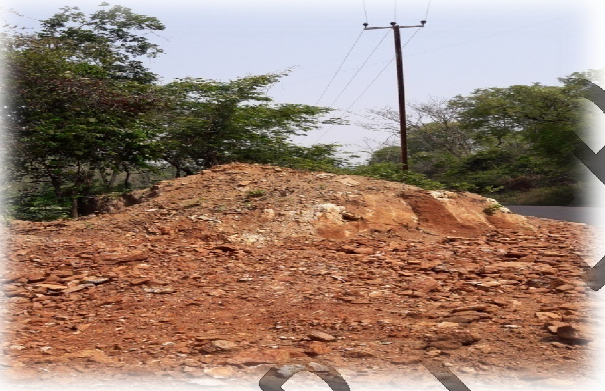
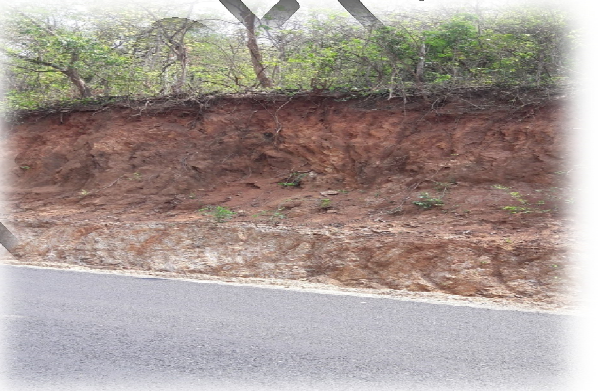
18	<p>At chainage: 97/000km, MB 7x9x4.2m, High embankment both side approaches need to provide safety barrier and protection to the embankment. Right side Hill, Horizontal curve affected with site distance.</p>

<p><i>RHS View</i></p>	<p>➤ Both side approach needs to provide safety barrier by using guard post or metal beam crash barrier, the high embankment should be protected with PCC/RCC concrete wall. Hill side may be protected with breast wall. Clearing the hip and ground for clear site distance needed.</p>	<p><i>Very much Essential</i></p>
19		<p>➤ Curve sign, no overtaking</p>	<p><i>Very much Essential</i></p>

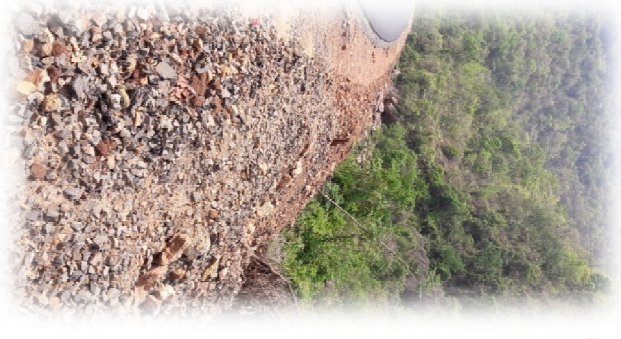
<i>Sl.No</i>	<i>Observation</i>	<i>Measures</i>	<i>Priority</i>
	At chainage: km (97/968), Sharpe CURVE, site distance obstructed, LHS Temple, RHS Reserve forest.	zone sign, Loose gravel falling symbol and road marking, lighting etc. to be provided, super elevation, extra widening , safety barrier at LHS to be provided	
20	At chainage: km 98/468 horizontal curve, vegetation affected the site distance.

➤ Curve sign, road marking, lighting etc. to be provided, site distance affected by the vegetation need to be clear.	<b>Very much Essential</b>

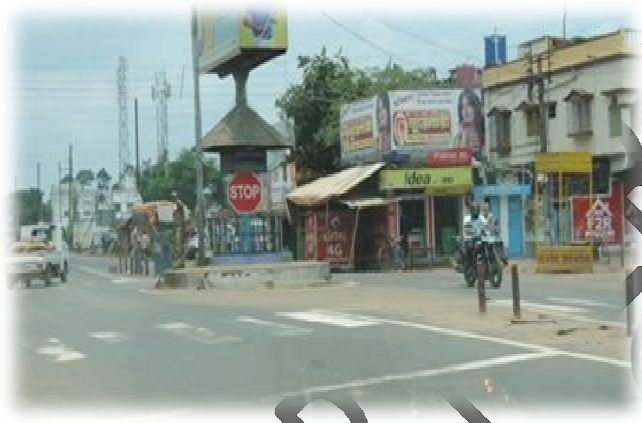
4.	<b>Road Crash Black Spot Analysis</b>		
4.1	<p><b>*Built up area</b> School/Aganawadi / Hospital/ Bank Km. 1/0-1/2 , 2/080, 2/830 , 58/0 -58/300, 58/550 – 58/880, 60/500 – 60/700, 60/800-61/000, 62/600-62/880, 69/200 – 69/500, 75/600 – 75/800, 82/700 – 82/800, 83/100-83/300, 93/900 -94/300</p>

<ul style="list-style-type: none"> <li>➤ Pedestrian crossing and side walk facilities at the intersection need to be created. Also consider painting the Road markings on all minor roads indicating the pedestrian crossings and road openings with dotted line coupled with the provision of STOP line marking on the intersecting road.</li> <li>➤ Proper signage is to be erected at least 100 mtr ahead of the these area</li> <li>➤ road marking, Zebra crossing</li> <li>➤ Rambler strip and delineator to be provided</li> </ul>	<b>Essential</b>
	<p><b>*High Embankment</b> 4/620 – 4/800 (RHS), 5/740 – 5/900 (BHS), 8/350 – 8/400 (LHS), 8/550-8/700 (LHS), 14/050 14/100 (RHS), 30/0 – 30/1, 60/130 -60/200, 61/500-61/600, 64/080-65/000, 68/740 – 68/760 (pond), 70/300-70/400, 70/900-71/100, 72/500 – 72/630 (LHS), 84/200 – 84/300, 89/300 – 89/700 (LHS Valley), 90/400 -90/700(RHS valley), 97/500 – 97/850 (RHS)</p>	<ul style="list-style-type: none"> <li>➤ Safety barrier, road marking, guard wall/ metal beam crash barrier / guard post need to be provided.</li> </ul>	<b>Essential</b>

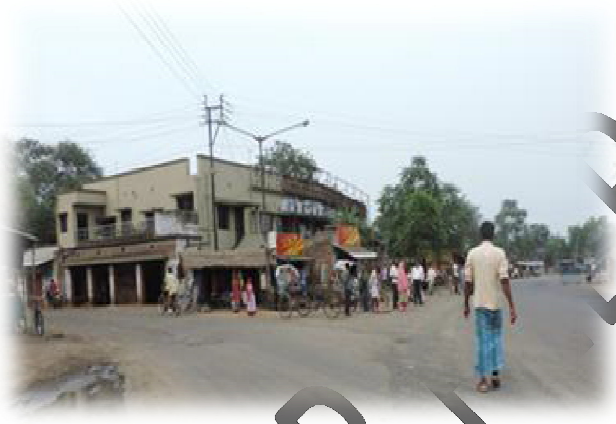
<i>Sl.No</i>	<i>Observation</i>	<i>Measures</i>	<i>Priority</i>
	<p><b>*Reverse Curve/Sharpe Curve</b> 1/0 – 1/4 , 3/555, 11/410, 12/100 -12/250, 17/150-17/250, 24/300 -24/500, 25/200 -25/600, 27/664, 70/700-70/900, 78/200 – 78/400, 79/00 -79/200, 80/400 – 80/600, 83/100 – 83/300 , 85/0 – 85/200, 87/300 – 87/400, 87/900 -88/100, 91/500 – 91/700, 91/800 -92/000, 92/200 -92/400, 95/400 -95/650,</p> <p><b>*Hair Pin Bend</b> 88/700 -89/00, 90/100 -90/400</p>	<ul style="list-style-type: none"> <li>➤ Proper signage is to be erected at least 100 mtr ahead of the curve area</li> <li>➤ road marking,</li> </ul> <p>Rambler strip and delineator to be provided on the both edges of the curve.</p>	<b>Essential</b>
	<p><b>*Rail Over Bridge</b> At chainage: 1/890km</p>	<ul style="list-style-type: none"> <li>➤ Informatory sign board to be provided.</li> </ul>	<b>Essential</b>
	<p><b>*Major Junctions</b> 0/0km, 0/330, 77/800</p>

<ul style="list-style-type: none"> <li>➤ Pedestrian crossing and side walk facilities at the intersection need to be created. Also consider painting the Road markings on all minor/major roads indicating the pedestrian crossings and road openings with dotted line coupled with the provision of STOP line marking on the intersecting road.</li> <li>➤ Junction need to develop properly and the grades of the junctions and merging point should be as per code provision.</li> <li>➤ Proper signage is to be erected at least 100mtr ahead of the these area</li> <li>➤ road marking,</li> </ul> <p>Rambler strip and delineator to be provided</p>
