Implementation of Road Safety Audit to highlight the deformities in the design and environmental safety features : A Case Study on National Highway -326

“NH-326 from Km 212.700 to Km 253.700 Km and Km 281.700 to Km 311.700 (Old chainage 0/000 to Km 30/000 and from Km 58/0 to Km 99/0)”

Table 2: Design Aspects and General Observations

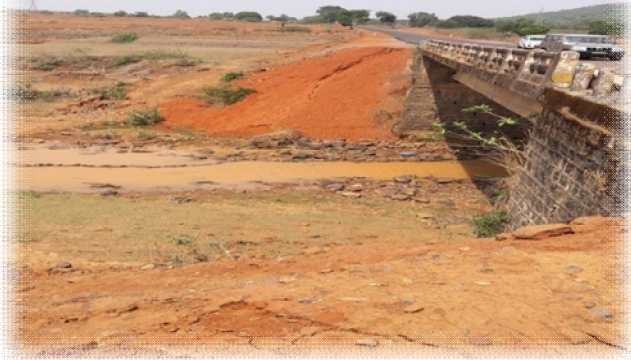
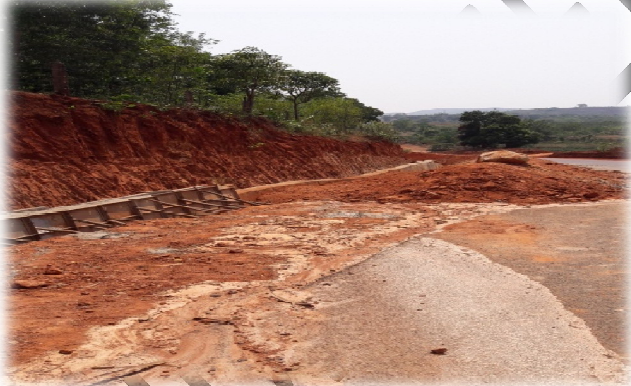
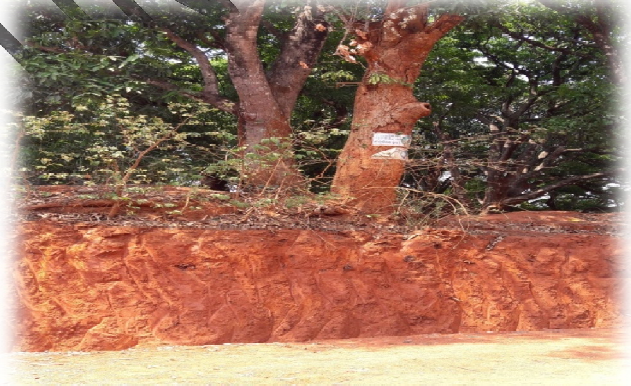
<p>(Left Side View)</p> <p><i>(Right Side View)</i></p>		
<p>Case - 3</p>	<p>At chainage km(21/800 -21/850), the road is constructed by cutting the road ways, the cutting is not maintaining slope 1:1, both side slope are vertical, so the embankment may falls at any time, both side edge bears trees it may fell down at any time.</p>

<p>➤ The slope should be maintained proper and check the stability of embankment, trees should be cut immediately. Breast wall on LHS around 50m length and RHS around 100m length need to be provided.</p>	<p><i>Very much Essential</i></p>

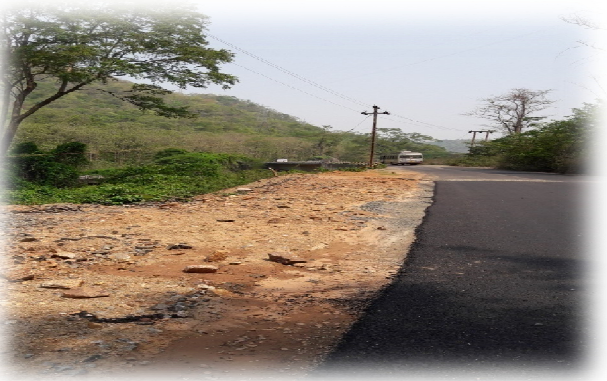
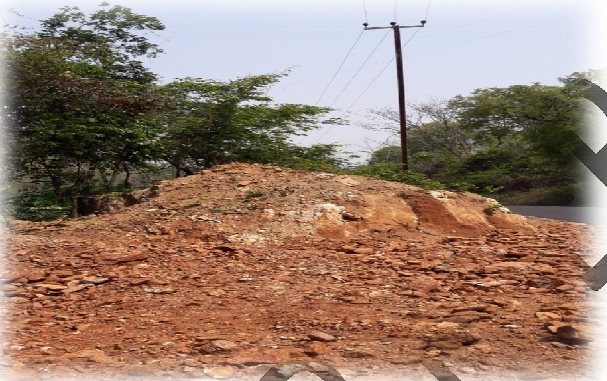
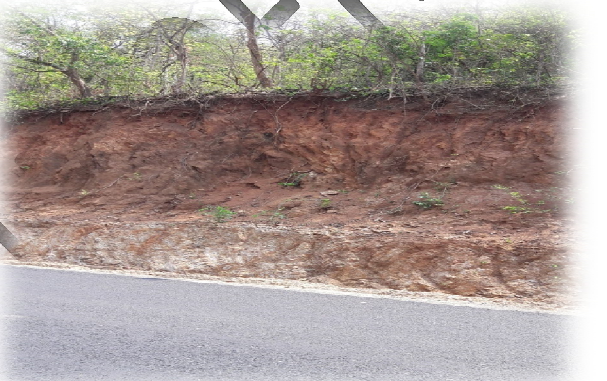
18	<p>At chainage: 97/000km, MB 7x9x4.2m, High embankment both side approaches need to provide safety barrier and protection to the embankment. Right side Hill, Horizontal curve affected with site distance.</p>

<p><i>RHS View</i></p>	<p>➤ Both side approach needs to provide safety barrier by using guard post or metal beam crash barrier, the high embankment should be protected with PCC/RCC concrete wall. Hill side may be protected with breast wall. Clearing the hip and ground for clear site distance needed.</p>	<p><i>Very much Essential</i></p>
19		<p>➤ Curve sign, no overtaking</p>	<p><i>Very much Essential</i></p>

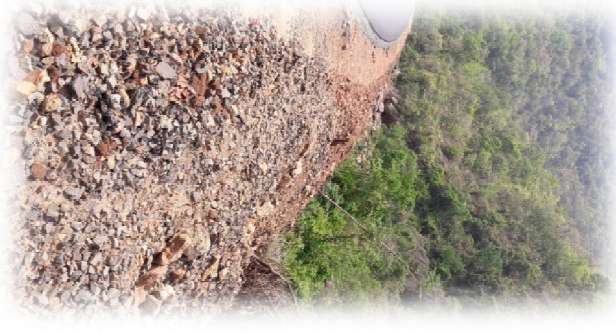
<i>Sl.No</i>	<i>Observation</i>	<i>Measures</i>	<i>Priority</i>
	At chainage: km (97/968), Sharpe CURVE, site distance obstructed, LHS Temple, RHS Reserve forest.	zone sign, Loose gravel falling symbol and road marking, lighting etc. to be provided, super elevation, extra widening , safety barrier at LHS to be provided	
20	At chainage: km 98/468 horizontal curve, vegetation affected the site distance.

➤ Curve sign, road marking, lighting etc. to be provided, site distance affected by the vegetation need to be clear.	Very much Essential
