Original Research Article
**Assessment of “The Serious Learner” Outdoor
Concrete Statue in TTU, Ghana: A Restoration
Process (Before and After)**

This paper **assesses** the restoration process (before and after) of "The Serious Learner", an outdoor concrete statue found at the forecourt of Oduro block, Takoradi Technical University (TTU)-Ghana. Direct observations and unstructured interviews under the qualitative research method were employed to elicit data from respondents such as art lecturers and students of the Sculpture Department, TTU. Data were analyzed using archival studies, descriptive and visual analysis tools with a studio-based process. The study revealed that "The Serious Learner" outdoor concrete statue formed an integral element of landscaping at the Oduro block, TTU. However, significant features such as the pedestal, body parts, lighting system and finishes of the outdoor statue have deteriorated due to weathering and had received no restoration since its erection. Repairs and management of artefacts in public space, not only in TTU, should be performed every two years to ensure their longevity and posterity as conservation and restoration method is significant

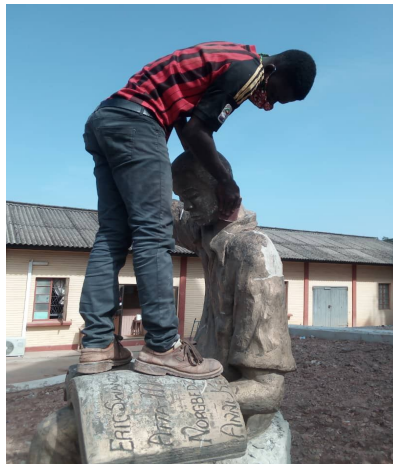
It was revealed that in undertaking the surface preparation of the outdoor concrete statue, the artists provided appropriate care to the substrate for repairs. The artists cut the border of the broken-off area. The surface preparation began by removing broken concrete surfaces with a hammer, plier and wire brush. The artists then remove the cracks on the surface to provide a better bonding and solidifying with the existing concrete. Paint peel-off was removed by scraper and coarse sandpaper to establish the degree of the repair. The artists remove all powder substances and dirt from the statue. Again, concrete deterioration such as cracking and delamination of metal caused by corrosion were removed for proper repairs and management. The artists finished the surface preparation to replicate the original appearance of the statue. A maintenance strategy is the most effective way to help shield the outdoor concrete statue of "The Serious Learner" from deteriorating. Figure 1 shows a surface preparation on the sculpture (The Serious Learner).

Fig. 1. Surface preparation of the outdoor concrete statue

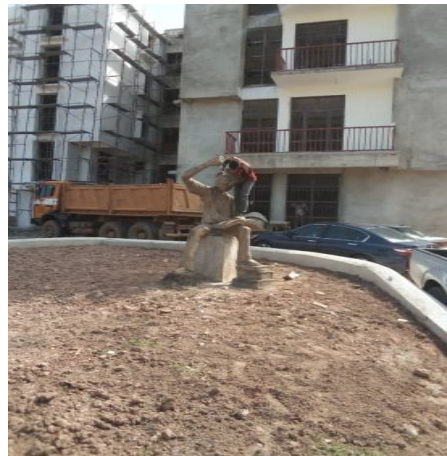
The study revealed that the detailing work with sealants required considerable attention. However, artists filled active cracks with cement mixture as penetrating sealants. A protection system such as the resin application was applied to the statue to protect it and increase the length of the service life of the outdoor concrete statue. The artists prepared land around the statue with cutlass and hoe to make it bear for replanting green glass [31], as shown in Figure 2.

Fig. 2. Finishing with cement mixture and clearing of surroundings

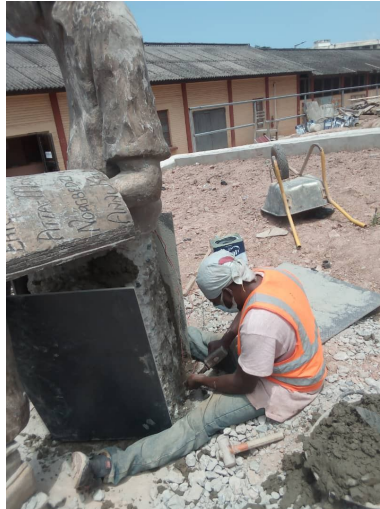
The surface of the pedestal was properly prepared, suitably levelled, cleansed, dried, and free of dust, grease or any loose material. The pedestal surface was secured without deflection and capable of carrying any additional load. In tiling the walls of the pedestal, consideration was given to floor tiles because of their heavyweight compared to wall tiles. Its weight of 3kg per m² allowed the artists to use it together with adhesive and grout. The artists performed different roles in concentrating on laying and bedding the tiles, while the others provided a constant supply of loose tiles and made cuts and retrieved tools as needed. A rubber mallet was used to gently but firmly tap and bed each tile into the mastic. Artists took appropriate care not to press or shift the tiles around to avoid having the mastic squeeze up into the grout lines between the tiles. Plastic spacers were placed between each tile as necessary. The mastic did not stick to the spacers, which were easily removed before the grouting of the joints began. The artists used a 4-foot level to ensure that tile edges were aligned and levelled across their surface.

Fig. 3. The artist lays tiles around the pedestal.

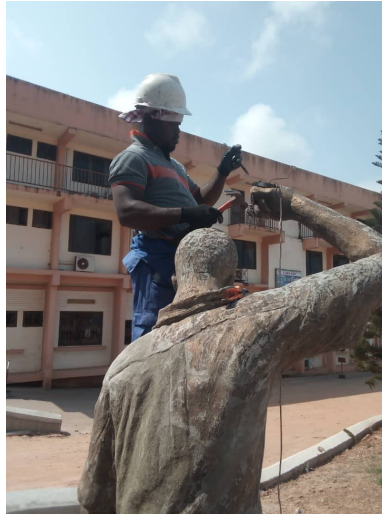
The artists used electric cable encased in a half ½ inch PVC pipe through "The Serious Learner" concrete statue from the pedestal and to the right hand of the figure holding the

lamp. The artists prepared the ground by creating a pipe-laying channel from the statue to the source of tapping electric power at the Oduro block. The bulb was fixed to the right hand of the sculpture (The Serious Learner) to complete the lighting process. Figure 4 shows the process of passing electric wire and the fixing bulb to the statue.

Fig. 4. Passing of electric wire and fixing of the bulb

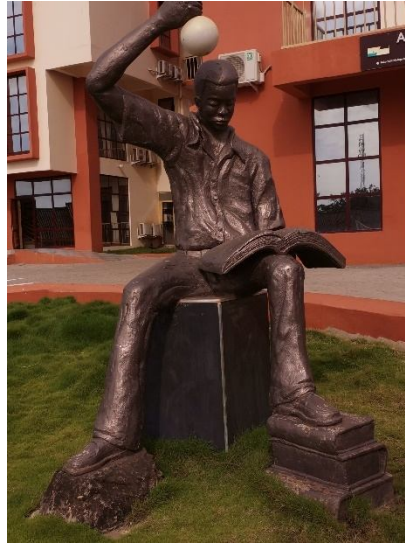
Before applying paint to the statue, the artists ensured that the statue was free of all forms of dirt by washing it with a soap solution and a duster. It was then allowed to dry for thirty minutes to ensure the paint sticks well to the body of the sculpture. The paint was then applied with a brush onto the statue with a half-gallon of enamel paint mixed with two litres of thinner. The finishing was done to retain the original form of the statue with bronze enamel paint, as shown in Figure 5.

Fig. 5: Application of enamel paint

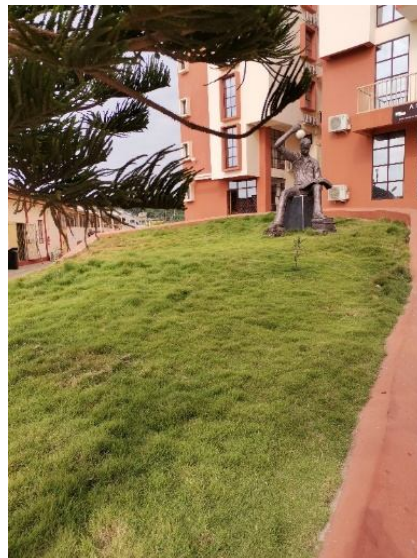
After the preparation of the land, two tipper truck trips of black soil were spread onto the prepared land by the artists with rakes. The ten (10) bags of green grasses were planted in the black soil on the prepared land with cutlasses and watered twice a-day (morning and evening). It was done continuously for one month with watering cans. This process was to ensure proper germination of the green grass [31]. Figure 6 shows the greening of the sculpture's environment.

Fig. 6: Greening the sculpture's environment

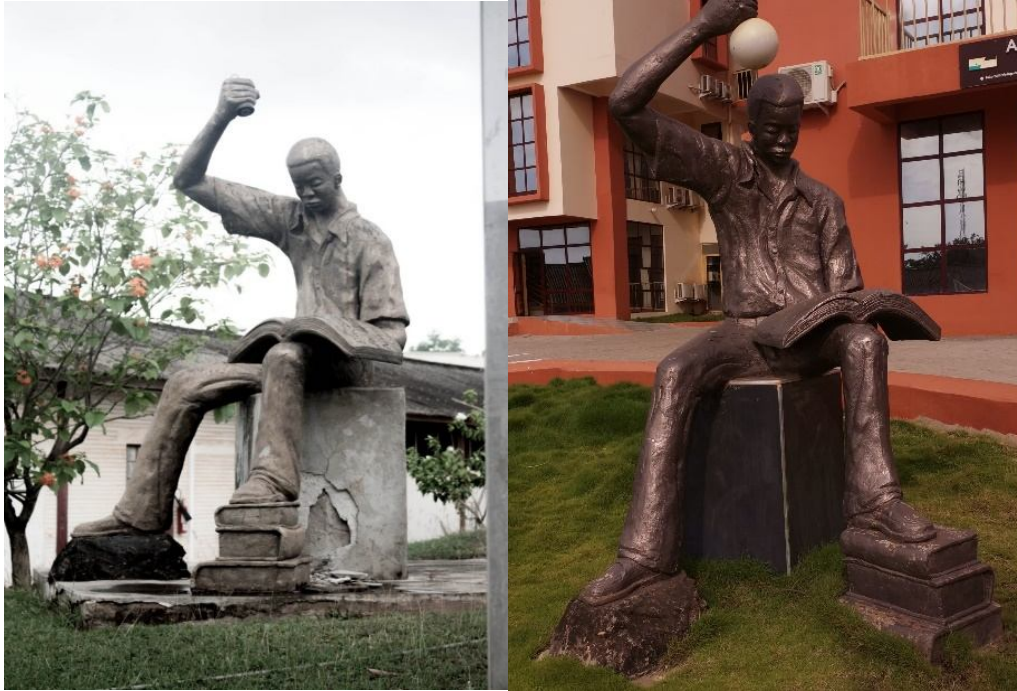
Fig. 7. Before and After Restoration

Information on the State of Conservation/Structural conditions: Surface molds, mildews, fungi, cracks, crazing, discoloration, scaling and curling of slow wear and damages, paint peel-offs, breakages at joints.

Surface appearance: Break in joints and surface discoloration.
