Original Research Article

EROSION RATE IN POST-COAL MINING RECLAMATION AREA IN KUTAI KARTANEGARA DISTRICT

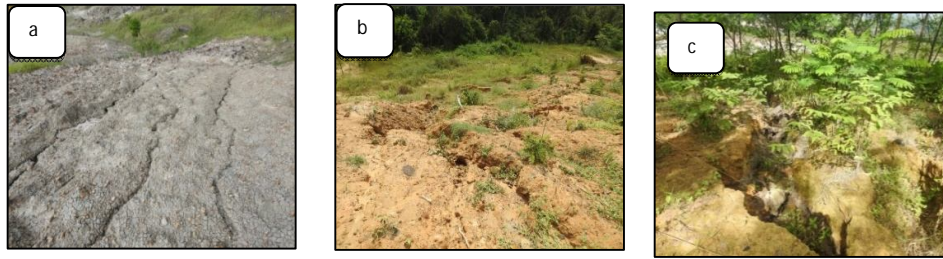
Figure 3. Condition of Reclamation Land
a) Disposal Area, b) Stock Soil Area, c) Reclamation Area in 2019

Based on the Erosion Hazard Class in the Jembayan Muarabara Group, Kutai Kartanegara Regency (Table 7), it is generally included in class V, which is very high. PT ABE in the Disposal area (558.55 tons/ha/year) and Stock Soil (552.39 tons/ha/year) fall into class V, while at the 2019 Reclamation research location (189.51 tons/ha/year) entered into class IV, namely high. At PT JMB, in the Disposal area (1341.94 tons/ha/year) and 2019 Reclamation (673.88 tons/ha/year), it is included in class V which is very high, while in the Stock Soil area (471.79 tons/ha/year) entered into class IV, namely high. PT KRA in the Disposal area (1003.38 tons/ha/year) and Stock Soil (693.51 tons/ha/year) is in class V which is very high, while in the 2019 Reclamation area (369.87 tons/ha/year) entered into class IV, namely high (Table 7). The class of soil erosion hazard from high to very high on the reclamation land is also shown in Figure 3, where groove erosion has formed up to gully erosion.

Each subsidiary's erosion rate in one year at the Jembayan Muarabara Group is different (Figure 3). In all research areas, the highest erosion rate was in the Disposal area ranging from 558.55 tonnes/ha/year to 1341.94 tonnes/ha/year. The highest erosion rate was at PT JMB at 1341.94 tons/ha/year, PT KRA at 1003.38 tons/ha/year, and PT ABE at 558.55 tons/ha/year.

The conservation technique in the Jembayan Muarabara Group is making bench terraces (terracing). The bench terrace is very helpful for reducing the erosion rate because it aims to reduce the slope length, retain water to reduce the speed and amount of surface runoff and increase the opportunities for water absorption by the soil. In addition to making bench terraces, there is also the construction of drains in the 2019 Reclamation area, but there are no drains in the Disposal and Stock Soil areas. Drains aim to reduce soil erosion by collecting and channelling surface water runoff, increasing water infiltration capacity into the soil and providing sufficient water for plants. Taking into account several other factors that affect the magnitude of the erosion rate at the study site in Jembayan Muarabara Group besides rainfall, vegetation cover, slope, volume weight and soil texture, namely at the Disposal location, there is no management of ground cover, there is no drainage around the barrier, especially at Disposal and Stock Soil locations.
