**REVIEW OF GULLY EROSION IN ANAMBRA STATE:
CAUSES,EFFECTS, CONTROL MEASURES AND
CHALLENGES ASSOCIATED WITH ITS MITIGATION**

Gully erosion is a severe environmental challenge faced by many parts of southeastern Nigeria particularly, Anambra state. Anambra state has more than 100 gully sites and about 30 gully sites have received measures of control but not yet subdued. Observations have shown clearly that the underlying geology of the area exerts major control in the development of gully erosion in the study area. The causes of progressive gullies in some parts of Anambra state is as a result of the topography, the pH of the soil/water, type of lithology, deforestation, hydro-geology and geotechnical properties of rock in the affected area. This erosion activity has resulted in the loss of productive lands, water pollution, sedimentation of water ways, loss of lives and properties, almost on a yearly basis. However, several government agencies have attempted managing it using concrete structures, stabilization work such as planting of bamboo tree, cashew tree to increase water intake, pipe structures to channel the water directly to a nearby surface water, construction of check da

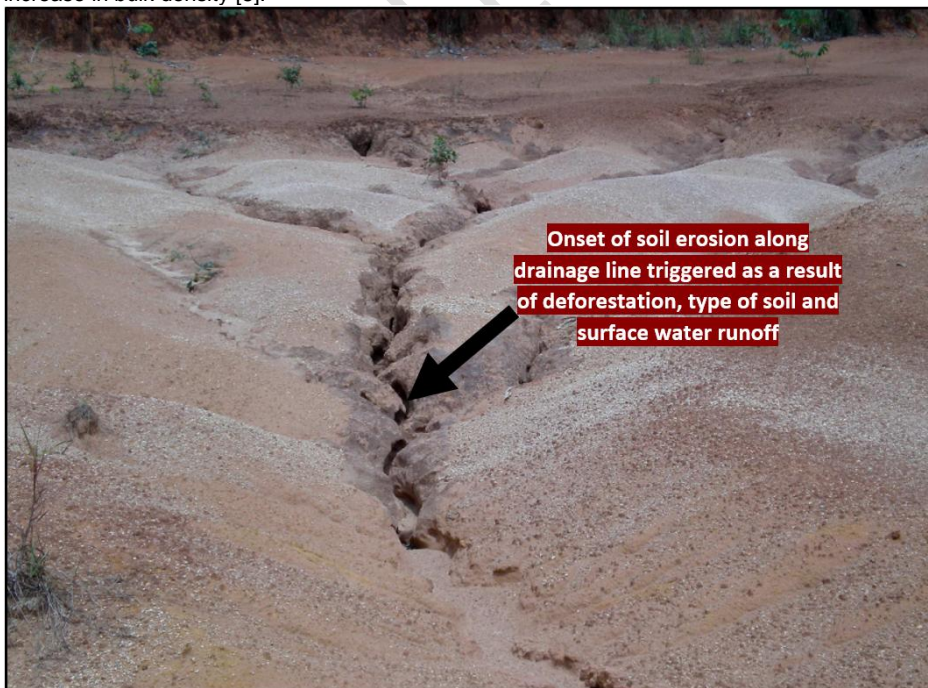
Fig 5: Onset of gully erosion triggered by deforestation and topsoil excavation [1].

Deforestation exposes the soil directly to the atmosphere and direct rainfall. During rainfall the soil will be compacted, thereby causing erosion along the drainage lines [1], [7]. The erodibility of soil increases with increased compaction because it reduces water infiltration by closing pore spaces thereby increasing surface runoff [1], [7]. This shows that Anambra state soils are following Federal Government specifications for non-weak soils. High compaction values for Anambra State soils depict high susceptibility to erosion. Erodibility of soil increases as compaction increases resulting in an increase in bulk density [8].

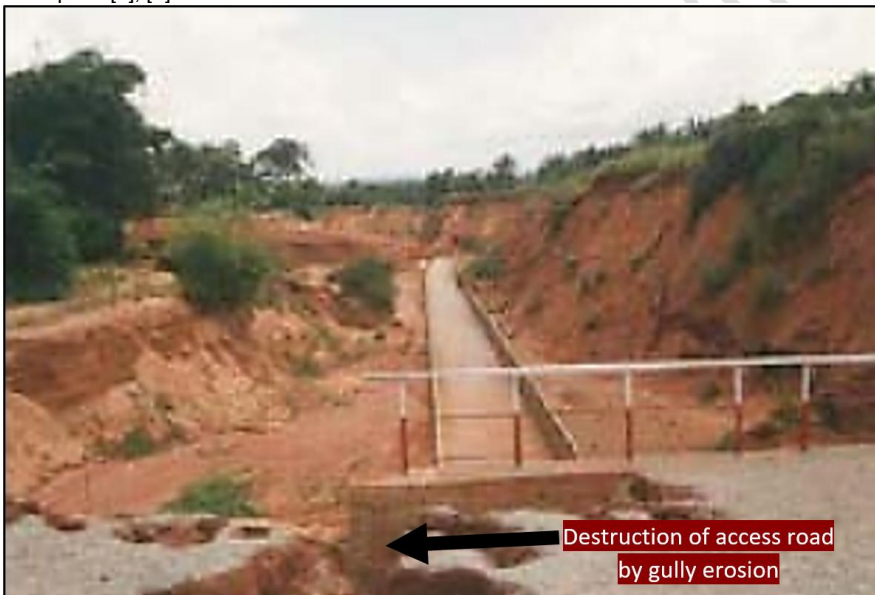
Fig 6: A Gully Site in Umuchiana, Aguata, showing the dissection of access road [12]

Gully erosion in Anambra state has enormous negative impact on both man and the environment. It leads to water pollution, loss of arable land use for farming, coloration of water, sedimentation of water ways, dissection of the property causing access and management difficulties and destruction of lives and properties[6]. A vast area of farmlands has been lost due to the menace of gully erosion while others are at their various stages of destruction leading to drastic decrease in agricultural productivity and ultimately food shortage that can lead to faming. If an unconfined aquifer is located close to the gully floor, dirty water from the gully will recharge the aquifer leading to contamination of the aquifer [1], [6].

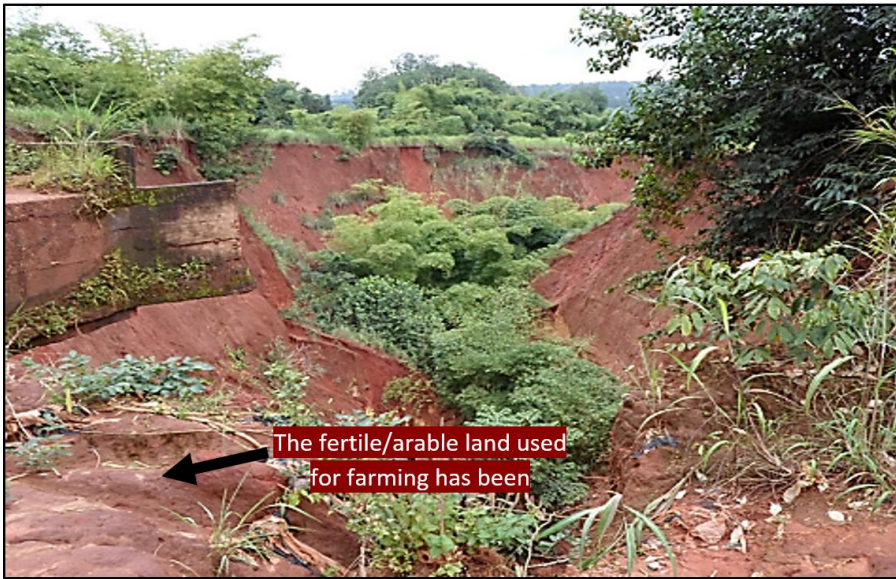
Fig 7:Gully site at Obinagu village showing loss of productive land [7].

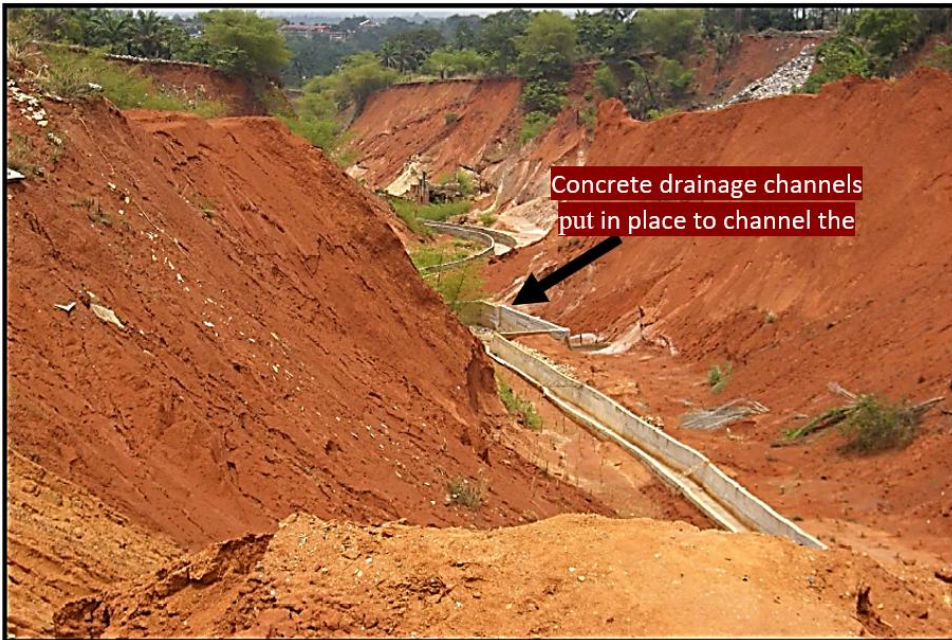
Fig 8:Control measure put in place to check gully erosion [1].

To be effective, gully control needs to be tackled in two ways: fixing the problems in the catchment, and stabilizing the gully itself. Gully walls can be stabilized through civil engineering works such as the construction of concrete embankment and grouting[1]. [15] suggested that enacting and enforcing all necessary legislations that will prevent developers from erecting structures along natural drains when appropriate channeling and/or alternative drains have not been provided should be put in place. [10]suggested that Organizing workshops, seminar, symposium, educating the communities in Anambra state, Environmental campaign awareness, Construction of storm water sock away, Good farming practices, and Construction of control Dams, ditches up valley, earth dams of adequate capacity should be should be encouraged to control the gullies.

[1]stated that Simple grouting and stabilization stop the increase of gullies especially when applied at a very early stage of development(fixing the problem in the catchment). Excess runoff can be controlled using pipeline structures this will help to channel the water to a nearby surface water. Materials to be used for the construction work should be acid resistant especially areas that are slightly acidic. Extensive afforestation program can be very effective in the control of gully erosion especially when well applied. This helps to protect the soil from the direct impact of raindrops and runoff as well as maintain the moisture content of the soil at responsible level during the dry season.[1] stated thatstability in moisture content isvery important to avoid the formation of tension crack which triggers erosion). Hydrogeology of the area influences the development and growth of gully, therefore controlling groundwater level by installation of well and dewatering facilities at strategic locations is necessary to check gully erosion.[1]opine that gully prone areas should be delineated and human activities such as agriculture and civil works controlled as these acts as gully triggers and catalyst.
