ASSESSMENT OF GEOTECHNICAL PROPERTIES OF SOIL IN CAPITOL GULLY EROSION SITE, UNIVERSITY OF BENIN, BENIN CITY, EDO STATE

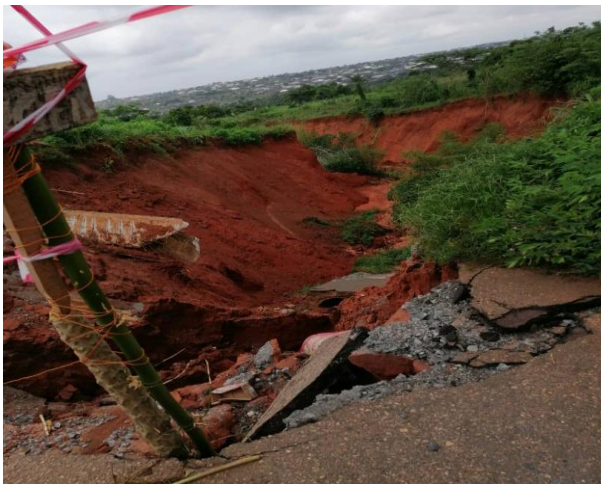
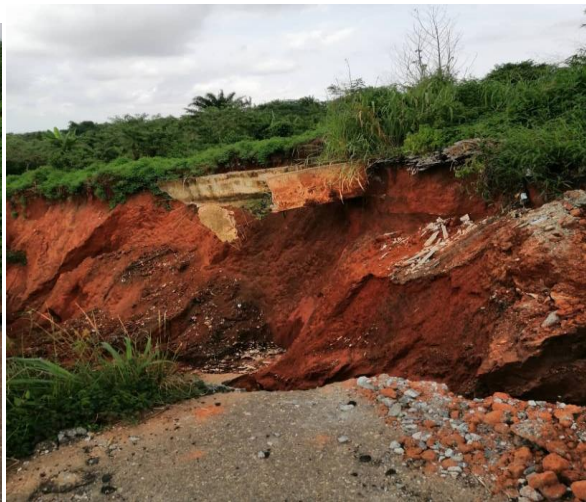
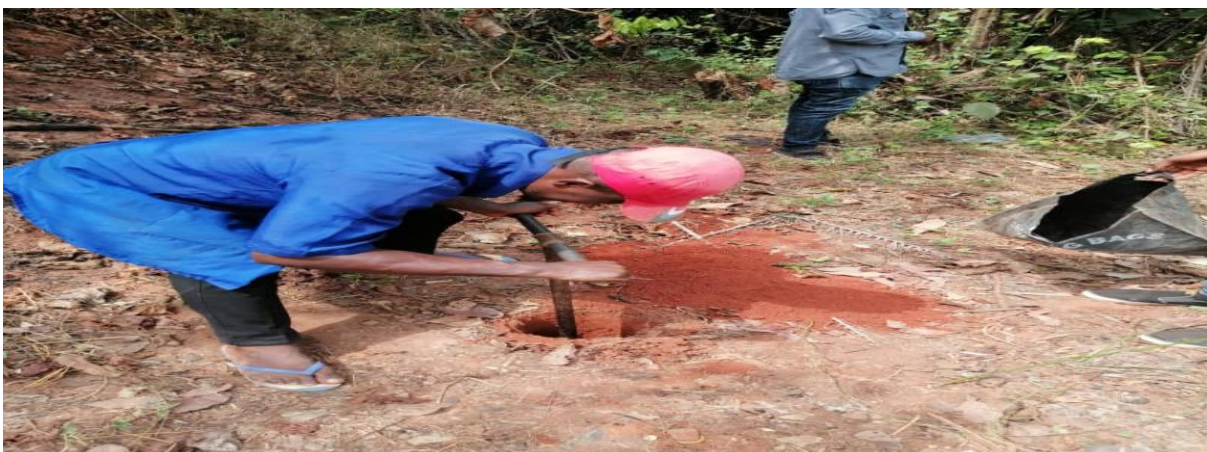
Three (3) soil samples were collected at depths of 1m each which is disturbed samples. Disturbed sample is a sample in which the natural structure of the soil is modified partly or fully during sampling. The following procedures was employed for the collection of disturbed sample that was used for this project.

- i. Drilling with the aid of continuous flight hand auger;
- ii. At a depth of 1.0m each, samples were collected.
