Integration of Remote Sensing and GIS for ~~modelling surface run-off~~ Surface rain-water flooding:

The Case of SharqElneel, study, Sudan Khartoum state, Sharq Elneel area.

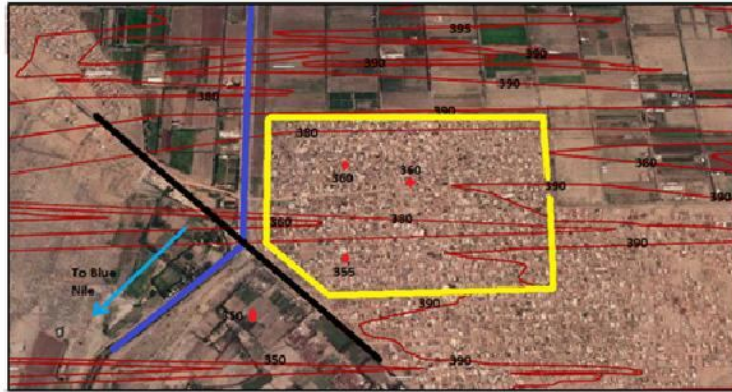
Figure 4, Google Earth topographic data of the study area, the study area (yellow), irrigation canal (blue), the highway (black) and direction of Blue Nile (light blue arrow).

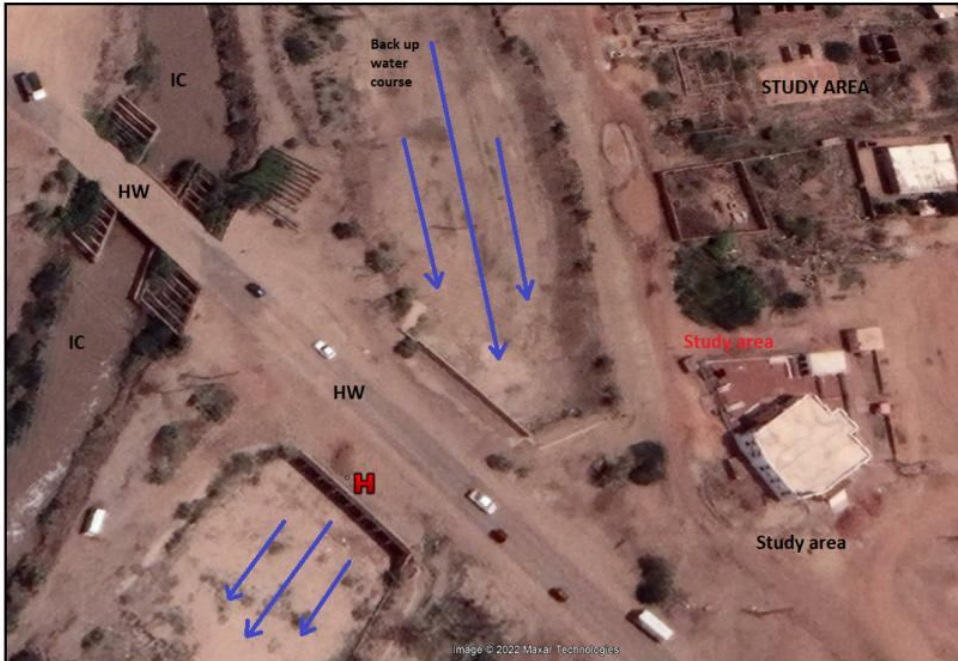
Figure 5, Back up water direction (blue arrows), large culvert (H), irrigation canal (IC) and highway (H).

The large culvert was located in the highway at its intersection with the canal (Figure-3). Figure 5, demonstrated the strong effect of these two man-made features on the study area. As mentioned before the surface rain-water from the large catchment area hit the canal and back-up following the natural drainage course in the direction of the Blue Nile. The bulk of this water runs by the side of the canal creating a very wide (30-40 m) and deep (2-3 m) water course by erosion. The back-up water hit the highway and accumulate due to the lack of an efficient drainage network. The result is that the water back-up again and accumulate in the low areas. As demonstrated in Figure 4, the study area is the lowest area in the vicinity. Thus it was severely affected in all of the past floods.
