Integration of Remote Sensing and GIS for Modelling Surface Run-off: Case Study of Marbeea-Alshareef, SharqElneel, Sudan

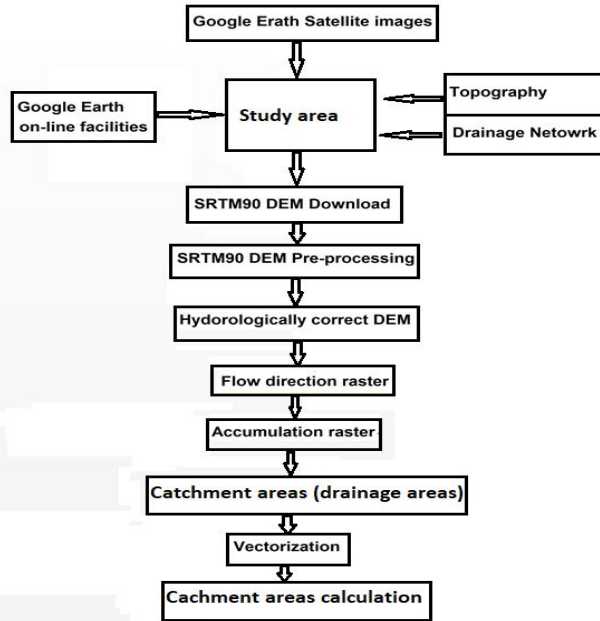
Flow chart 1. Data processing and derivation of the catchment areas

- 1- The main man-made and natural features in the area were identified using Google Earth photos and on-line GIS facilities (geographical model of the area)
- 2- The hydrological model of the area was formed using its SRTM90 digital elevation model [9] and the hydrological modules in QGIS application program, version 3.22.1 [10].
- 3- The main catchment draining areas affecting the study area were identified and their geometric information was derived (Flow chart 1).
- 4- The topographical and hydrological models parameters were integrated to answer the research question.

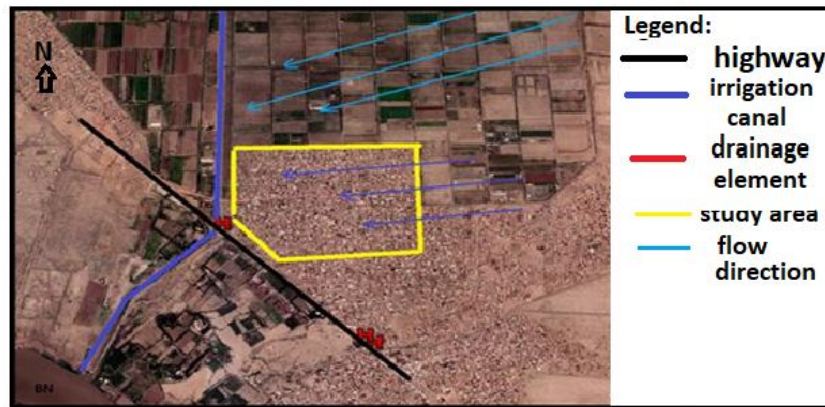
Fig.3.The drainage elements in the study area

Fig.3, clearly demonstrated that the large catchment area run-off will be blocked by the irrigation canal, back-up and flow parallel to the canal through the study area (yellow) on its way to the Blue Nile, causing flood crises. The

situation even get worse when the running water blocked by the highway with an embankment 2.7 meters high, with a very limited drainage elements which are not capable of passing this large volume of water.

The draining elements in the area were explored using Google Earth on-line GIS facilities. Three

elements were identified in the highway (marked red H). One large culvert (27x5 meters) and two small culverts (7x3 meters). There are no draining elements in the irrigation canal and it is surrounded by agricultural areas and has an embankment three meters high approximately (Fig. 3).

The large culvert was located in the highway at its intersection with the canal (Fig. 3). Fig. 5, demonstrated the strong effect of these two man-made features on the study area. As mentioned before the surface run-off from the large catchment area hits the canal and back-up following the natural drainage course in the direction of the Blue Nile. The bulk of this water runs by the side of the canal creating a very wide (30-40 m) and deep (2-3 m) water course by erosion. This water hits the highway and accumulate due to the lack of an efficient drainage network. The result is that the water back-up again and accumulate in the low areas. As demonstrated in Fig. 4, the study area is the lowest area in the vicinity. Thus it was severely affected in all of the past floods.

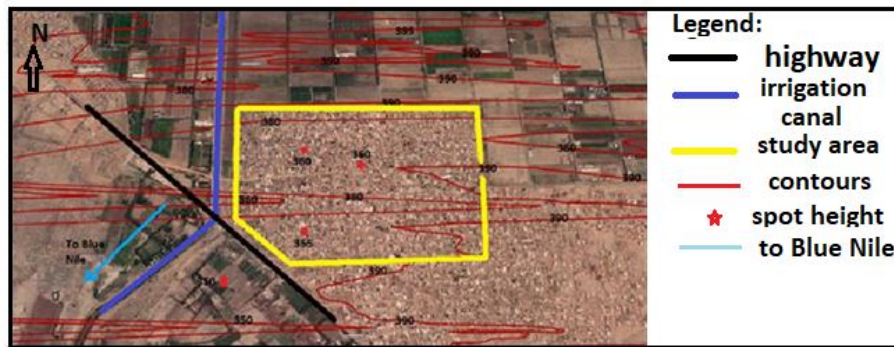
Fig. 4. Google Earth topographic data of the study area

The result is that the run-off water blocked by the irrigation canal and the highway will back-up and accumulate in the low areas. As demonstrated by Fig. 4, the study area (yellow) is the lowest area in the investigated area. This explained why the study area was the most severely affected by floods in 2007, 2013, 2014 and 2016. Normally, these floods cause a serious damage in the study area, in the form of fully and partially damaged houses and properties and losses of lives [13], [14]. However, the investigation clearly demonstrated that the floods in the study area are mainly attributed to the man-made features and to some extent to the low topography of the area. Though the study area is low compared to areas in its vicinity, it will not be severely affected by surface run-off if the irrigation canal and the
