# ASSESSMENT OF THE CHARACTERISTICS OF SLUM IN THE CORE OF AKURE, NIGERIA

This paper examined the characteristics of slum in the core of Akure, Nigeria, with a view to suggesting means of correcting the abnormalities caused by the slum environment. A sample size of 350 households amounting to 5% of the household population was randomly selected across eight selected neighbourhoods in the study area for questionnaire administration. Personal interview was conducted with the residents while field observation was made on the condition of the environment. Google Earth imagery was digitized to ascertain the number of buildings in the environment. Secondary data were collected from relevant journals, articles and textbooks. Data collected using the questionnaire was coded into the IBM Statistical Packages for Social Sciences (SPSS) version 23, where it was analyzed with the use of descriptive statistics such as frequency distribution and percentage. The results of the analysis were presented in Tables. Findings revealed that majority of the houses in the study area were informal. Majority of the buildings were old and dilapidated. Residents of the study area mostly use poorly maintained

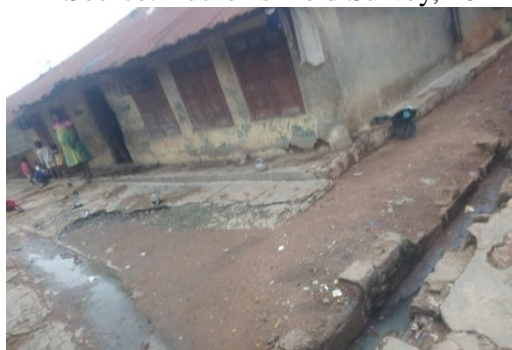
Analysis on the types of houses the respondents occupy shown in Table 2 revealed that the tenement housing also known as the Brazilian type was predominant in the study area [72%]; while the traditional, detached/semi-detached and blocks of flats had 12%, 2% and 14% respectively. Overcrowding, no doubt influences slum development; observations made during the field survey revealed that this type of building in the study area accommodates more family households. In a single face-to-face building, households between four [4] to six [6] was observed with an average of eight [8] rooms. This of course is one major characteristics of slum [overcrowding] which affects the state of health of residents. Evans, Wells, Chan and Saltzman [24] noted that overcrowding in houses has detrimental effect on both mental and physical health. Figure 4 showed the pattern of tenement building at Odojoka.

**Figure 4: Tenement Building at Odokoyi**

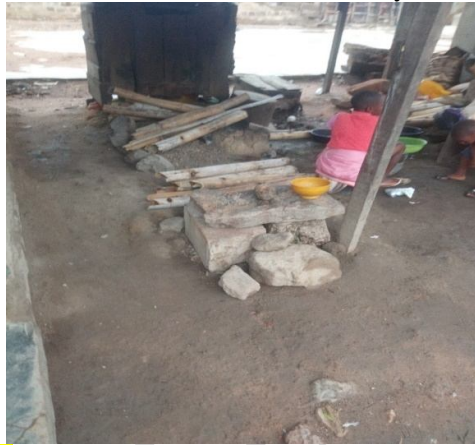
detached and constructed separately within the same compound. Residents mostly use firewood to prepare their meals. Exposure to firewood smoke leads to respiratory diseases including acute respiratory illness and impaired lung function [26]. Food is prepared in the open where flies, domestic animals, rodents, reptiles and filth are present. It is not surprising why diarrhea and other forms of gastro-enteric disorders are common in the core districts [27]. Figure 5 gave an example of a kitchen located outside the building at Isolo.

**Figure 5: Kitchen Located Outside the Building at Isolo**

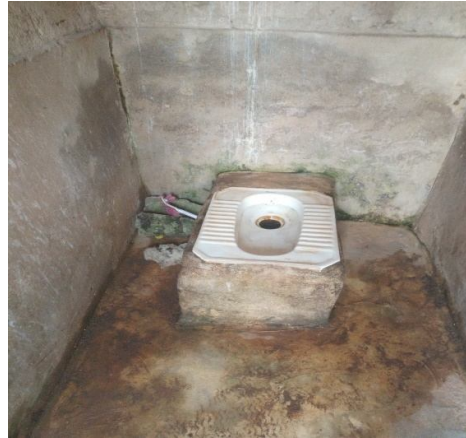
Analysis as shown in Table 5 revealed pit latrine to be the dominant means of convenience the residents of this community use. Majority of these toilets in the study area are located outside the building and are not well kept; the sanitation consciousness of the toilets by the users is very low. Poorly maintained shared pit toilet facility is a breeding ground for diseases vectors and an avenue for transmission of communicable and infectious diseases [27]. Evidence of a pit latrine with modern squat-bowl at Oja-Oshodi is shown in Figure 6.

**Figure 6: Pit Latrine with Modern Squat-Bowl at Oja-Oshodi**

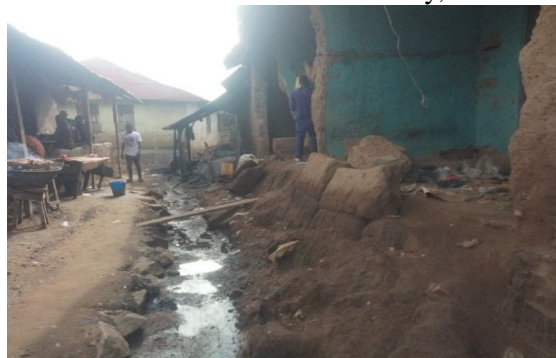
**4.6 Building Construction Materials** It was obvious from the field survey, that majority of the buildings in this study area were constructed with mud. As presented in Table 6, 72.9% of the buildings were constructed with mud while 27.1% was constructed with cement block. This clearly characterized the environment as slum. As a matter of fact, some of these buildings constructed with mud were not plastered with concrete; which is subject to wear and tear. It is not surprising that the deterioration of the environment can be linked with the construction materials employed in the study area. This housing material also established the fact that the buildings had been constructed many years ago, such as those that precedes modern planning. This shows that the level of technology of building construction in the study area is primitive. It was deduced from the survey that majority of these buildings are not in a sound state; they are mostly dilapidated and some almost falling apart. **Figure 7** showed dilapidated buildings constructed with mud at Odojoka where people still. Residents living in old houses constructed with mud experience cold more, especially during raining season or harmattan which affects their health. This study agreed with Wilkinson [28] who opined that the older the age of dwellings, the colder it becomes.

**Figure 7: Dilapidated Building Constructed with Mud at Odojoka**

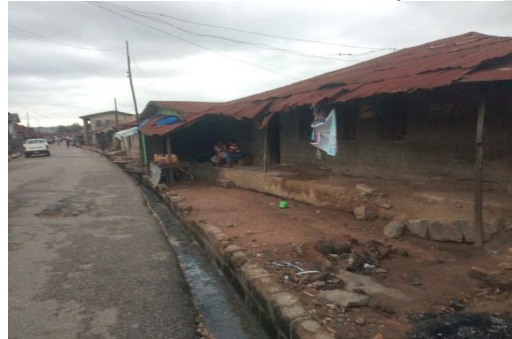
Analysis as shown in Table 7 revealed corrugated iron sheet to be the prevalent roofing material used for the buildings in the study area. Corrugated iron sheet when exposed to sunlight, rainfall and humidity over time leads to rusting which changes the colour of the roof and subsequently becomes dilapidated. It is evident from the survey conducted that majority of these roofing sheets are dilapidated, flapping and leaking. The implication is that, when rain drops, residents are exposed to leakages of water coming from the opening of their roofs. **Figure 8** gave a typical example of a dilapidated roofing sheet **at Araromi**.

**Figure 8: Dilapidated Corrugated Iron Sheet for Building Construction at Araromi**

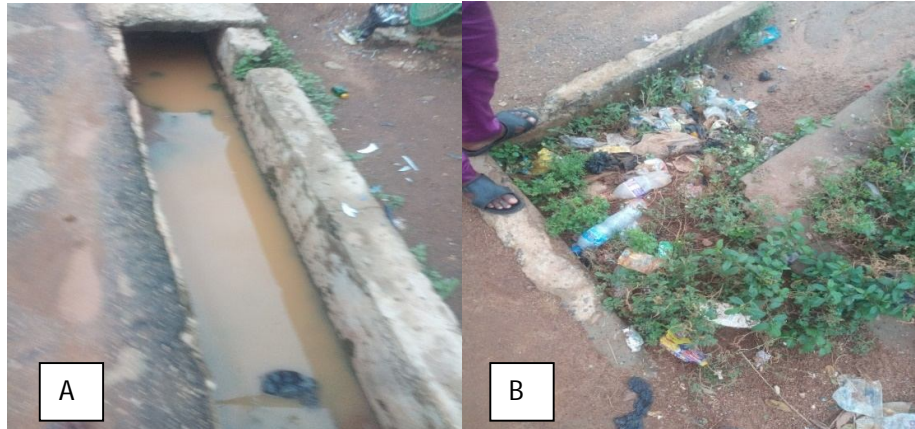
Analysis presented in Table 8 revealed the drainage condition in the study area. 76.6% of respondents agreed to have a free-flowing drainage beside the road leading to their homes, 10% had their blocked 3.4% experienced a water logged drainage while 10% do not have a drainage system at all. Although, some of the respondents while interviewing them noted that the drainage system becomes waterlogged especially when there is heavy downpour. This is due to the fact that some of the residents engage in depositing their waste into the drainages during this period. It was observed that some of the drainages produces obnoxious odour, this is connected to the attitude of some of the residents who deposit liquid waste from kitchen, bathroom and laundry indiscriminately to the drainages. This type of drainage condition breed mosquitoes which is the causative organism for malaria. The deposition of urine into the drainages also contribute to the foul smell emitted from these drainages, thus making it look unattractive. **Figures 9 [A & B]** gave a clear picture of a water-logged and clogged drainage system respectively **at Araromi and Owode**.

**Figure 9A: Water logged drainage at Araromi, B: Blocked Drainage at Owode**

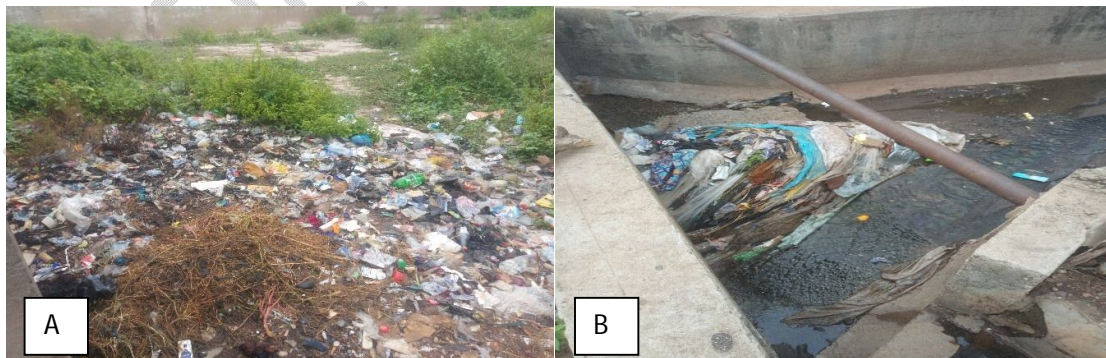
Analysis presented in Table 9 showed the waste management practices of the residents of the area under study. Data obtained from respondents revealed that the Ondo State Waste Management Board are in charge of waste collection in the area. A large proportion of the respondents [90.6%] revealed that the Waste Management Board do come with their trucks to evacuate waste generated by residents from the area. Despite the effort of the government in ensuring that the environment is kept clean, some still deposit their waste into open drains especially during rainfall, which causes the drainage to be water logged or completely blocked. Others deposit theirs in open spaces. This act harbor insects, rodents and some reptiles that is dangerous to the health of the residents. Figures 10 [A&B] depicts the indiscriminate waste practice of residents at Imuagun and Odokoyi

**Figure 10A: Indiscriminate Disposal of Waste at Imuagun, B: Accumulated Waste in Odokoyi Drainage**

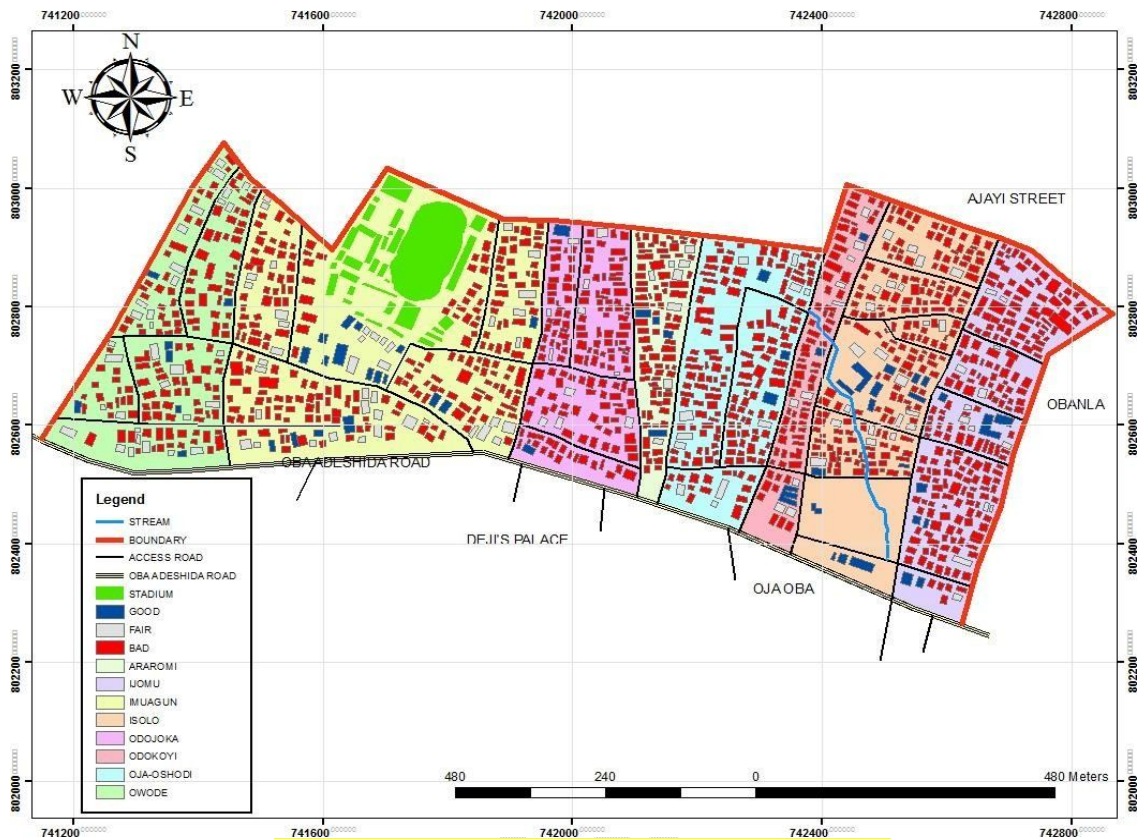
The Geographic Information System [GIS] was used to ascertain the extent of slum in the study area. Through this application, the condition of buildings in the study area was known and classified according to their extent. **Figure 11** presents the condition of the buildings in each of the neighbourhoods according to their degree of decay. It was discovered that out of the total 187 buildings in Owode, 147 [78.6%] were bad, 33 [17.6%] was fair and only 7 [3.7%] buildings were in a good condition. With this high number of poor buildings, this housing quarter can be regarded as a slum environment. At Imuagun, a large number of 217 [78.9%] buildings out of the total 275 were bad, 41 [14.9%] was fair while 17 [6.2%] was in a good condition. Here also, the poor buildings supersede the good ones therefore classifying the area as slum. 173 [93%] out of the total 186 buildings at Odojoka were bad, 11 [5.9%] was fair while a paltry 2 [1.1%] was good. This shows that Odojoka of Akure core had a huge number of poor buildings over the good ones, hence referred to as a slum environment. At Araromi, 74 [86%] buildings of the total number of 86 buildings were in a deplorable condition while 8 [9.3%] was considered to be fair and only 4 [4.7%] was in a good condition. The conditions of the buildings at Araromi were seen to be generally poor, hence, its classification as a slum environment. Out of the 167 buildings recorded at Oja-Oshodi, 152 [91%] was discovered to be in a poor condition, 12 [7.2%] were considered fair, while only 3 [1.8%] was realized to be in a good condition. With this prevalence of the poor buildings over the good ones, Oja-Oshodi which form part of the core can be identified as a slum environment. At Odokoyi, a total of 72 [83.7%] buildings were identified to be in a poor condition, 11 [12.8%] was fair, while 3 [3.5%] was discovered to be in a good condition. With the present situation of this housing quarter, the area hence regarded as a slum environment. At Isolo, out of the 184 observed buildings, 148 [80.4%] were seen to be in a poor state; 22 [12%] were fair while 14 [7.6%] were observed to be in a good condition. This huge number of dilapidated buildings categorize the environment as slum. At Ijomu 221 buildings was observed, of which a huge number of 200 [90.5%] were in a total deplorable condition, with 13 [5.9%] fair buildings, while 8 [3.6%] were observed to be in a good condition. With the deplorable condition of these buildings, Ijomu can as well be regarded as a slum environment. 85% of the buildings in the study area were in an extreme poor condition.

**Figure 11: Housing Condition of the Study Area**

Based on the empirical analysis results, this study proposed that urban renewal exercise should take place in the slum environment. The state government can partner with the

private organization to achieve this feat. During this stage, rehabilitation of dilapidated buildings should be done, rehabilitation of dilapidated roads and the provision of basic infrastructures. There is the need to go back to the old sanitation inspection conducted by the Ministry of Environment; this routine inspection will help checkmate the sanitation practices of residents of the area. The State House of Assembly should also make a legislation that will guide urban sanitation which will give room for the authorities to make it obligatory for households and service providers to play their part in ensuring a full sanitation practice. Public enlightenment via radio and television jingles, newspapers, and community meetings should be done so as to enlighten the residents on the need to ensure a safe and clean environment and how poor and unkempt environment can damage their health.
