Review Article

Recent developments in damage detection of CFRP composites using non-destructive techniques – a review

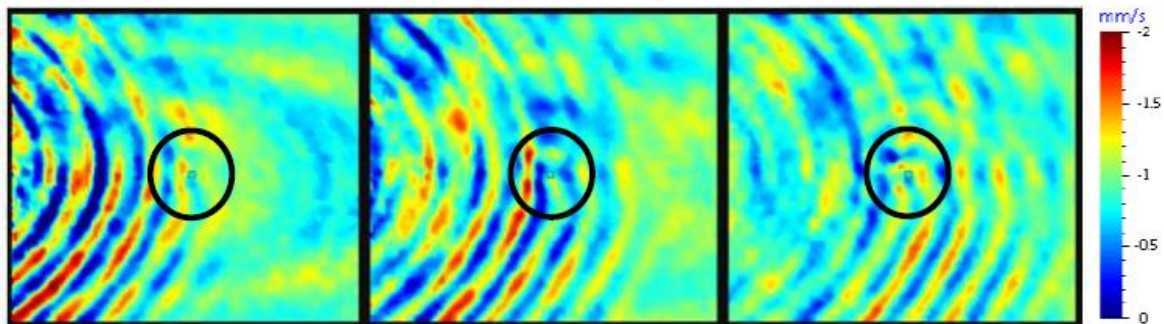
Figure 1. Interaction of the A0 mode with the damage from the high-resolution scan at 100 kHz with area of damage circled

grounded. Acoustic Emission (AE) monitoring and Acousto-Ultrasonics (AU), both of which are based on knowledge of the propagation of ultrasonic waves, are two aspects of SHM that are being explored. In this work, authors [3] have understood how AU waves interact with delamination in carbon fibre reinforced polymers. 3D Scanning laser vibrometry is being used to track AU wave propagation. A PZT transducer was utilized to emit three frequencies, and a cross correlation approach was used to analyse the signal that was received. 100 kHz was observed to be the frequency that propagated the best of the three signals from this and the vibrometer scans. Then, a high-resolution scan was carried out at this frequency, revealing that only the wave's out-of-plane component, particularly the A0 mode, interacted with the damage. The most efficient frequency was determined to be 160 kHz through a 3D Fast Fourier Transform.

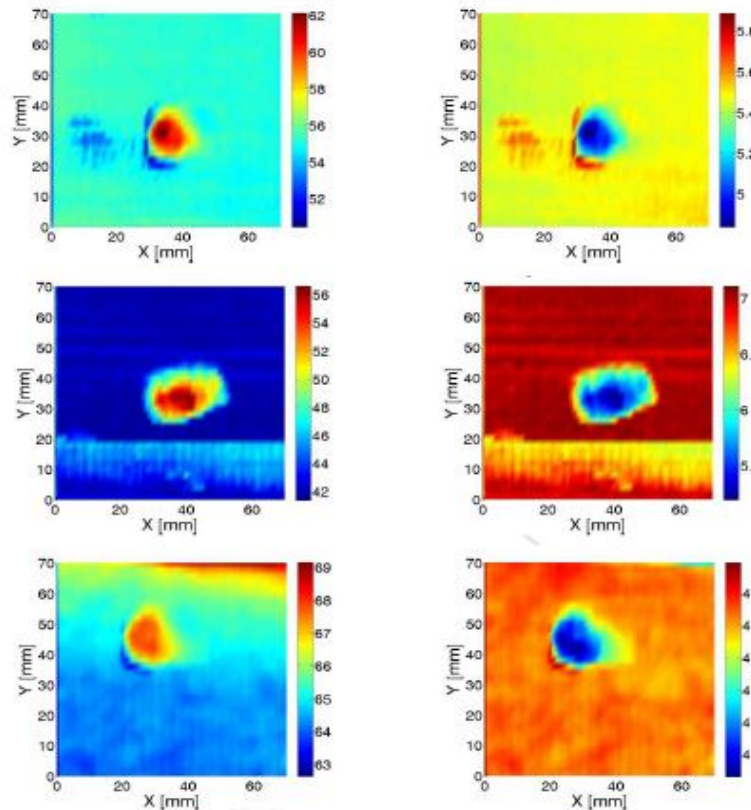
Figure 2. Capacitive images of delamination due to impact in the CFRP samples acquired at 300.04MHz, capacitance

of delamination are first determined using the spectral features of the capacitive sensor response to CFRP properties. The best excitation frequencies for the studied samples were discovered to be greater than 200MHz. Each of the samples exhibited in figure 2 had delaminations that could be clearly seen by capacitive imaging. To establish the existence and size of the delaminations, phased array method was used to obtain ultrasonic (UT) C-Scans of hits. For imaging shallow faults in composite materials at depths where UT has insufficient time domain resolution, capacitive imaging techniques can be utilised as a complement to UT.

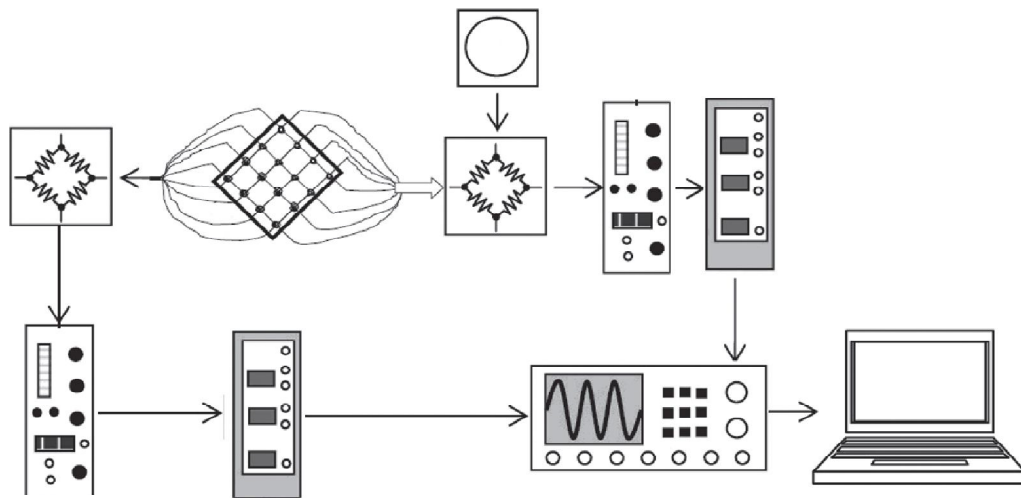
Figure 3: Schematic illustration of the experimental setup for dynamic measurements.

For the strain detection of Structural Health Monitoring a 3D braided composite preform with carbon nanotube thread strain sensor was developed. The inquiry by authors [7] into a network of carbon nanotube threads placed in 3D composites for the purpose of detecting damage yielded data on changes in the electrical resistance of the carbon nanotube threads. The response surface method was used to estimate the location and magnitude of damages in the 3D composites

shown in figure 3 based on changes in electrical resistance. This method provided an efficient way to estimate the location and number of damages.

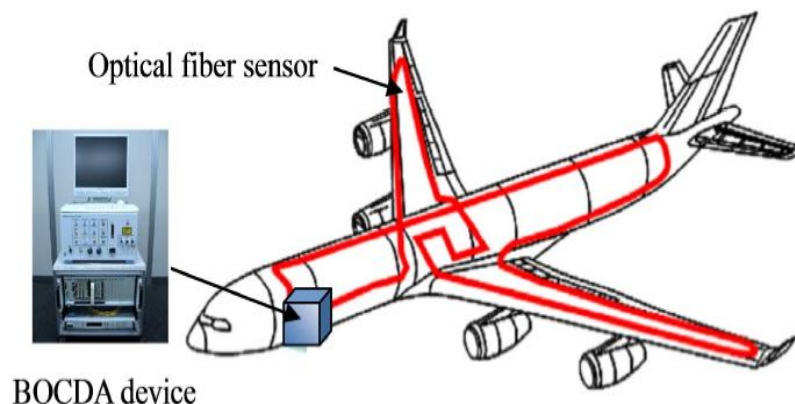
Due to its strength Figure 4. Application concept of BOCDA-SHM Technology frequently utilised in the construction of aeroplanes like the Boeing 787 and Airbus A380. Still used in primary constructions are bolted joints. Bearing failure is the primary failure mode for bolted joints. Because CFRP are brittle materials with limited yielding, stress concentrations that occur close to bolted joints are not eased by plastic deformation, bearing failures may result in catastrophic failures. Bolted joints are crucial inspection parts as a result. Inspection times will

vii) Distributed BOCDA Optical Fiber Sensor: One of the distributed optical sensing methods that makes use of the Brillouin scattering phenomenon is Brillouin optical correlation domain analysis (BOCDA). The BOCDA monitoring capability for composite damages, such as debonding at adhesive connections and micro-damages at bolted joints, as seen in figure 4, is described in this study [9] in terms of its current state of development.

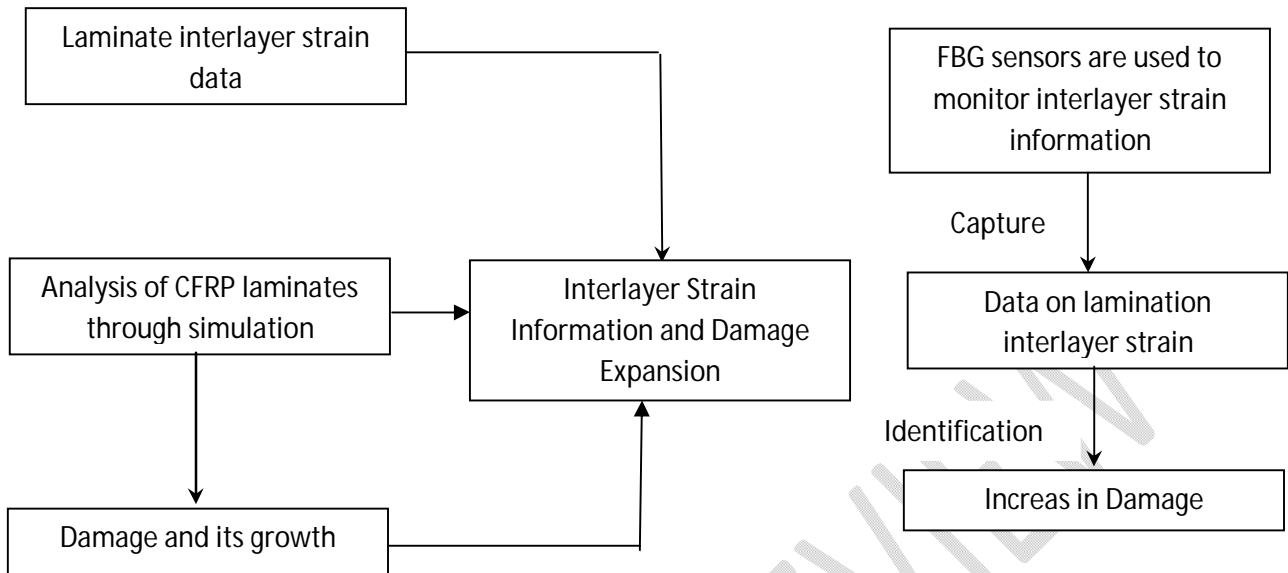
Figure 5. Damage recognition theory based on FBG Sensor for CFRP laminated plates

(xii) Fiber Bragg Grating Sensors: Based on an analysis of the relationship between changes in the strain distribution and damage expansion of CFRP laminated plates and the strain information shown in figure 5, the damage recognition method of CFRP laminated plates is proposed in this study [14]. The accuracy of the CFRP laminate damage detection method is next verified by performing the CFRP laminate damage identification experiment based on FBG sensor. Next, a Fibre Bragg Grating (FBG) sensor-based CFRP laminate damage monitoring system is developed. The results reveal that the difference between the load at which a damage appears on the FBG sensor and the load at which a damage to CFRP laminated plates expands in accordance with the simulated analysis is, at most, 16%. CFRP laminated plates' expansion process and damage recognition are both completed, and the efficacy of the damage recognition method for CFRP laminated plates is validated.

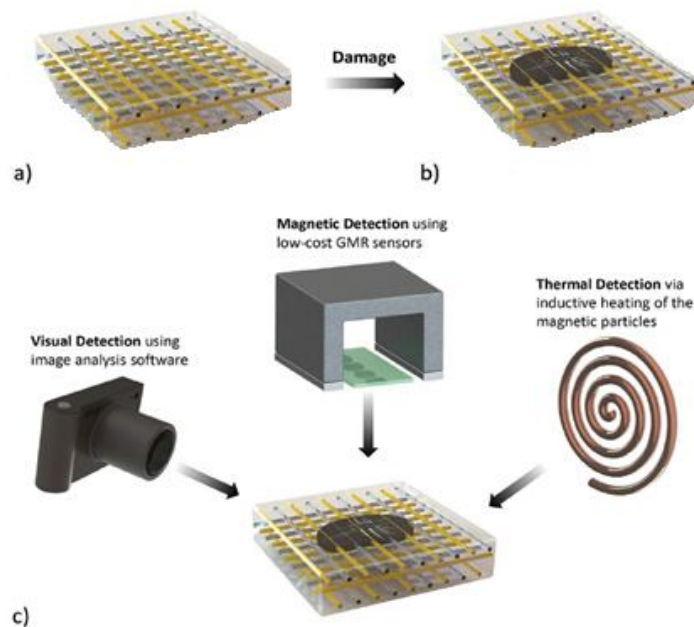
Figure 6. a) Schematic of the active vascular material system used to deliver the liquid constitutive parts of the magnetic particles. b) Mixing of the liquids causing precipitation of magnetic material in the damaged region. c) Schematic of three modes of damage detection: visual, magnetic, and thermal. Each mode is possible because of the high contrast between damaged and undamaged areas provided by the magnetic particles.

(xiv) Multimodal Damage Detection in Self-Sensing Fiber Reinforced Composites: Fibre reinforced polymer composite materials with functional elements have internal delamination damage. A vascular system that delivers fluids that precipitate magnetic particles upon mixing is used to achieve damage-triggered magnetization of the delaminated zone in figure 6. This magnetic substance is detected using a variety of detecting methods. By creating a biomimetic "bruise" with the magnetic particles that contrasts sharply between damaged and unharmed areas, visual detection is made possible. Even if the particles are covered in paint or opaque reinforcement, like carbon fibre, magnetic scanning can still find them. Inductive heating of the magnetic particles and infrared camera detection of the temperature difference are other methods for thermal detection. To determine accuracy, the efficacy of each detection mechanism is described [16] and contrasted with the accepted C-scan method. Visual detection measures the

damage area with a 76% accuracy, while magnetic detection measures it with a 91% accuracy, using the C-scan damage area as a baseline. Accuracy of thermal detection is time-dependent, as anticipated. Consistently, damage is found using every detecting method. The versatility of this material enables damage detection methods to be customised for the application and offers a parallel system to support and possibly improve self-healing.

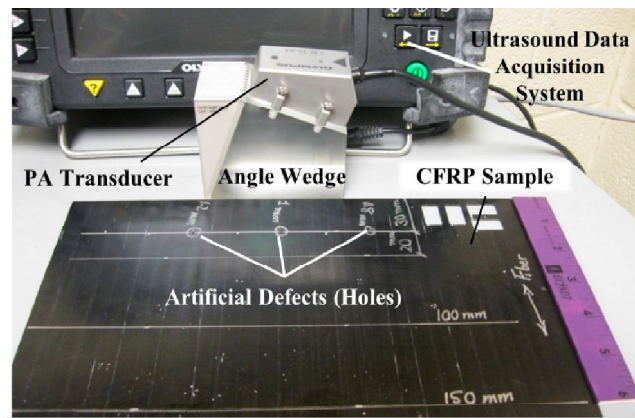
Figure 7. Experimental setup for flaw detection in CFRP sample using PAUT guided wave method

(xv) Phased Array Nondestructive Ultrasonic Inspection of Composite Materials: Due to their exceptional strength-to-weight ratio and resistance to corrosion, carbon- and glass-fiber reinforced polymer (CFRP and GFRP) composite materials have found employment in a variety of industries, including the automotive and aerospace sectors. For safe functioning, these materials' quality is crucial. Techniques for nondestructive testing (NDT) are a useful way to examine these composites. Although conventional ultrasonic NDT, utilising single element transducers, has disadvantages including high attenuation and low signal-to-noise ratio (SNR), it has been utilised in the past to inspect composite materials. Signals can be produced at appropriate angles and distances using the phased array ultrasonic testing (PAUT) procedures depicted in figure -7. For composites, where the anisotropic nature makes signal assessment difficult, these capabilities offer encouraging results. Detection of flaws in composites based on bulk and directed waves was reported by [17]. By comparing the signal characteristics to the traditional technique, the PAUT's potential and susceptibility to errors were assessed. According to the findings, PAUT can detect flaws with a size as tiny as 0.8 mm and a penetration depth of up to 25 mm, and the result signals exhibit better properties than those produced by traditional

ultrasonic technology. Additionally, it has been demonstrated that guided waves produced by PAUT have a remarkable capacity for finding flaws in composite materials.

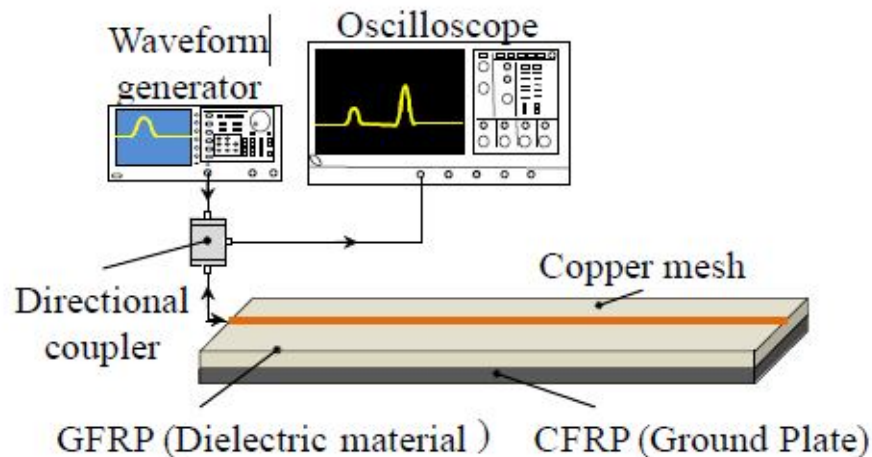
Figure 8. Schematic representation of self-sensing TDR method for damage detection of a CFRP laminate.

(xvii) Self-Sensing Curved Micro-Strip Line Method: The current study employs a self-sensing Time Domain Reflectometry (TDR) technique for CFRP laminate damage detection, which has been supported by [19]. In a gearbox line, carbon fibre sensors are used. Several research articles have been written about the self-sensing TDR technology. The self-sensing TDR technique reduces the amount of electrodes required to detect damage while sacrificing detection sensitivity. Using the micro-strip line (MSL) method to obtain impedance matching with a coaxial cable, damage to a CFRP laminate was successfully found in the earlier examination. In the current investigation, an impedance-matched transmission line for the larger region shown in figure 8 is experimentally tested as a long, curved MSL to identify damage to a CFRP laminate. Fibre breaking is simulated by drilling a hole. Since a CFRP laminate has a substantially orthotropic electric conductance and the electric properties of a CFRP laminate at

the high frequency are unknown, the impact of the orthotropic conductance at the bent gearbox line is experimentally examined

As a result, it is shown that orthotropic conductance at the curved strip line has no bearing and that the self-sensing curved MSL approach may identify fibre breakage that takes place close to the copper strip line.

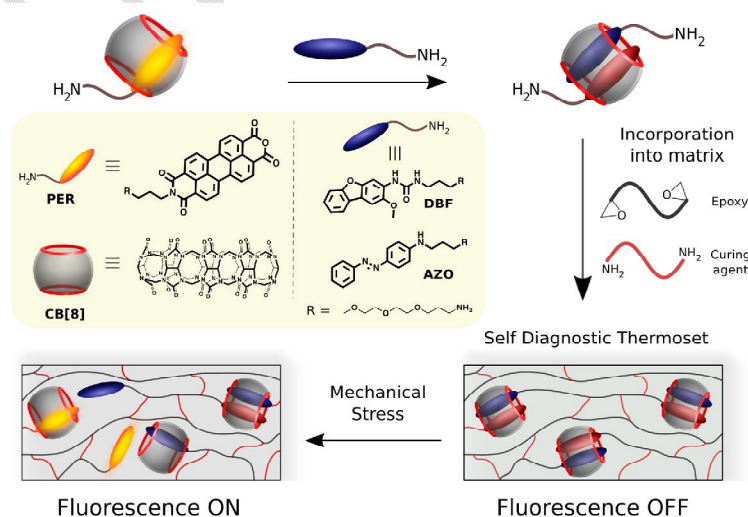
Figure 9. Schematic representation of the working principle and components of the damage reporting carbon fiber-epoxy resin composites

(xviii) Supramolecular approach: It has been reported that the introduction of a CB8-based ternary complex as an additive utilising a supramolecular technique enabled self-diagnosis of early-stage damage in a carbon fibre epoxy composite material [20]. The CB8-encapsulated complex, which consists of a fluorescent probe and a quencher, is added to the epoxy resin of the composite as a supramolecular crosslinking agent, causing its stress-induced dissociation to activate the probe's fluorescence. This makes it possible to identify irreversible mechanical strain and fatigue at an early stage, allowing for the evaluation of microdamage in the material depicted in figure -9.

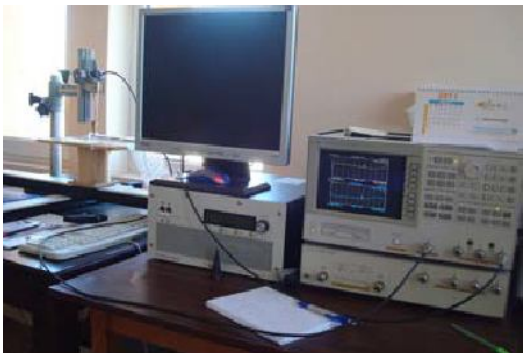
Figure 10.a - Electromagnetic testing

The behaviour of carbon fibre woven-PPS composites at low velocity impacts is discussed by the authors [21] in this study. Since the plastic deformation after impacts changes the transversal electrical conductivity, electromagnetic procedures (figure 10a) can be used to evaluate CFRP using a high-resolution sensor with a metamaterials lens and compare the results to those from ultrasound testing with a phased array sensor. When phased array ultrasound is utilised (figure 10b), the area of the delamination is overstated, but electromagnetic testing significantly underestimates it. The finite element simulations and the experimental data were found to be in good agreement.

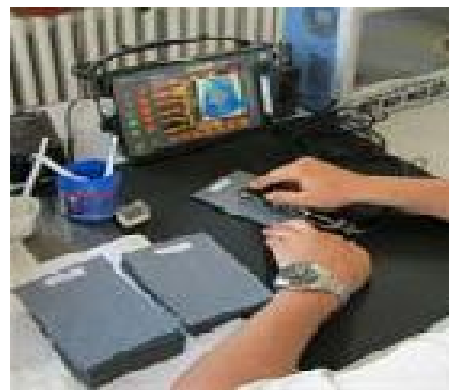
Figure 10.b - Ultrasound Testing

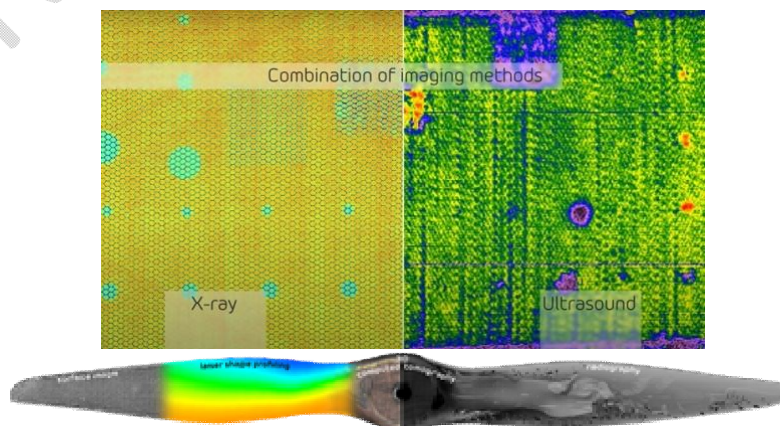
(xx) X-ray combined with Ultrasound for damage detection in CFRP: Radalytica [22] created a multimodal inspection method that combines ultrasonic testing (UT) and x-rays for the purpose of identifying impact damage to composite materials. Because delamination may be very accurately identified by ultrasound but cannot be detected by x-ray. If there are cracks in impact damage, high-resolution x-ray imaging gives a lot of information, but it is impossible to discern any surrounding delamination. However, with ultrasonography, only the delamination may be seen, not the entire impact. The current idea is to combine these two methods to give a far better overall picture of damage identification in composites.
