Original Research Article

Application of Deep Learning Techniques in the Development of Predictive Maintenance and Fault Detection in Electric Motors

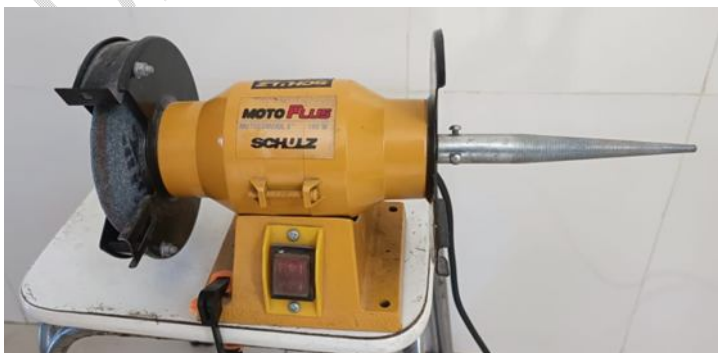
To evaluate the deep learning technique associated with thermographic analysis, an experimental procedure was proposed to overheat an electric motor in a controlled manner without causing permanent damage to the equipment. Thus, the electric motor used was a bench grinder, as shown in Fig. 1. To modify the temperature profile of the motor, a resistive load was applied to rotation on the right axis of the equipment.

Fig. 1. Bench grinder used in the overheating study.

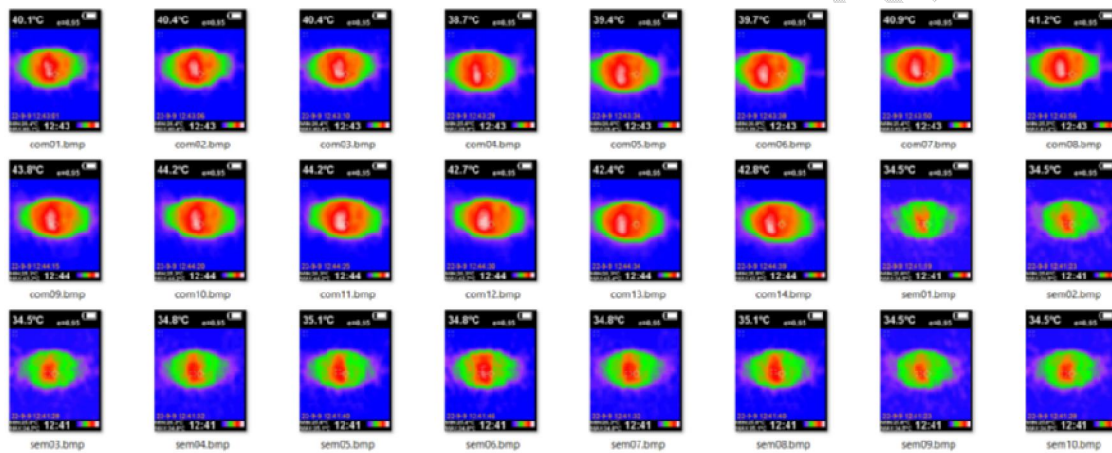
Fig. 2. Thermographic images obtained from the bench grinder with and without load.

As can be seen in general, the images obtained by thermography allow the identification of two different temperature profiles of the monitored component subjectively and humanly. Since the temperature profiles are already sufficient to interpret the equipment's stress condition clearly in this work, the color tones were not readjusted in scale.

As can be seen from the color scale at the bottom of the thermal pictures and by overlay, the green temperature profile still represents a lower temperature pattern, with the center of the motor experiencing the most heating. If the motor had some leakage of charges, or wear, increasing friction in rotation close to the bearings, these details would also represent hot spots in the images. However, the limited and non-destructive procedure adopted in this study was limited to applying a frictional load on the axis on the right side of the image, promoting a greater demand on the motor and thus causing overheating in Fig. 2.

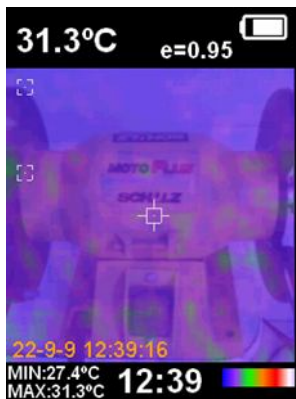
Fig. 3. Image taken by the thermographic camera.

In Fig. 3, it is possible to see the option of the camera to superimpose the thermal images on the actual image of the object to facilitate the positioning of the tripod to take pictures. However, due to the low mass of the bench, it suffered small displacements from the base caused by engine rotation. Nevertheless, this noise did not impact the classification step of the temperature profiles.

Still, in Fig. 3, there is no significant color variation when it is turned off or at the beginning of the motor rotation. To reinforce this point, Fig. 4 is presented, a photo taken shortly before Fig. 3, removing the overlap of the actual image.
