## **Original Research Article**

# **Application of Deep Learning Techniques in the Development of Predictive Maintenance and Fault Detection in Electric Motors**

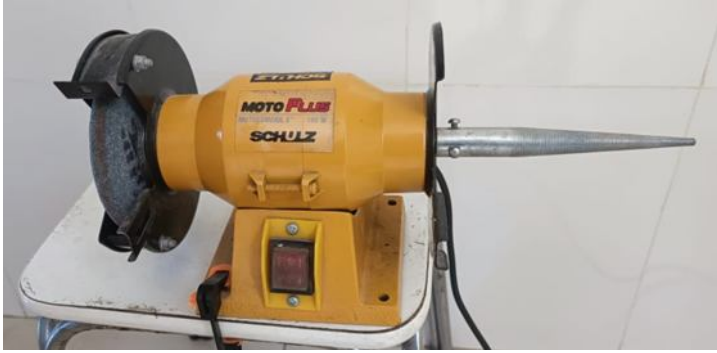
To evaluate the deep learning technique associated with thermographic analysis, an experimental procedure was proposed to overheat an electric motor in a controlled manner without causing permanent damage to the equipment. Thus, the electric motor used was a bench grinder, as shown in Fig. 1. To modify the temperature profile of the motor, a resistive load was applied to rotation on the right axis of the equipment.

**Fig. 1.** Bench grinder used in the overheating study.

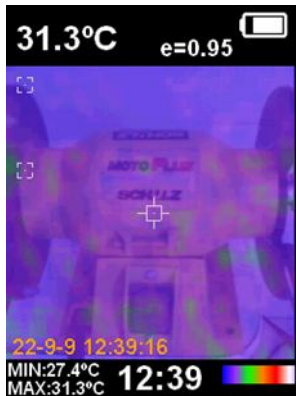
**Fig.3.**Image taken by the thermographic camera.

In Fig.3, it is possible to see the option of the camera to superimpose the thermal images on the actual image of the object to facilitate the positioning of the tripod to take pictures. However, due to the low mass of the bench, it suffered small displacements from the base caused by engine rotation. Nevertheless, this noise did not impact the classification step of the temperature profiles.

Still, in Fig.3, there is no significant color variation when it is turned off or at the beginning of the motor rotation. To reinforce this point, Fig.4 is presented, a photo taken shortly before Fig.3, removing the overlap of the actual image.

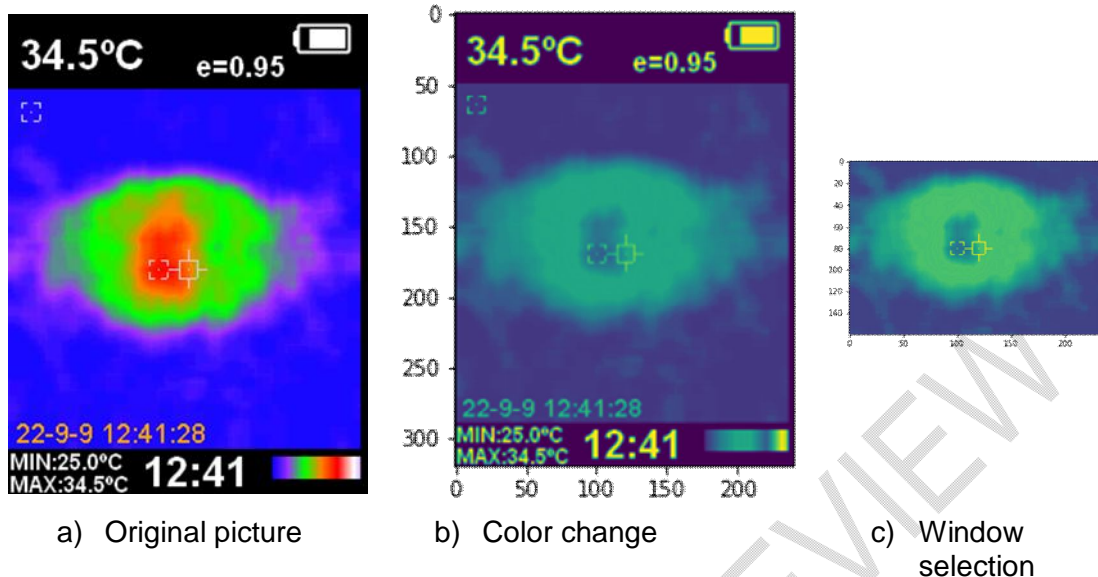
A binary classification model based on convolutional neural networks was constructed with images obtained from loaded and unloaded profiles on the grinder. Images obtained after pre-processing were used as input parameters for the model. This pre-processing first consisted of transforming the RGB color pattern (three layers of colors) into one of 256 levels of gray. Then remove the header and footer from the image shown in Fig.3. Fig.6 illustrates this sequence of pre-processing steps.

**Fig.6. Pre-processing of images with header and footer removal.**
