**EXPERIMENTAL STUDY CORROSION PARAMETERS OF COPPER AS
AN ECO-FRIENDLY HEAT COLLECTOR FOR SOLAR WATER HEATERS**

Aims: The corrosion behaviour of copper as a solar collector material was adequately simulated in tests in a solar water heating system

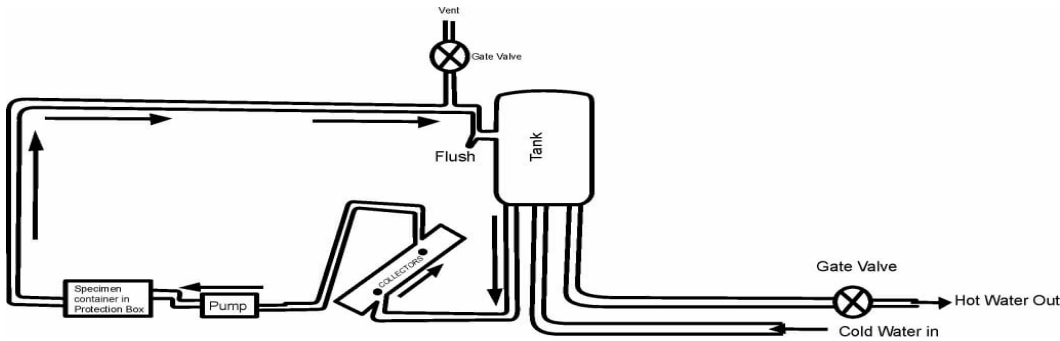
Figure 1: shows the general layout of the experiment.

This consists of:

- (i) A flat plate solar collector comprising two (1mx1m) parallel flat plates with 12.5mm diameter risers spaced 8cm apart. The corrugated collector was initially nickel plated but due to age, the plating was far from perfect and it was repainted with black gloss paint. The initial solar collector excludes the pump and the specimen container as it was thermosiphon driven between collector and tank.
- (ii) The pump is a KB25 KWABATA centrifugal pump with a maximum head of 100' (33m) and a maximum capacity of 21US gallon/minute. A variac variable device to vary motor speed was added. The pump was to aid the circulation of the hot water through the specimen container.

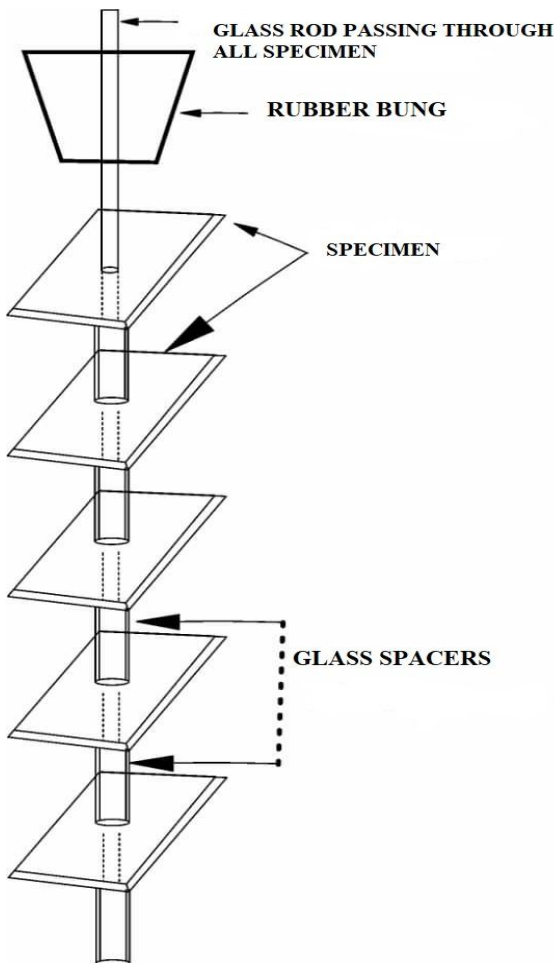
Fig 2: Specimen container

- (iii) The specimen container (Figure 2), fabricated in the chemistry department of University of Delta, Agbor was a 100mm diameter tube and the function for vertical holding of specimen was 60 mm. The glass was protected by holding it in a box stuffed with saw dust.

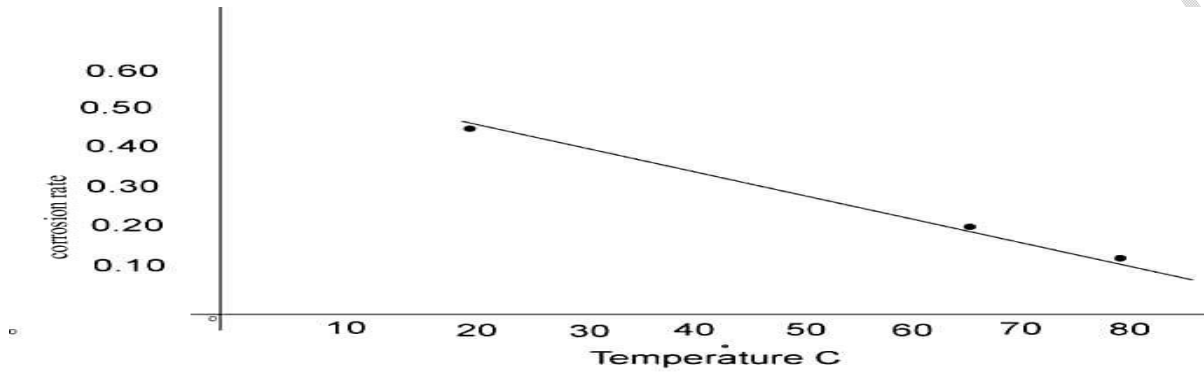
Fig 4: relationship between corrosion and temperature

From this table, it appears that the higher the mean temperature, the smaller was the corrosion rate. This result agrees with [7], that as oxygen is removed copper corrosion is stifled. Figure 4 shows that there is a drop in corrosion rate as temperature increases. The work of [8] show that oxygen solubility in water decreases very rapidly as the temperature rises.

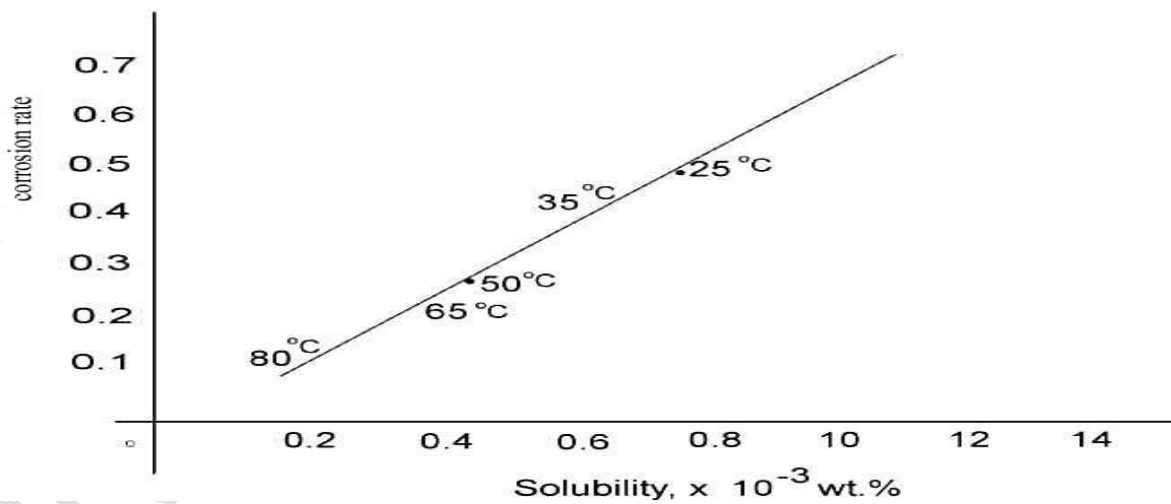
Fig 5: relationship between corrosion and oxygen solubility

The confirmation through the present experiments that there exists a relationship between corrosion and oxygen solubility is provided by figure 5, where there is a direct correlation. This implies that corrosion in copper solar collectors is more serious at lower temperatures. At the higher temperatures likely to be encountered, copper corrosion becomes insignificant.
