EXPERIMENTAL STUDY CORROSION PARAMETERS OF COPPER AS AN ECO-FRIENDLY HEAT COLLECTOR FOR SOLAR WATER HEATERS

Abstract

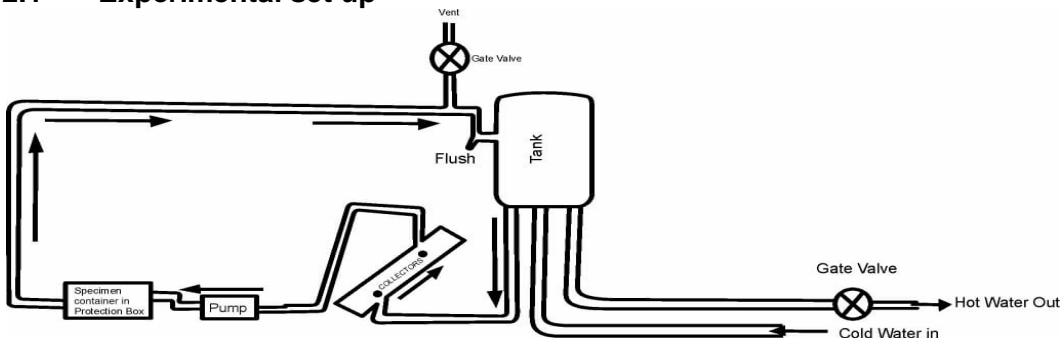
Figure 1: shows the general layout of the experiment.

(i) A flat plate solar collector comprises two (1mx1 m) parallel flat plates with 12.5 mm diameter risers spaced 8 cm apart. The corrugated collector was initially nickel plated but due to age, the plating was far from perfect and it was repainted with black gloss paint. The initial solar collector excludes the pump and the specimen container as it was thermosiphon driven between collector and tank.

(ii) The pump is a KB25 KWABATA centrifugal pump with a maximum head of 100' (33 m) and a maximum capacity of 21US gallons / minute. A variac variable device to vary motor speed was added. The pump was to aid the circulation of the hot water through the specimen container.

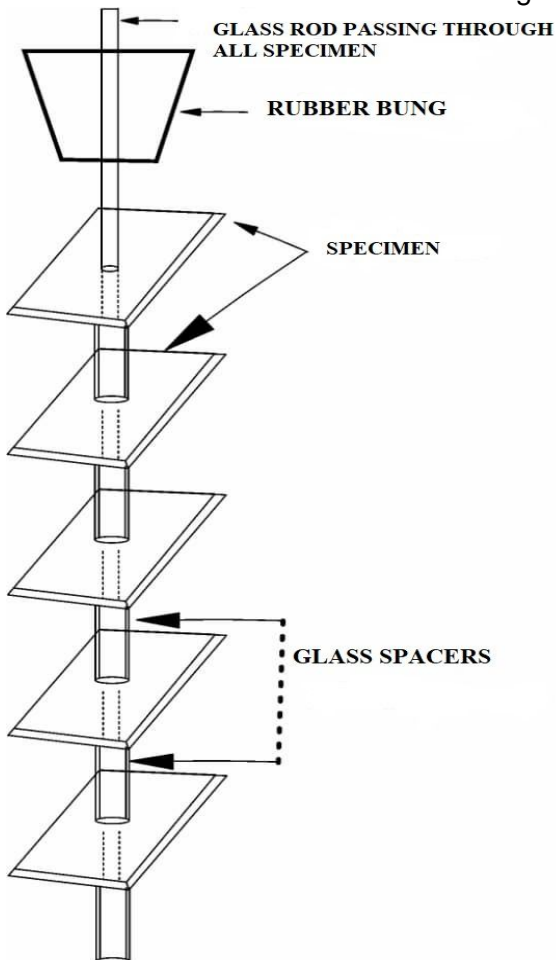
Fig 2: Specimen container

(i) The specimen container (Figure 2), fabricated in the chemistry department of University of Delta, Agbor was a 100 mm diameter tube and the function for vertical holding of specimen was 60 mm. The glass was protected

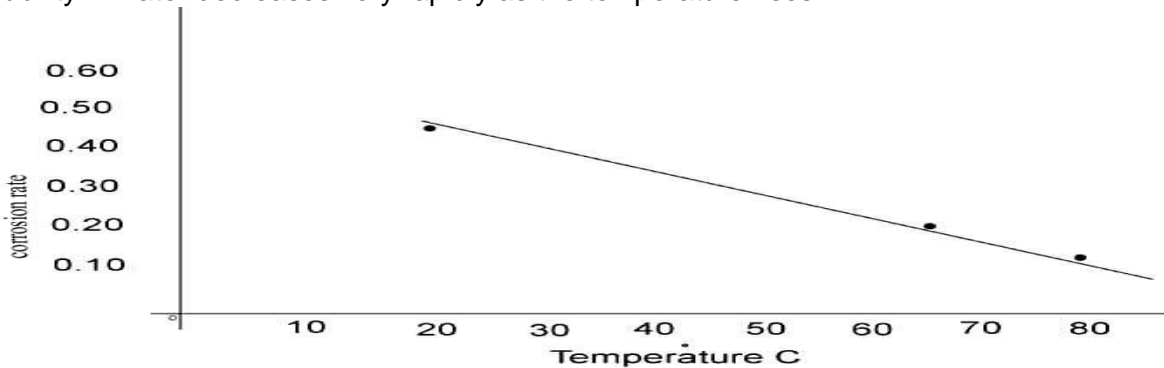
From table 1, it appears that the higher the mean temperature, the smaller was the corrosion rate. This result agrees with [7], that as oxygen is removed, copper corrosion is stifled. Figure 4 shows that there is a drop in corrosion rate as temperature increases. The works of [8][9][10] shows that oxygen solubility in water decreases very rapidly as the temperature rises.

Fig 4: relationship between corrosion and temperature

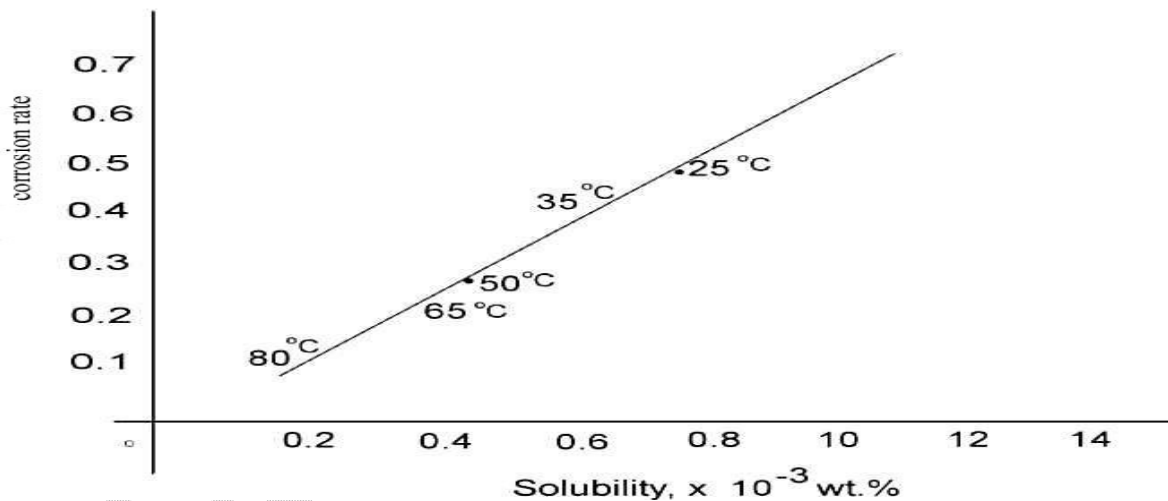
The confirmation through the present experiments that there exists a relationship between corrosion and oxygen solubility is provided by figure 5, where there is a direct correlation. This implies that corrosion in copper solar collectors is more serious at lower temperatures. At the higher temperatures likely to be encountered, copper corrosion becomes insignificant.

Fig 5: relationship between corrosion and oxygen solubility
