Anthropogenic Geomorphology of the Magoye Riverine Landscape, Zambia

ABSTRACT

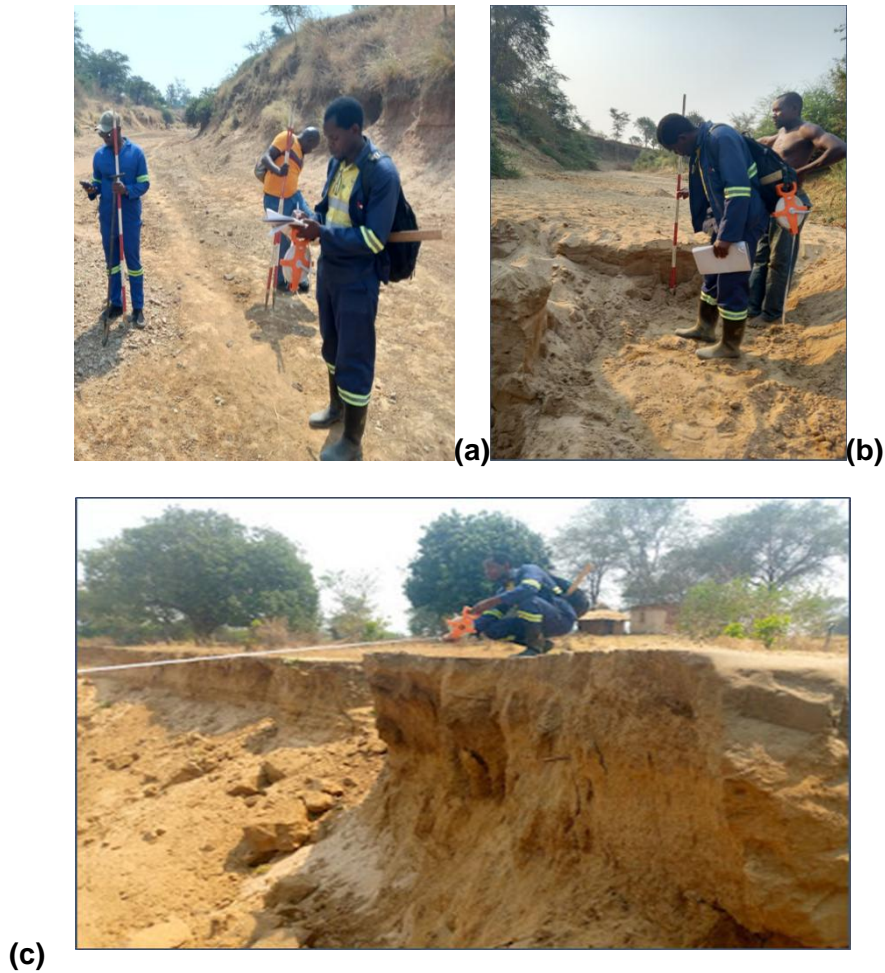
the channel width were 31. Below is figure 2. (a)-(b)-(c) that show data collection on the channel and bed morphology of the Magoye River.

Fig 2: (a-b) Field measurements of sediment depth and (c) Degraded channel and bed morphology of the Magoye River.

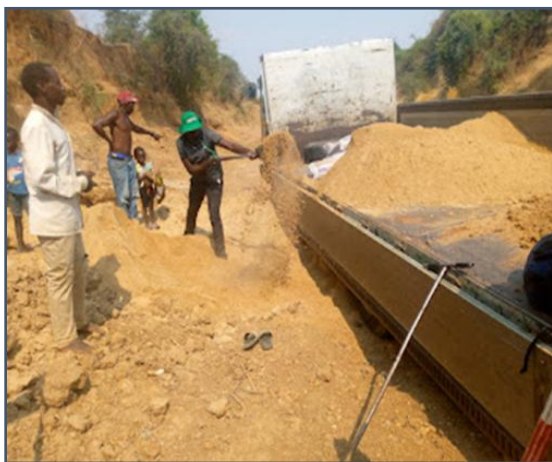
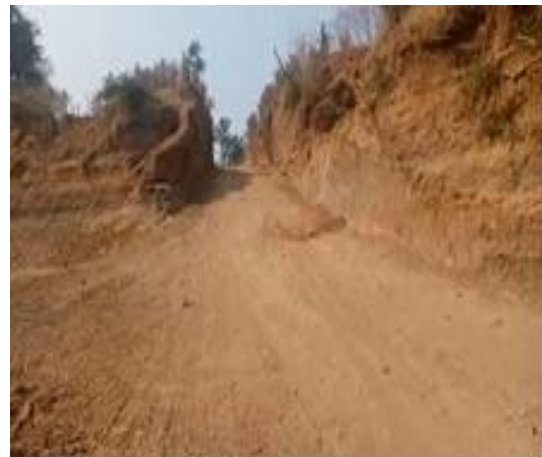
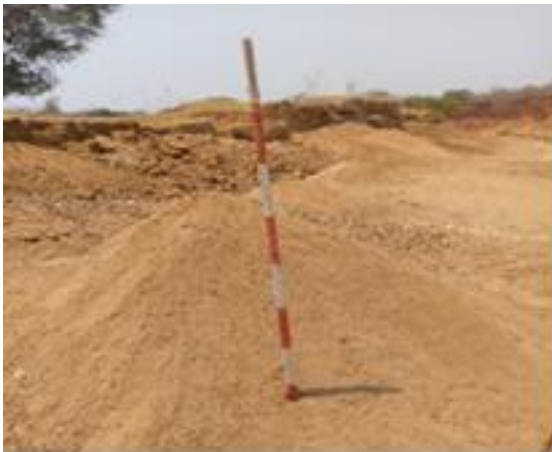
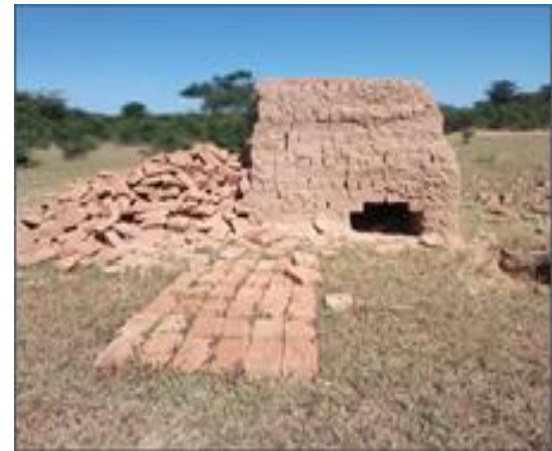
The findings further reveal that, the most imposing 1000m² of dry surface area. Through field was excessive siltation of the river channel bed experimental assessment on 31 out of 47 damaged leading to drastic loss of flowing water-holding cross sections of the river channel widths from the capacity, potential oxbow lakes and floodplains. In Magoye River, the study noted other geomorphic formation. This coupled with sand mining triggered features like water access points, sand collection, heavy burden of sediment on the riverbed amounting to over 5 million cubic Meters spread across 46 (Figure 5).

Fig 5. Showing (a) Sand collection (b) Vehicle access roads (c) Sand cone (d) Brick moulding

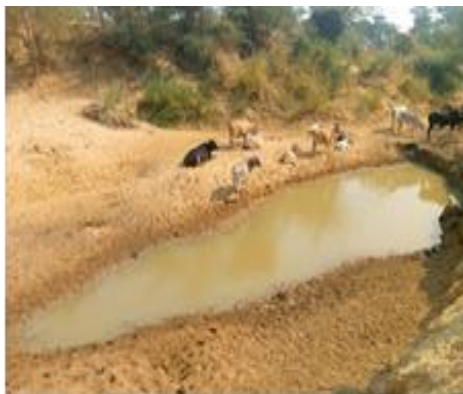
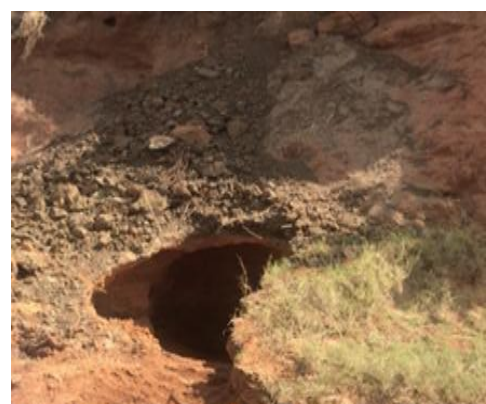
microphytes and micro invertible organisms, river bank cutting to create road access into the river, brick moulding and sand mining. Figure 7 (a) Reservoir on the riverbed (b) Sand open-pit.

Fig. 7. One of the water pools (a) on Riverbed and a Riverbank cave (b)

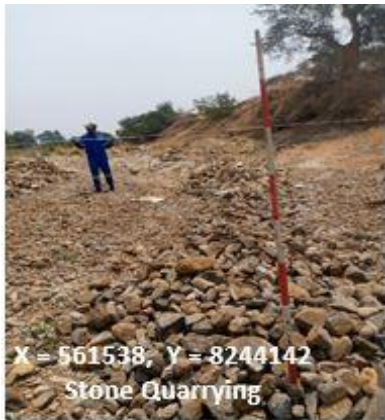
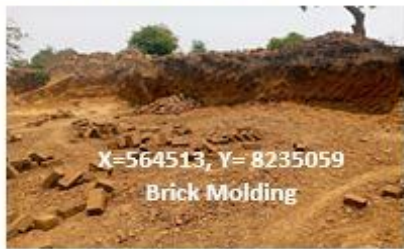
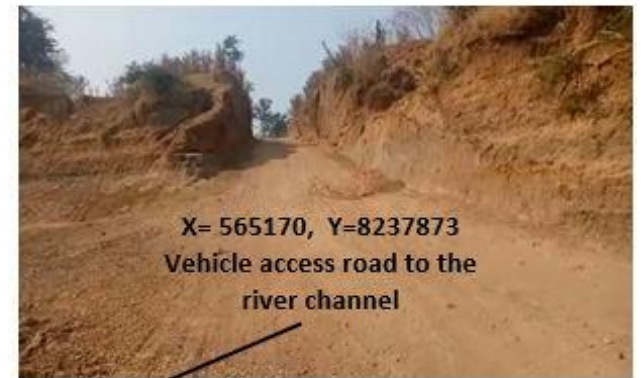
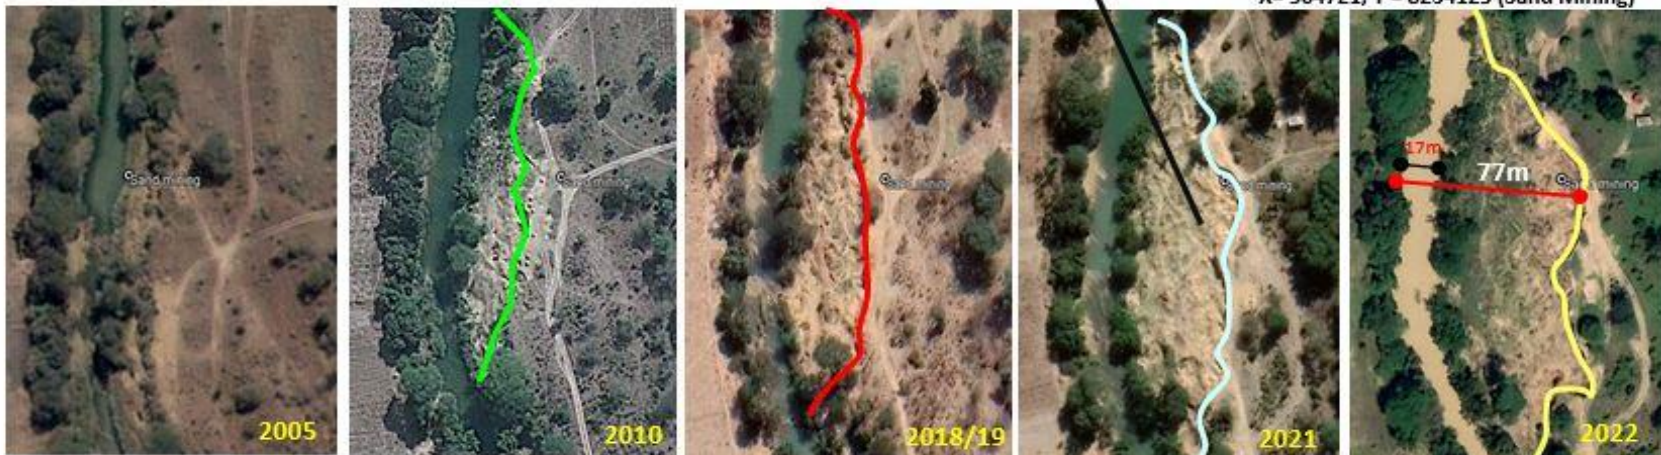
X= 564721, Y = 8234125 (Sand Mining)

The visual evidence of some of the observed destructive human activities in the buffer zone are qualified in Figure 8, which depicts negative impact of stone quarrying on the river bed and

Fig. 8. Visual impressions of human activities in the Magoye River Buffer Zone.
