Geotechnical Assessment of Seismic Vulnerability in the Built Environment of Fako Division, South West Region-Cameroon

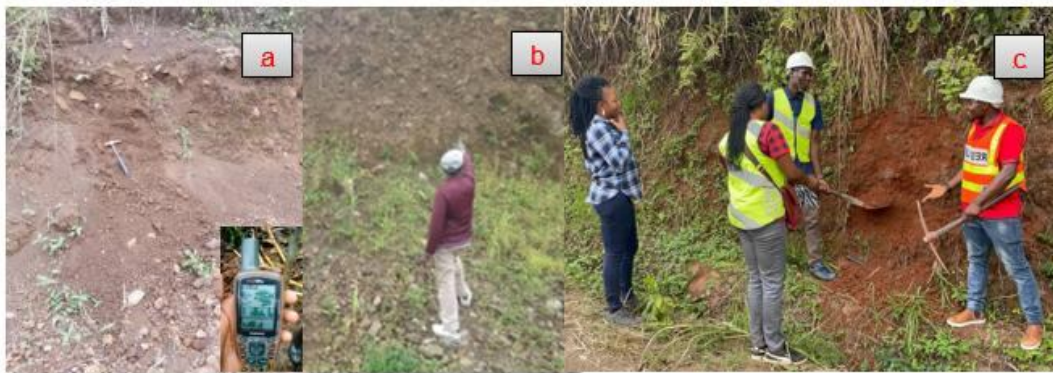
Fig.3. Field survey and sample collection showing: a. GPS Points recording and marking of outcrops, b. geologic description & c. sample collection

Reconnaissance survey was conducted in various localities to gather crucial information about the study area, develop survey strategies, and overcome potential shortcomings. The survey involved physical observation, geological descriptions, and marking outcrops for geological analysis prior to soil sample collection from sixteen sample points. Detailed descriptions including the name of the locality, rock/soil type, and soil characteristics were recorded during this phase for all the 16 points. GPS points and photographs were taken to produce a geologic map and provide a true depiction of the area's geology (Fig.3).

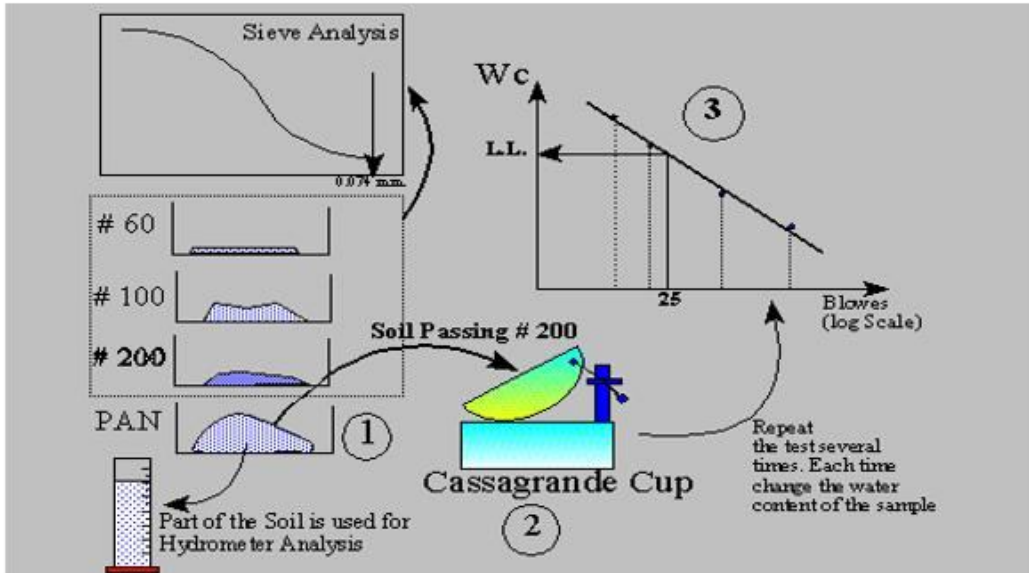
Fig.4. Steps in carrying out the Atterberg's limits tests and presentation of results

The plastic limit test determines the water content at which soil transitions from a plastic to a semisolid state by rolling a soil sample into a thread until it crumbles at a diameter of 3.2 ± 0.5 mm, indicating the soil's plastic limit. This process involves reducing the soil's water content, forming it into an ellipsoidal mass, and repeatedly rolling it on a glass plate until it reaches the specified diameter and crumbles (Fig 4).

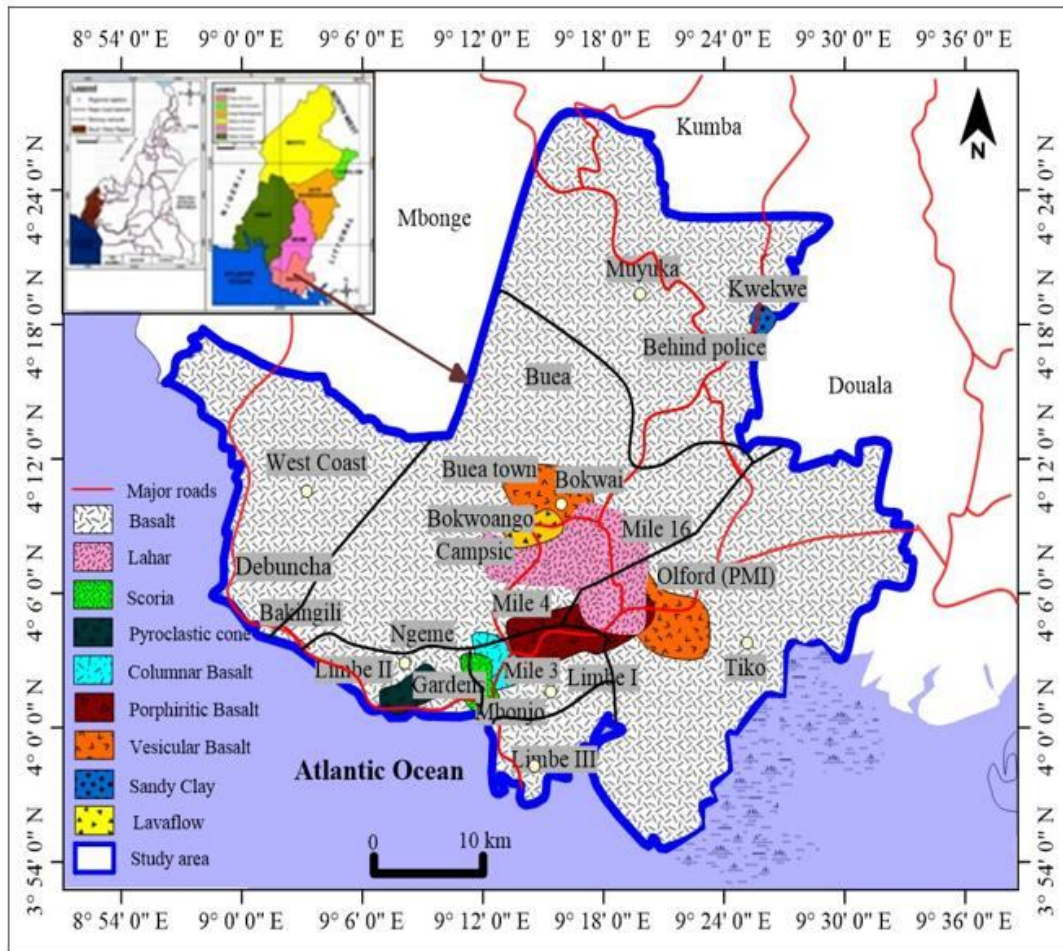
Fig.5. Geology of Fako showing localities from which samples were collected for geotechnical analyses

Mt. Cameroon's geology across the seven council areas reflects a complex volcanic landscape with a variety of volcanic rocks and deposits, including lahar deposits, basaltic lava flows, pyroclastic materials, and weathered volcanic soils. This geological diversity influences the soil properties and susceptibility to hazards (Fig 5).

In Limbe I, the geology reflects volcanic activity and pyroclastic processes. Mile 4 comprises porphyritic basalt, which has large crystals set in a finer matrix, indicative of complex cooling histories. Mile 3 is characterized by columnar basalts, formed from the cooling and contraction of lava into hexagonal columns. Gardens is dominated by a pyroclastic cone made of scoria, a highly vesicular volcanic rock formed from explosive eruptions. In Limbe III, Mbonjo is represented by weathered basalts, showing significant alteration from the original basaltic lava due to weathering processes. Limbe II has a mix of pyroclastic and basaltic materials, with Ngeme composed of porphyritic basalts indicating slow cooling and crystallization of lava, Mukundange containing lapilli-sized pyroclastic materials from explosive eruptions, and Batoke dominated by a scoria cone formed from pyroclastic fragments due to volcanic activity (Fig. 5).

Tiko's geology features various volcanic and sedimentary materials. Olford (PMI) includes pyroclastic materials and sediments mixed with vesicular basalts, indicative of both explosive volcanic deposits and quieter lava flows. Police School area has similar geology with pyroclastic materials and vesicular basalts. Mutengene is characterized by loamy soil with patches of porphyritic basalts, suggesting fertile soil with scattered volcanic rocks. Washing Point and Limbe Road also have loamy soil with porphyritic basalts, indicating mixed volcanic influences. The West Coast Council Area showcases a variety of basaltic formations. Bakingili features weathered massive basaltic rocks, indicative of significant alteration and soil formation processes. Debundcha and Idenau are dominated by massive basaltic lava and rocks, suggesting solidified lava flows. The Chocolate Brown Loamy Soils in the region are fertile, well-drained soils derived from volcanic parent material (Fig 5).

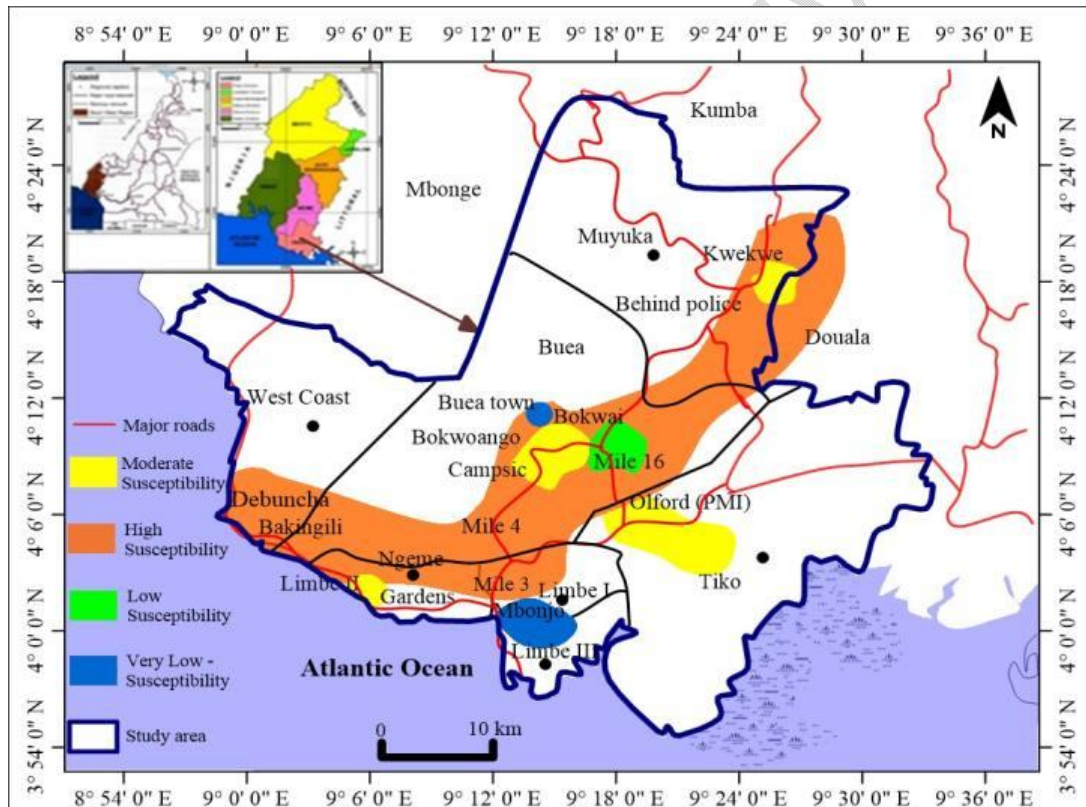
Fig.6. Susceptibility Map for Mount Cameroon Area (Fako)

The soil strength, derived from C.B.R. values and load-bearing capacity, directly influences the susceptibility to various hazards. Soils with high C.B.R. and load-bearing capacity, such as those in Buea Town and Mutengene, exhibit high strength and low susceptibility to deformation. Conversely, areas like Behind Police in Muyuka and Mile 4 in Limbe I have very low soil strength due to low C.B.R. values, making them highly susceptible to settlement and soil instability. The susceptibility level across the localities ranges from low to moderate in areas with high C.B.R. and low plasticity to high in areas with low C.B.R. and high plasticity (Table 1 and Fig 6).

The combined analysis of Atterberg limits, plasticity, C.B.R., and load-bearing capacity provides a comprehensive understanding of soil behavior in these regions (table 1 and Fig 6). For areas like Molyko and Batoke, where the susceptibility level is low to moderate, standard construction practices may suffice. However, in high susceptibility regions like Bokwango, Bokwai, and Behind Police, enhanced geotechnical interventions such as soil stabilization, reinforcement, and careful load management are crucial to mitigate risks associated with settlement and instability. These findings highlight the importance of localized soil assessments to inform safe and sustainable construction practices.

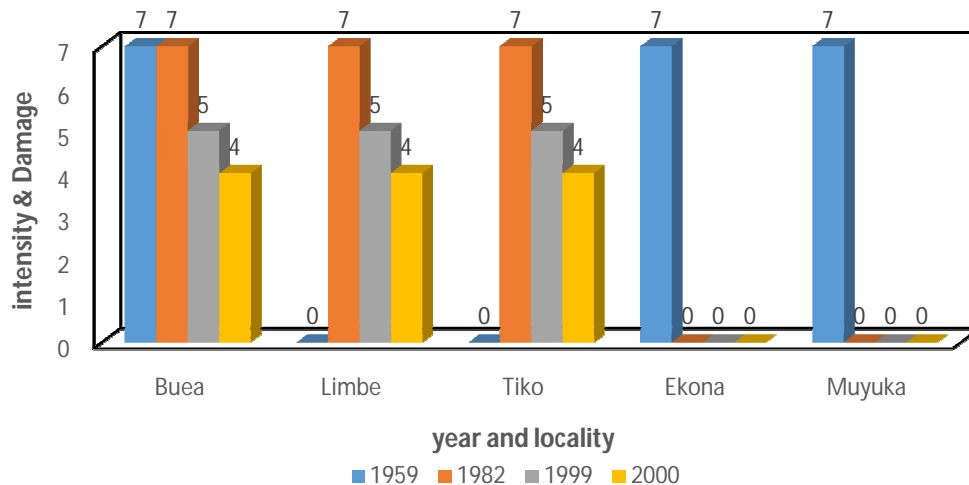
Fig.7. Intensities and associated impacts (Damages) from the 1959, 1982, 1999 & 2000 eruptions

The 1999 eruption had a higher impact in Buea as a whole than other areas (Fig 7&8) than the 1959 and 1982 events with major and minor damages greatly felt in Bokwango, Buea Town, Small Soppo, Bonduma, Molyko, Bomaka and Muea. However, some houses experienced no effects. This high impact within the city of Buea could be linked to the fact that the epicentre of the quake was within the city of Buea.
