Geotechnical Assessment of Seismic Vulnerability in the Built Environment of Fako Division, South West Region-Cameroon

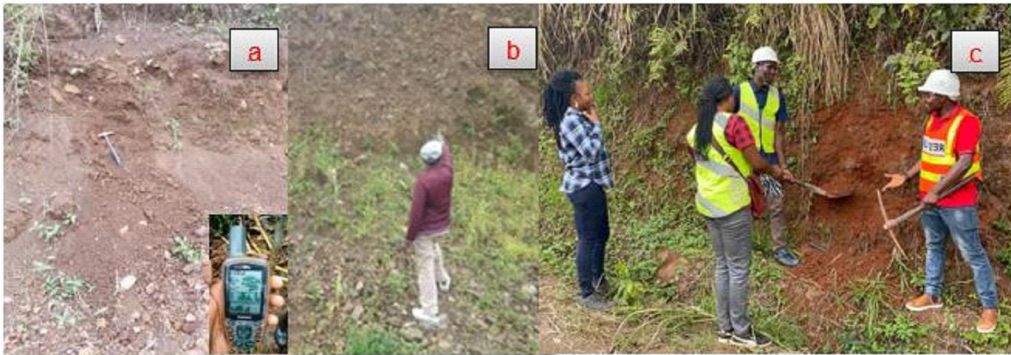
Fig. 3. Field survey and sample collection showing: a. GPS Points recording and marking of outcrops, b. geologic description & c. sample collection

Reconnaissance survey was conducted in various localities to gather crucial information about the study area, develop survey strategies, and overcome potential shortcomings. The survey involved physical observation, geological descriptions, and marking outcrops for geological analysis prior to soil sample collection from sixteen sample points. Detailed descriptions including the name of the locality, rock/soil type, and soil characteristics were recorded during this phase for all the 16 points. GPS points and photographs were taken to produce a geologic map and provide a true depiction of the area's geology (Fig.3).

Soil sampling was carried out meticulously to ensure the accuracy of geotechnical analyses. Samples were collected from specific depths relevant to the study objectives, considering laboratory test calibration. Depending on soil type and analysis purpose, samples were gathered from appropriate depths (at least 2M deep), often from exposed outcrops. Each sampling point yielded at least 40 kg of soil to ensure sufficient material for various analyses. Equipment for soil sampling included basic tools like soil augers, spades, and trowels for collection, mixing, and storage, alongside items for data documentation and transportation. Clean buckets and soil bags lined with plastic were used for mixing and storing samples respectively. Marking tools, tags, and sample information sheets aided in proper labeling and documentation. Field data including GPS coordinates and photographs were captured for comprehensive record-keeping and analysis (Fig. 3.). Additionally, accessories like hammers for rock sampling, portable water, and transportation vehicles ensured the efficiency and smooth execution of the sampling process.

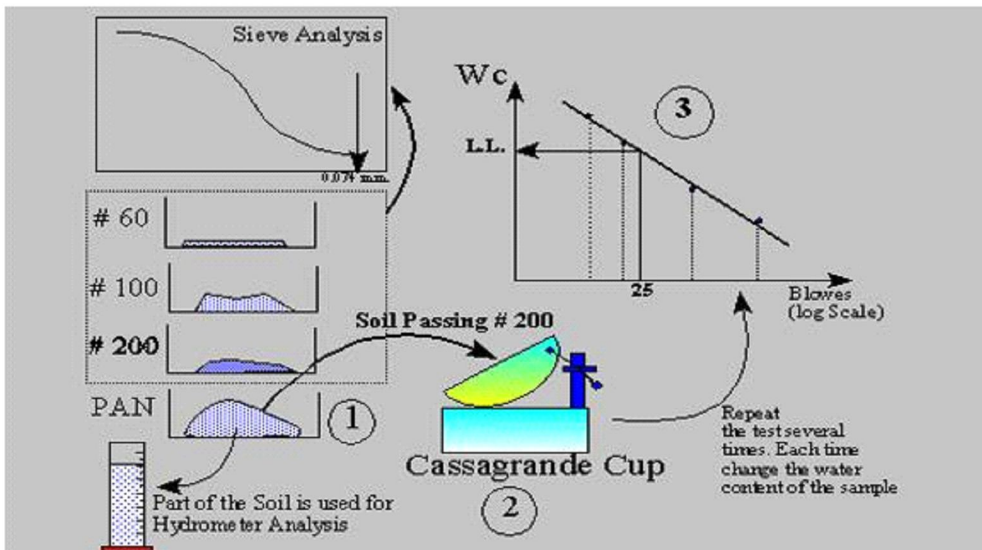
Fig. 4. Steps in carrying out the Atterberg's limits tests and presentation of results

The plastic limit test determines the water content at which soil transitions from a plastic to a semisolid state by rolling a soil sample into a thread until it crumbles at a diameter of 3.2 ± 0.5 mm, indicating the soil's plastic limit. This process involves reducing the soil's water content, forming it into an ellipsoidal mass, and repeatedly rolling it on a glass plate until it reaches the specified diameter and crumbles (Fig 4).

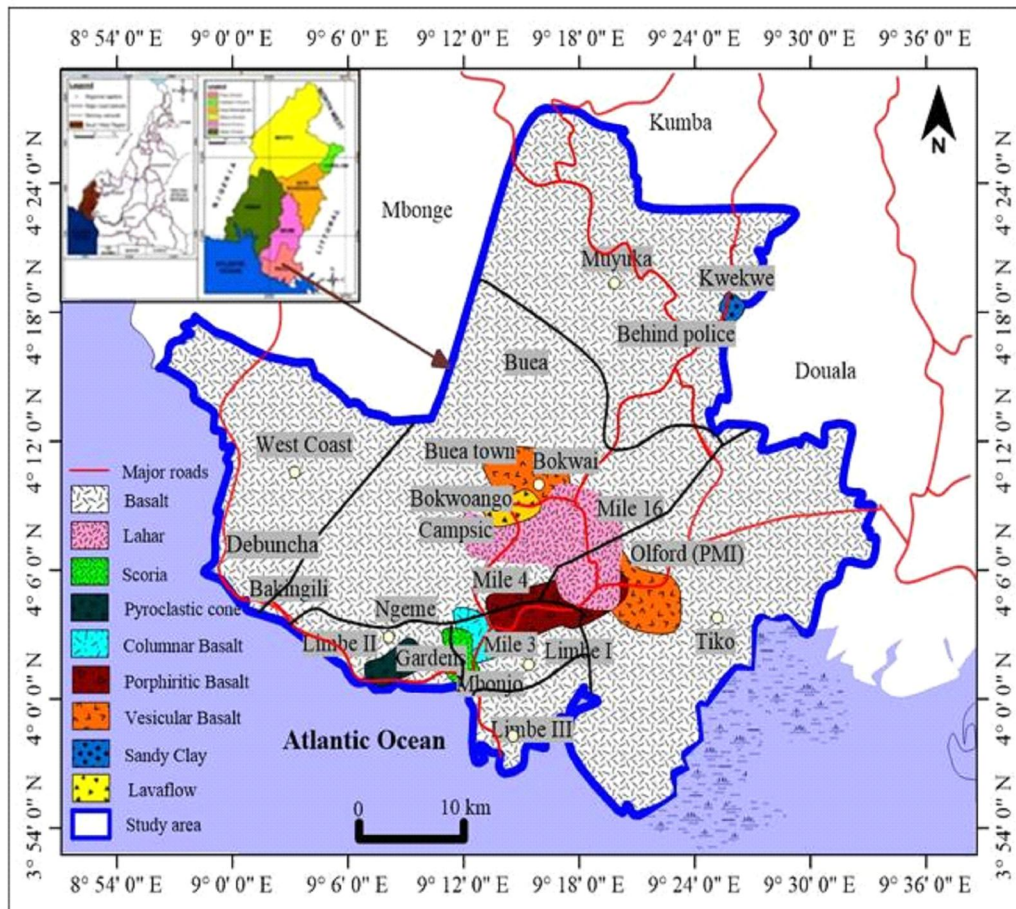
Fig. 5. Geology of Fako showing localities from which samples were collected for geotechnical analyses

Mt. Cameroon's geology across the seven council areas reflects a complex volcanic landscape with a variety of volcanic rocks and deposits, including lahar deposits, basaltic lava flows, pyroclastic materials, and weathered volcanic soils. This geological diversity influences the soil properties and susceptibility to hazards (Fig 5).

weathered basaltic rocks and varying particle sizes from gravel to boulders. The presence of grey porphyritic basalts and unconsolidated sediments contributes to the spongy texture of the soil. Basalts from cooled lava, typical of volcanic eruptions where lava has solidified to form dense, hard rock, dominate Molyko. Mile 16 and Mile 14 feature lahar deposits with boulders containing muscovite, a mica mineral, indicating a mix of volcanic material with metamorphic influences. Blocky basalts, formed from solidified lava into large, angular blocks, characterize tole/Sasse. In Limbe I, the geology reflects volcanic activity and pyroclastic processes. Mile 4 comprises porphyritic basalt, which has large crystals set in a finer matrix, indicative of complex cooling histories. Mile 3 is characterized by columnar basalts, formed from the cooling and contraction of lava into hexagonal columns. Gardens is dominated by a pyroclastic cone made of scoria, a highly vesicular volcanic rock formed from explosive eruptions. In Limbe III, Mbonjo is represented by weathered basalts, showing significant alteration from the original basaltic lava due to weathering processes. Limbe II has a mix of pyroclastic and basaltic materials, with Ngeme composed of porphyritic basalts indicating slow cooling and crystallization of lava, Mukundange containing lapilli-sized pyroclastic materials from explosive eruptions, and Batoke dominated by a scoria cone formed from pyroclastic fragments due to volcanic activity (Fig. 5).

includes pyroclastic materials and sediments mixed with vesicular basalts, indicative of both explosive volcanic deposits and quieter lava flows. Police School area has similar geology with pyroclastic materials and vesicular basalts. Mutengene is characterized by loamy soil with patches of porphyritic basalts, suggesting fertile soil with scattered volcanic rocks. Washing Point and Limbe Road also have loamy soil with porphyritic basalts, indicating mixed volcanic influences. The West Coast Council Area showcases a variety of basaltic formations. Bakingili features weathered massive basaltic rocks, indicative of significant alteration and soil formation processes. Debundcha and Idenau are dominated by massive basaltic lava and rocks, suggesting solidified lava flows. The Chocolate Brown Loamy Soils in the region are fertile, well-drained soils derived from volcanic parent material (Fig 5).

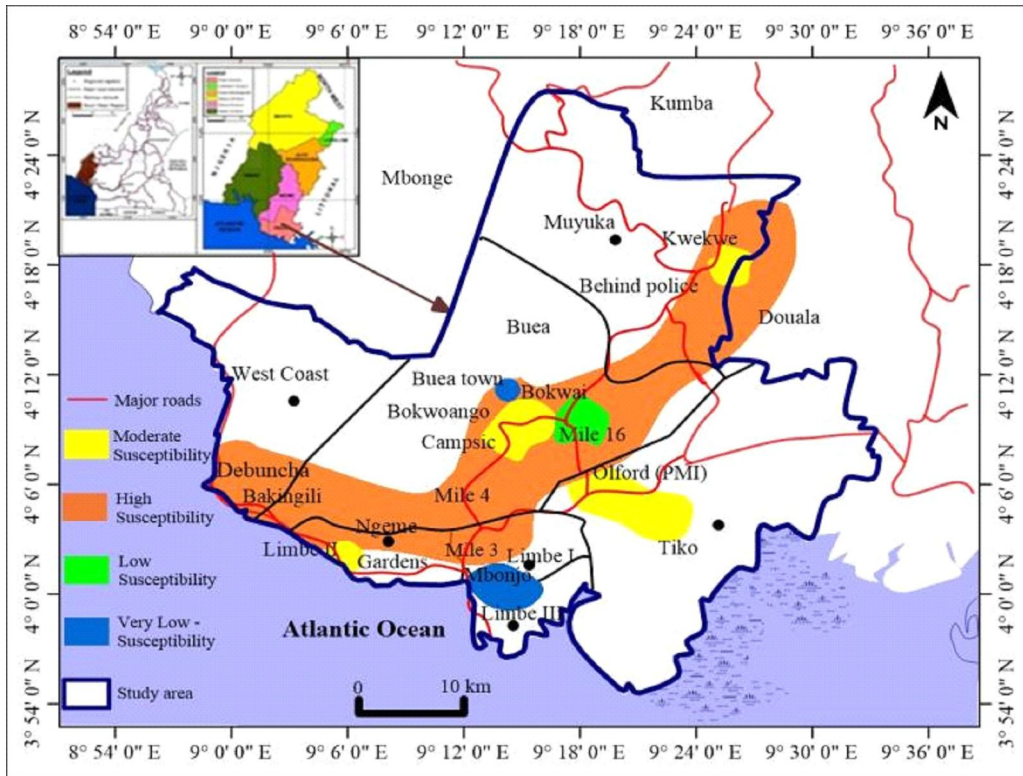
Fig. 6. Susceptibility Map for Mount Cameroon Area (Fako)

The soil strength, derived from C.B.R. values and load-bearing capacity, directly influences the susceptibility to various hazards. Soils with high C.B.R. and load-bearing capacity, such as those in Buea Town and Mutengene, exhibit high strength and low susceptibility to deformation. Conversely, areas like Behind Police in Muyuka and Mile 4 in Limbe I have very low soil strength due to low C.B.R. values, making them highly susceptible to settlement and soil instability. The susceptibility level across the localities ranges from low to moderate in areas with high C.B.R. and low plasticity to high in areas with low C.B.R. and high plasticity (Table 1 and Fig 6).

The combined analysis of Atterberg limits, plasticity, C.B.R., and load-bearing capacity provides a comprehensive understanding of soil behavior in these regions (table 1 and Fig 6). For areas like Molyko and Batoke, where the susceptibility level is low to moderate, standard construction practices may suffice. However, in high susceptibility regions like Bokwango, Bokwai, and Behind Police, enhanced geotechnical interventions such as soil stabilization, reinforcement, and careful load management are crucial to mitigate risks associated with settlement and instability. These findings highlight the importance of localized soil assessments to inform safe and sustainable construction practices.
