# ***Geotechnical Assessment of Seismic Vulnerability in the Built Environment of Fako Division, South West Region of Cameroon***

**Aim:** Evaluate the geotechnical characteristics of soils in Fako division to estimate their seismic vulnerability and recommend suitable stabilization techniques to enhance the safety and resilience of built environments.

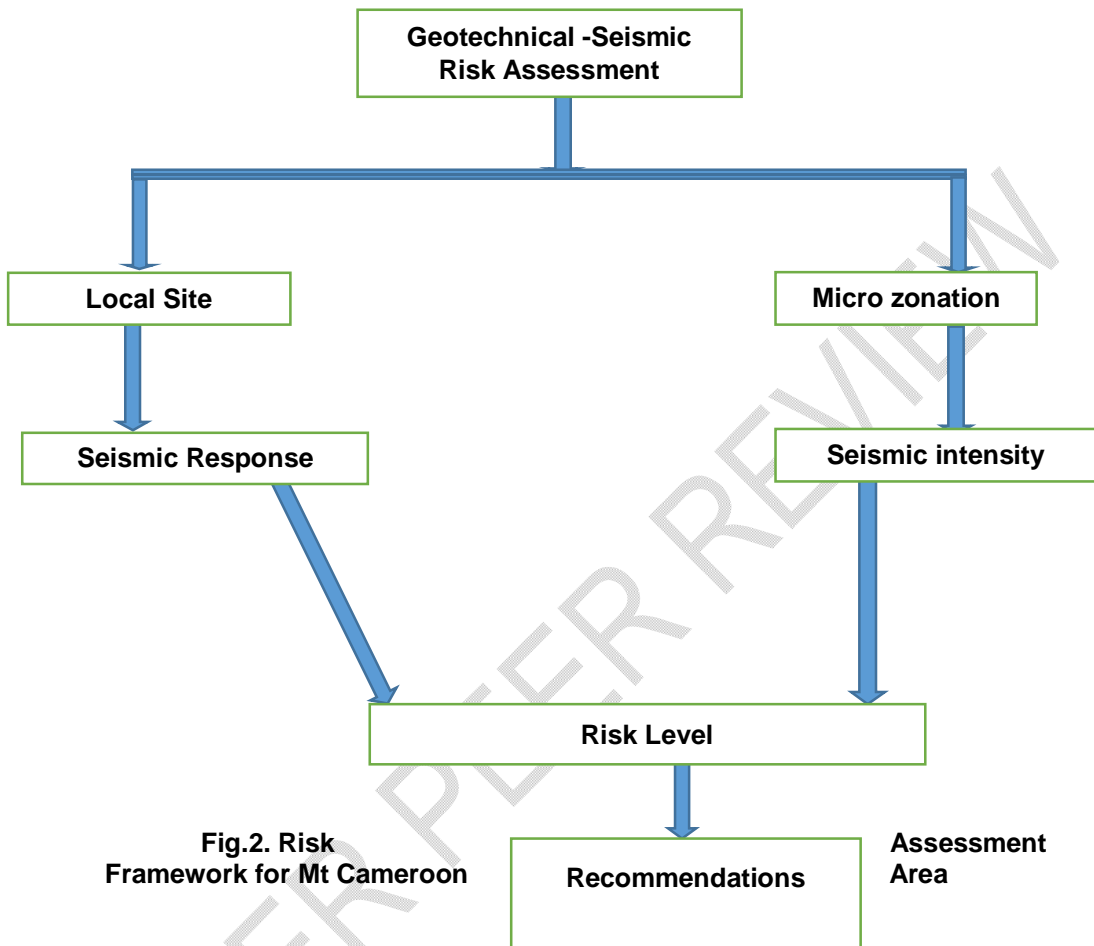
Fig.2. Risk Framework for Mt Cameroon

characterization using geotechnical methods, Estimation of seismic hazard using seismic intensities (modified Mercalli intensity scale) and geology of the terrain. Having researched the literature described above, a framework for assessing seismic risk within Mount Cameroon area is schematically represented (Fig 2).

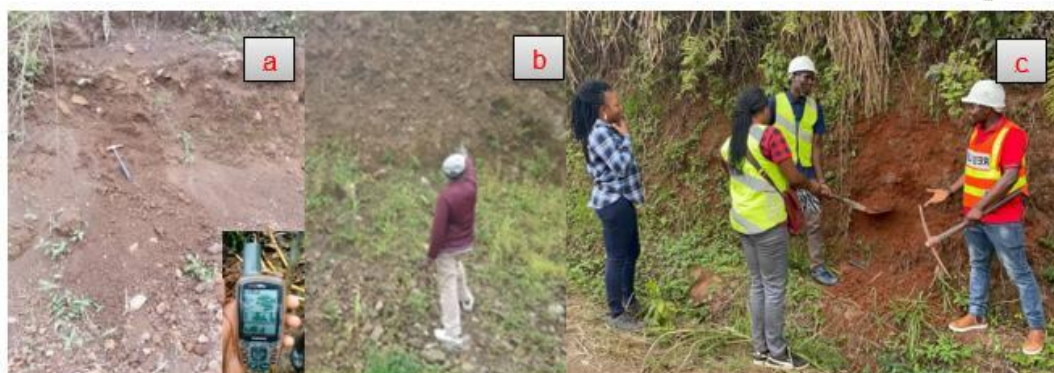
**Fig.3.Field survey and sample collection showing: a. GPS Points recording and marking of outcrops,b. geologic description &c. sample collection**

Reconnaissance survey was conducted in various localities to gather crucial information about the study area, develop survey strategies, and overcome potential shortcomings. The survey involved physical observation, geological descriptions, and marking outcrops for geological analysis prior to soil sample collection from sixteen sample points. Detailed descriptions including the name of the locality, rock/soil type, and soil characteristics were recorded during this phase for all the 16 points. GPS points and photographs were taken to produce a geologic map and provide a true depiction of the area's geology (Fig.3).

Soil sampling was carried out meticulously to ensure the accuracy of geotechnical analyses. Samples were collected from specific depths relevant to the study objectives, considering laboratory test calibration. Depending on soil type and analysis purpose, samples were gathered from appropriate depths (at least 2M deep), often from exposed outcrops. Each

sampling point yielded at least 40 kg of soil to ensure sufficient material for various analyses. Equipment for soil sampling included basic tools like soil augers, spades, and trowels for collection, mixing, and storage, alongside items for data documentation and transportation. Clean buckets and soil bags lined with plastic were used for mixing and storing samples respectively. Marking tools, tags, and sample information sheets aided in proper labeling and documentation. Field data including GPS coordinates and photographs were captured for comprehensive record-keeping and analysis (Fig. 3.). Additionally, accessories like hammers for rock sampling, portable water, and vehicles for transportation ensured the efficiency and smooth execution of the sampling process.

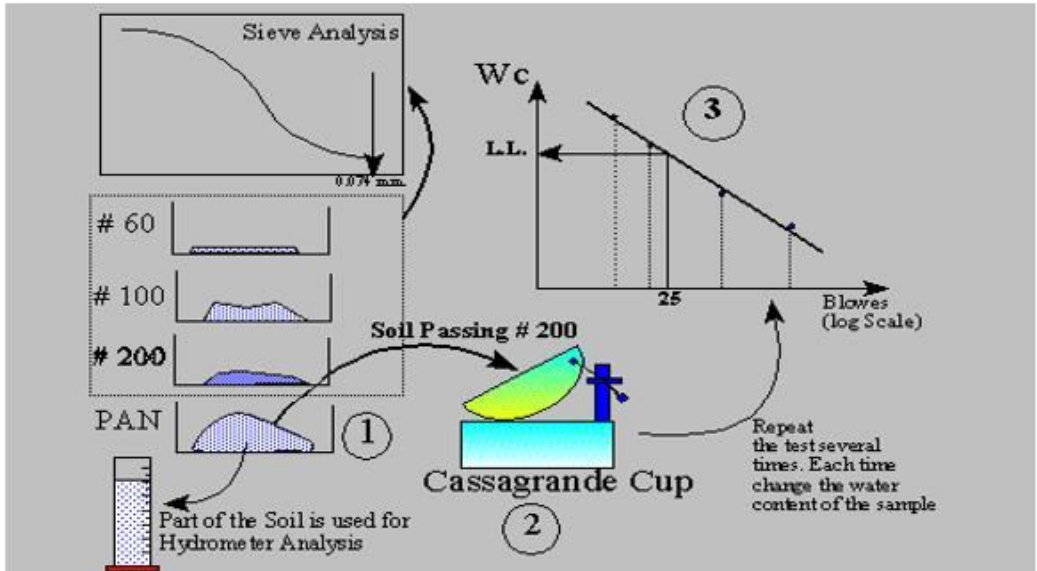
**Fig.4. Steps in carrying out the Atterberg's limits tests and presentation of results**

The Atterberg's limits test determines the water content at various soil consistency stages using; a grooving tool and Cassagrande's apparatus, where the liquid limit was found by plotting the relationship between water content and the number of drops needed to close a groove in the soil. This analysis provided essential data on soil behavior under different moisture conditions, and can aid engineering decisions for construction projects.

The plastic limit test determines the water content at which soil transitions from a plastic to a semisolid state by rolling a soil sample into a thread until it crumbles at a diameter of  $3.2 \pm 0.5$  mm, indicating the soil's plastic limit. This process involves reducing the soil's water content, forming it into an ellipsoidal mass, and repeatedly rolling it on a glass plate until it reaches the specified diameter and crumbles (Fig 4).

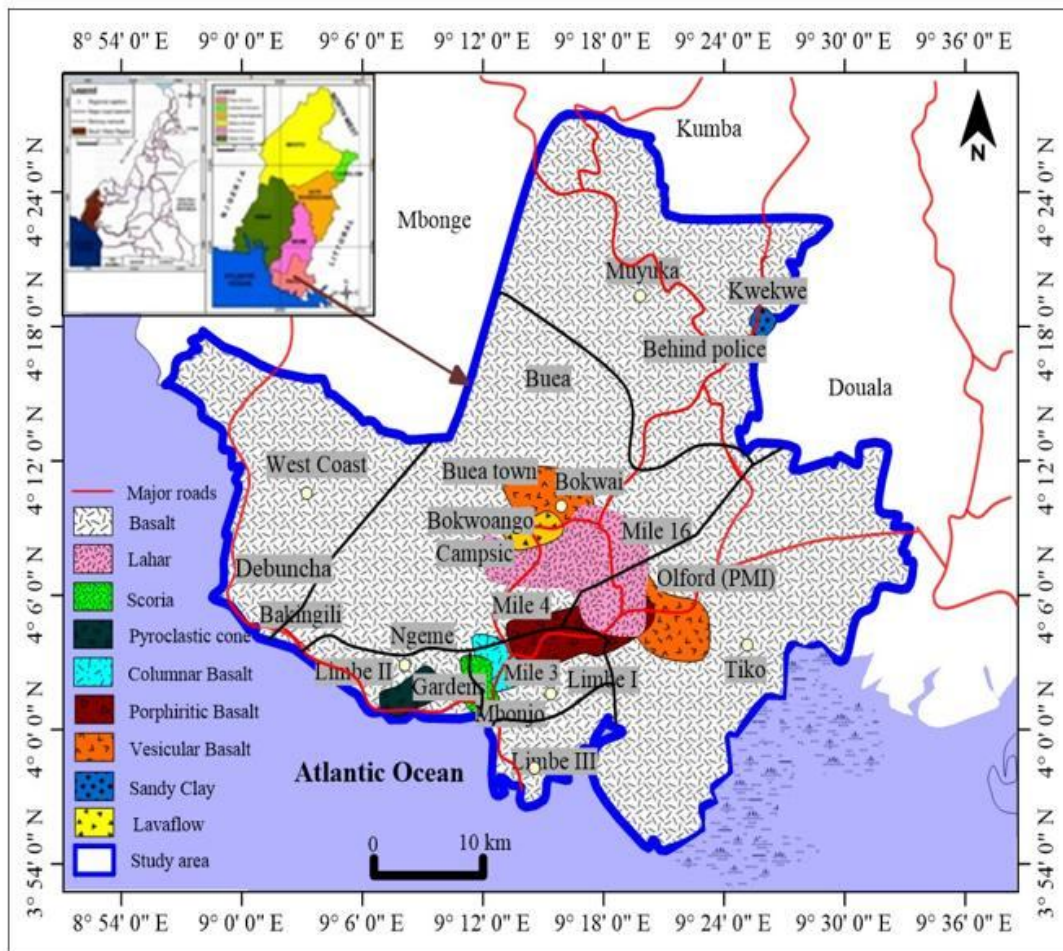
**Fig.5. Geology of Fako showing localities from which samples were collected for geotechnical analyses**

Mt. Cameroon's geology across the seven council areas reflects a complex volcanic landscape with a variety of volcanic rocks and deposits, including lahar deposits, basaltic lava flows, pyroclastic materials, and weathered volcanic soils. This geological diversity influences the soil properties and susceptibility to hazards (Fig 5).

In Limbe I, the geology reflects volcanic activity and pyroclastic processes. Mile 4 comprises porphyritic basalt, which has large crystals set in a finer matrix, indicative of complex cooling histories. Mile 3 is characterized by columnar basalts, formed from the cooling and contraction of lava into hexagonal columns. Gardens is dominated by a pyroclastic cone made of scoria, a highly vesicular volcanic rock formed from explosive eruptions. In Limbe III, Mbonjo is represented by weathered basalts, showing significant alteration from the original basaltic lava due to weathering processes. Limbe II has a mix of pyroclastic and basaltic materials, with Ngeme composed of porphyritic basalts indicating slow cooling and crystallization of lava, Mukundange containing lapilli-sized pyroclastic materials from explosive eruptions, and Batoke dominated by a scoria cone formed from pyroclastic fragments due to volcanic activity (Fig. 5).

Tiko's geology features various volcanic and sedimentary materials. Olford (PMI) includes pyroclastic materials and sediments mixed with vesicular basalts, indicative of both explosive volcanic deposits and quieter lava flows. Police School area has similar geology with pyroclastic materials and vesicular basalts. Mutengene is characterized by loamy soil with patches of porphyritic basalts, suggesting fertile soil with scattered volcanic rocks. Washing Point and Limbe Road also have loamy soil with porphyritic basalts, indicating mixed volcanic influences. The West Coast Council Area showcases a variety of basaltic formations. Bakingili features weathered massive basaltic rocks, indicative of significant alteration and soil formation processes. Debundcha and Idenau are dominated by massive basaltic lava and rocks, suggesting solidified lava flows. The Chocolate Brown Loamy Soils in the region are fertile, well-drained soils derived from volcanic parent material (Fig 5).

Muyuka Council Area also presents diverse volcanic influences. Behind Police features sandy clay, a mix of finer and coarser volcanic materials. Kwekwe is characterized by interbedded basalts, indicating alternating layers of solidified lava flows. This diverse geology across the seven council areas of Mount Cameroon reflects a complex volcanic landscape which highlights the need for localized geotechnical assessments for construction and land use planning.

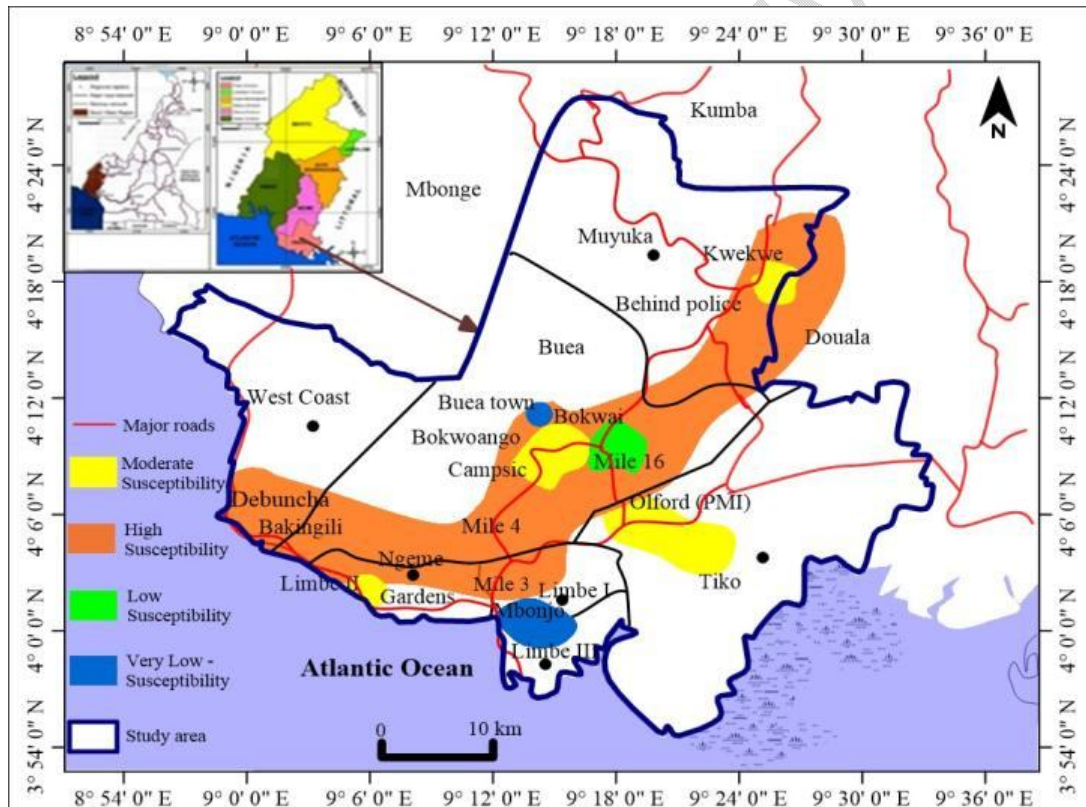
Fig.6. Susceptibility Map for Mount Cameroon Area (Fako)

The soil strength, derived from C.B.R. values and load-bearing capacity, directly influences the susceptibility to various hazards. Soils with high C.B.R. and load-bearing capacity, such as those in Buea Town and Mutengene, exhibit high strength and low susceptibility to deformation. Conversely, areas like Behind Police in Muyuka and Mile 4 in Limbe I have very low soil strength due to low C.B.R. values, making them highly susceptible to settlement and soil instability. The susceptibility level across the localities ranges from low to moderate in areas with high C.B.R. and low plasticity to high in areas with low C.B.R. and high plasticity (Table 1 and Fig 6).

The combined analysis of Atterberg limits, plasticity, C.B.R., and load-bearing capacity provides a comprehensive understanding of soil behavior in these regions (table 1 and Fig 6). For areas like Molyko and Batoke, where the susceptibility level is low to moderate, standard construction practices may suffice. However, in high susceptibility regions like Bokwango, Bokwai, and Behind Police, enhanced geotechnical interventions such as soil stabilization, reinforcement, and careful load management are crucial to mitigate risks associated with settlement and instability. These findings highlight the importance of localized soil assessments to inform safe and sustainable construction practices.

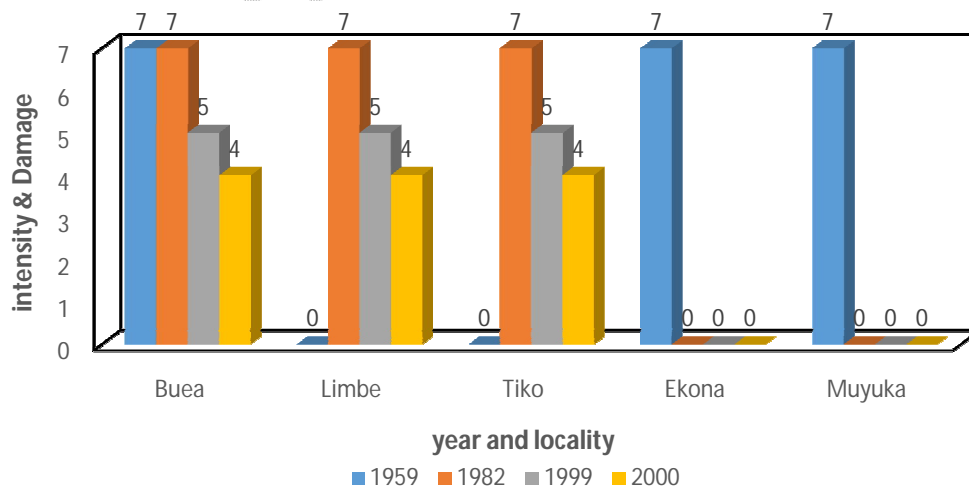
**Fig.7. Intensities and associated impacts (Damages) from the 1959, 1982, 1999 & 2000 eruptions**

The 1999 eruption had a higher impact in Buea as a whole than other areas (Fig 7&8) than the 1959 and 1982 events with major and minor damages greatly felt in Bokwango, Buea Town, Small Soppo, Bonduma, Molyko, Bomaka and Muea. However, some houses experienced no effects. This high impact within the city of Buea could be linked to the fact that the epicentre of the quake was within the city of Buea.
