## Case report

# Management of Complicated Crown Fracture with Rapid Orthodontic Extrusion and Glass Fibre Post: A Case Report

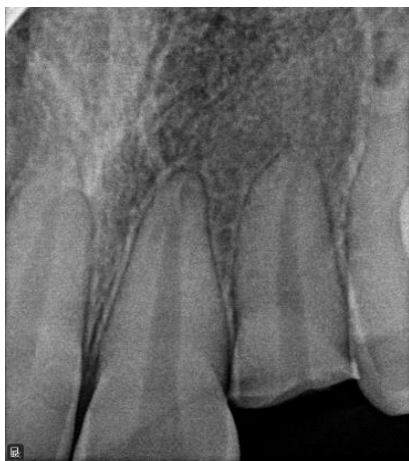
Fig.1 Preop Radiograph

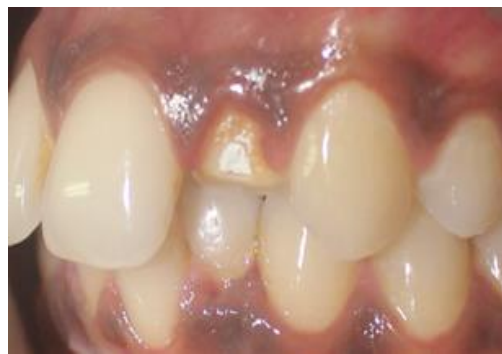
Fig.2 Preop Clinical - Buccal View

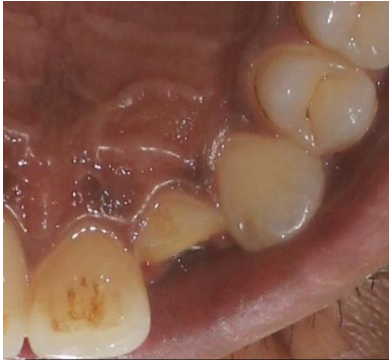
Fig.3 Preop Clinical -Palatal View

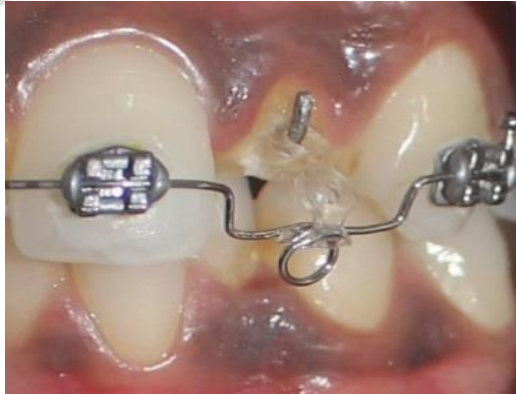
Fig. 5 Orthodontic extrusion -After 1 month.

Orthodontic extrusion was performed using a fixed appliance to re-establish the biological width. A 0.018- inch round stainless steel orthodontic wire (Konark ever bright dental stainless steel wire) was fixed with orthodontic brackets bonded to the labial surface of the maxillary left central incisor and maxillary left canine, at the incisal third, to provide the necessary anchorage for tooth movement. A 19 gauge stainless steel wire (Konark ever bright dental stainless steel wire) was bent to form a 2-mm diameter loop with a 4-mm radicular extension, which was further roughened with diamond disks to provide retention and was cemented with glass ionomer cement (GC Gold Label 1) in the coronal root canal third of the fractured tooth. Next, a 1/8 diameter orthodontic elastic was placed through the coronal loop and tied to the labial wire fixed between the neighbouring teeth. The elastic string was changed once a week. Orthodontic extrusion was terminated when a circumferential ferrule of 1 mm was achieved, which was in 45 days.

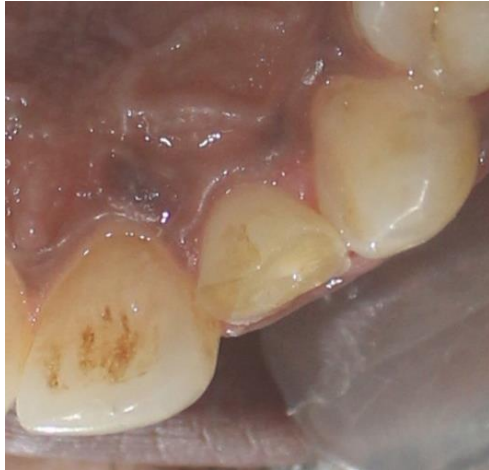
Fig. 6 After orthodontic extrusion (after 45 days)

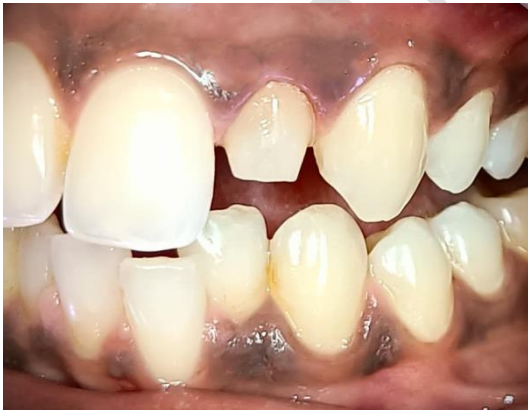
Fig. 9 Crown preparation

After obtaining adequate ferrule, the prefabricated glass fibre post was selected according to root canal width. A prefabricated glass fibre post of diameter 1.80 mm was cemented into the canal using dual curing resin cement. The fibre post provided additional support to the weakened tooth structure. Core buildup was completed using the Paracore system, followed by crown preparation. A porcelain jacket crown was fabricated and cemented onto the prepared tooth. Patient was put on follow up. At 12 months follow up there were complete

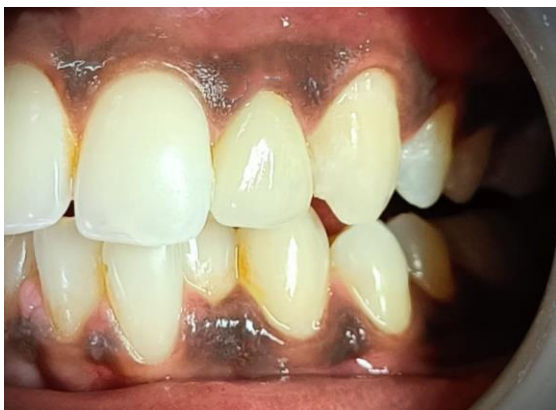
Fig. 10 Post OP after crown placement
