Original Research Article

Comparative Analysis of Precast and Insitu Concrete and Their Effectiveness on Koga Irrigation Structures

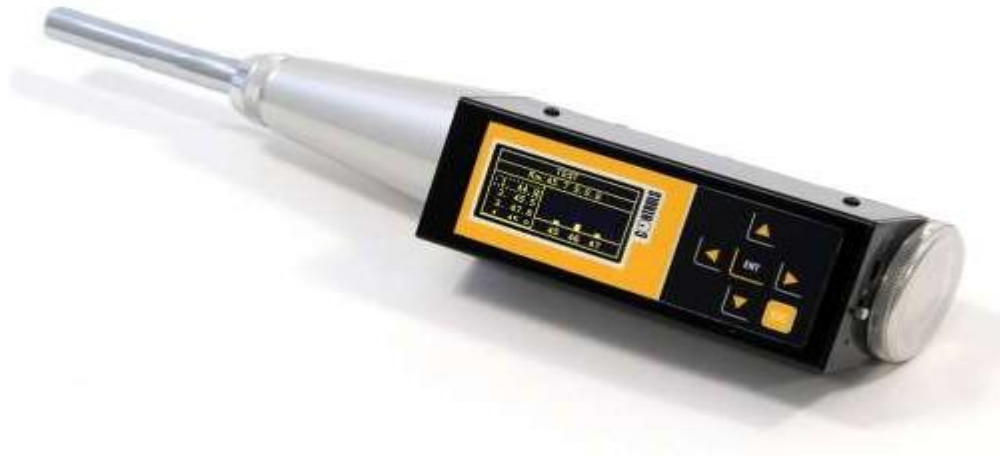
Figure 2: Digital Rebound Hammer Device

Among the other NDT tests, the rebound hammer test was conducted due to its availability in the Bahir Dar University laboratory. To get a precise result, several experimental data on CCS, and rebound numbers from rebound hammer tests are required. The rebound test apparatus which was used for this experiment is digital and it can directly display the CCS in MPa. The experimental data were collected from 6 points for evaluating the hardened compressive strength of concrete was tested from a concrete constructed 14 years ago and the compressive strength of concrete is taken as the output. The rebound value can be calculated using innovative technology by considering the anvil speed before and after the loading. This working principle is similar to the traditional measurement of maximum spring length after the impact, but it provides higher accuracy and stability of the readings.

The setting of the impact angle is no longer required and checking of the device's reliability can be performed during each impact, even without the calibration anvil. Digital Rebound Hammer Model 58-C0181/DGT with Accessories is used for the study as shown in Fig. 2.

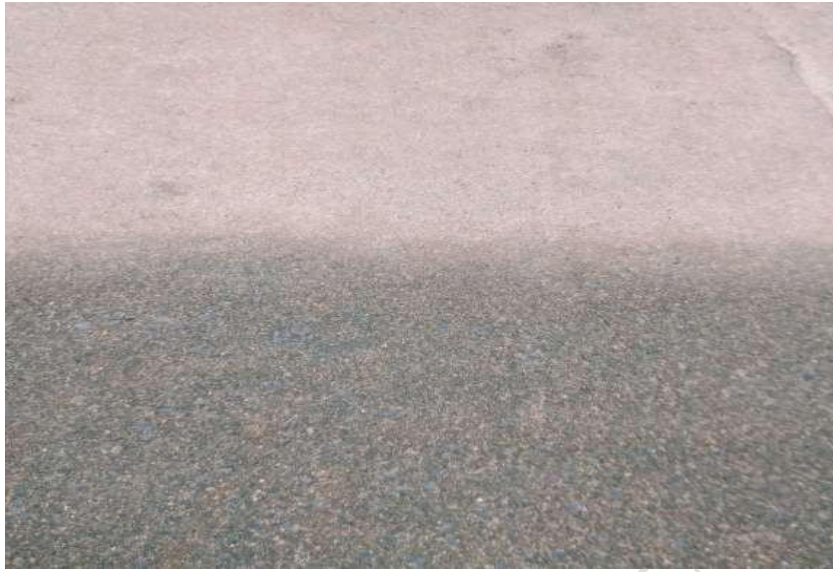
Figure 3: Observation of Concrete Face Above and Below the Free Board

From the visual inspection results, it was observed that all part of the lined canal under the freeboard is subjected to light scaling. So, the light defect category of scaling is generalized throughout the longitudinal section of the canal lining below the freeboard. But the severe loss of mortar and more exposure of coarse aggregate is observed more at the insitu linings.

The light scaling defects are very significant and observed on both precast and insitu concrete lining throughout the longitudinal section under the freeboard of the canals. But the severe scaling defect is observed more on the insitu concrete linings. This defect occurs in concrete that does not have proper air entrainment and is continuously saturated.

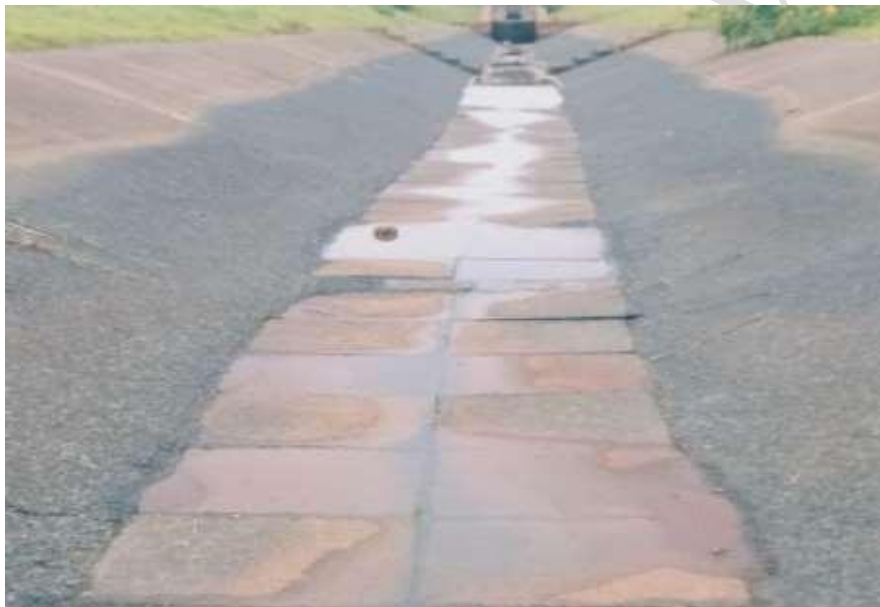
Figure 4: Differential Movements on the Precast Concrete

In most precast concrete canals, simple differential settlements were observed at the bed of the canal as shown in Fig. 4. But the insitu concrete passes the settlements as a slab.

The pop-outs and spalling defects can be taken as acceptable defects and insignificant problems. These problems will not further continue and are observed rarely in a few places only. In most precast concrete canals, simple differential settlements are observed at the bed of the canal. But the in-situ concrete may bridge over those settlements.

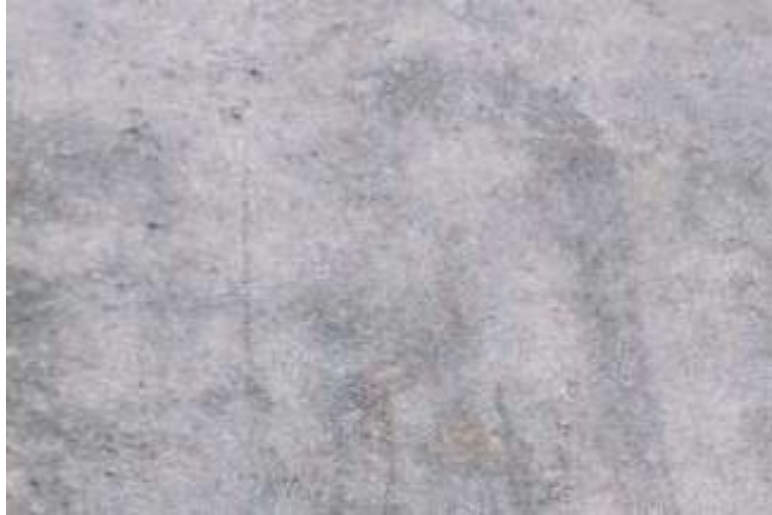
Figure 5: Effect of Rainfall on the Insitu Concrete

One of the main problems of insitu concrete construction is that, when the rain falls on concrete before its setting time in the summer season, the jell of the concrete mix will be washed away by the rainfall. But the precast elements were assembled after setting and curing time was finished in a controlled and protected room.

Properly placing, finishing, and curing concrete can have a big impact on service life. It is difficult to construct insitu concrete linings in the rainy season, because the rain may wash and erode the fresh concrete before its setting time. But in the case of precast concrete linings, the contractor can manufacture the precast elements in a rainy time in a protected room and assemble them during a dry time. Pre-cast concrete linings are susceptible to the growth of grasses in the closely spaced joints. In the same manner, the cracks of insitu concrete are sensitive to the growth of grass and vegetation. The joints of precast concrete lining canals are scoured and removed.

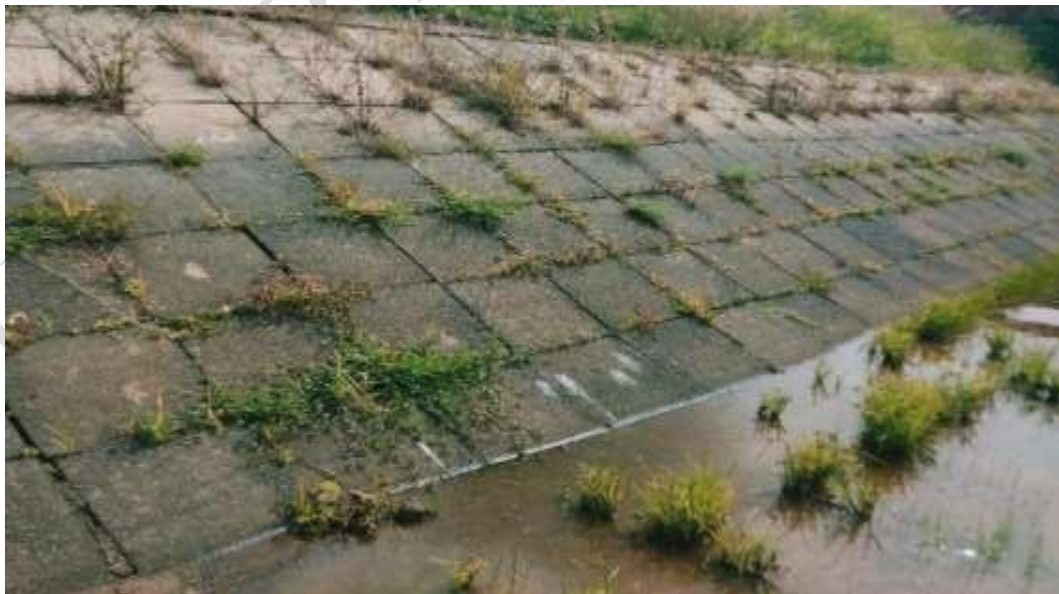
Figure 6: Vegetation and Grass Growth on the Joints of Precast Concrete

As shown in Fig. 6, the pre-cast concrete part of the canal is sensitive to the growth of vegetation and grass at the closely spaced joints due to the accumulation of dust inside the openings.

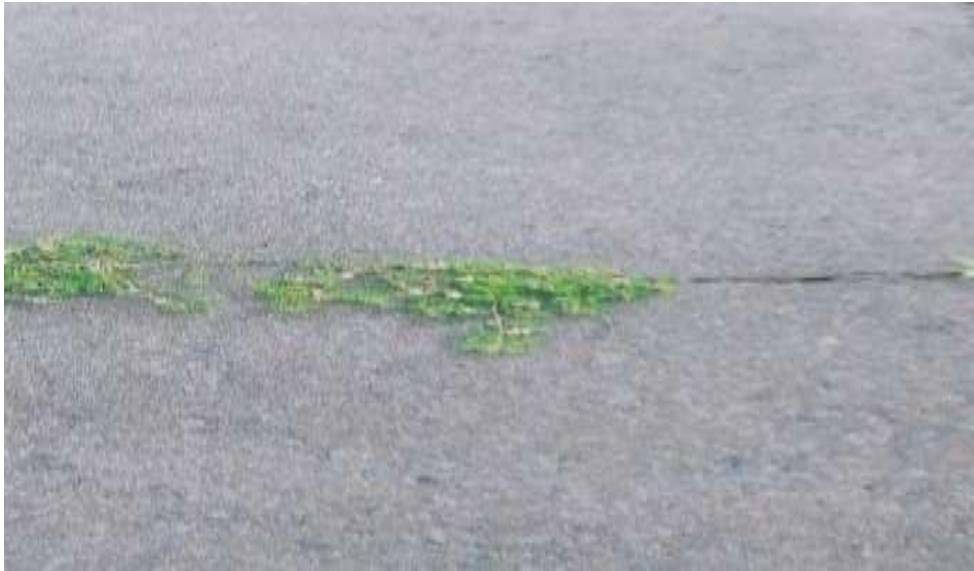
Figure 7: Vegetation and Grass Growth in the Cracks of Insitu Concrete

It was observed that Vegetation and grass have grown on the wider cracks of insitu concrete canal linings.

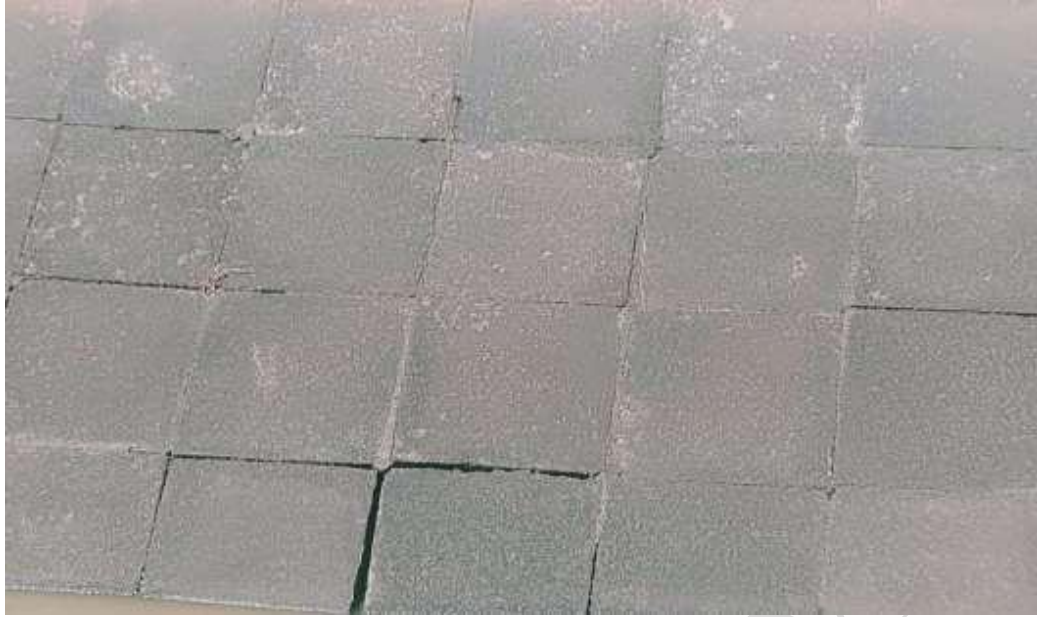
Figure 8: Removal of Joints between the Joints of Precast Concrete

Some of the mortar-filled joints, which are the weak points of precast concrete canals, were removed by the scouring action of water (Fig. 8).

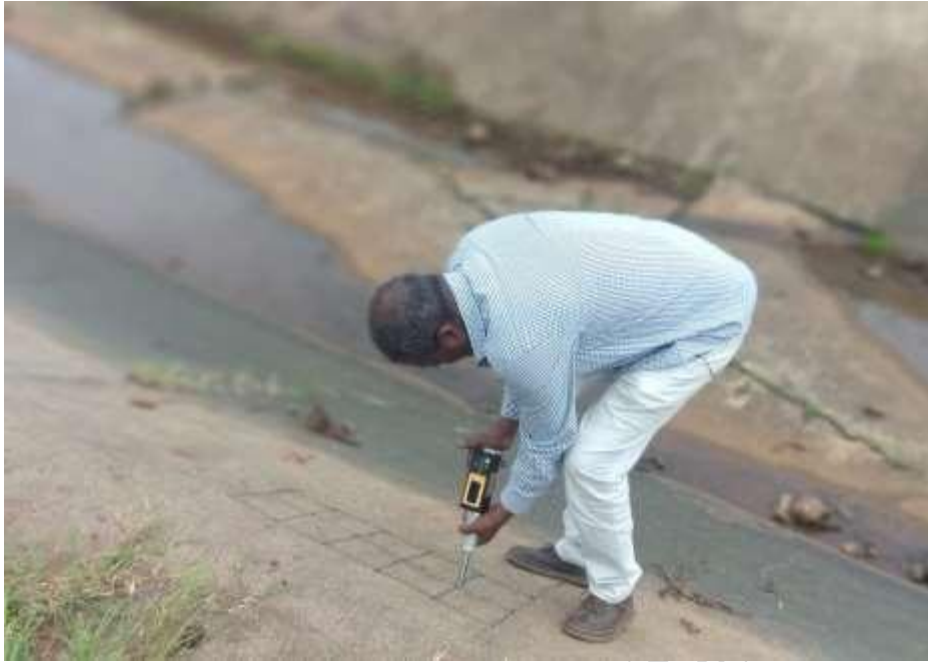
Figure 9: Conducting Rebound Hammer Test

According to the results of the rebound test, the compressive strength values are very much increased when compared with the design characteristic strength values. This situation is observed on both precast and insitu concrete elements. But, based on a comparison of the average and standard deviation of CCS results, the strength and uniformity of the compressive strength of precast concrete are much better than the insitu concrete. The rebound hammer test results, which are conducted by making grid squares at six places and 10 points at each place and their corresponding locations, are listed in Table 6.

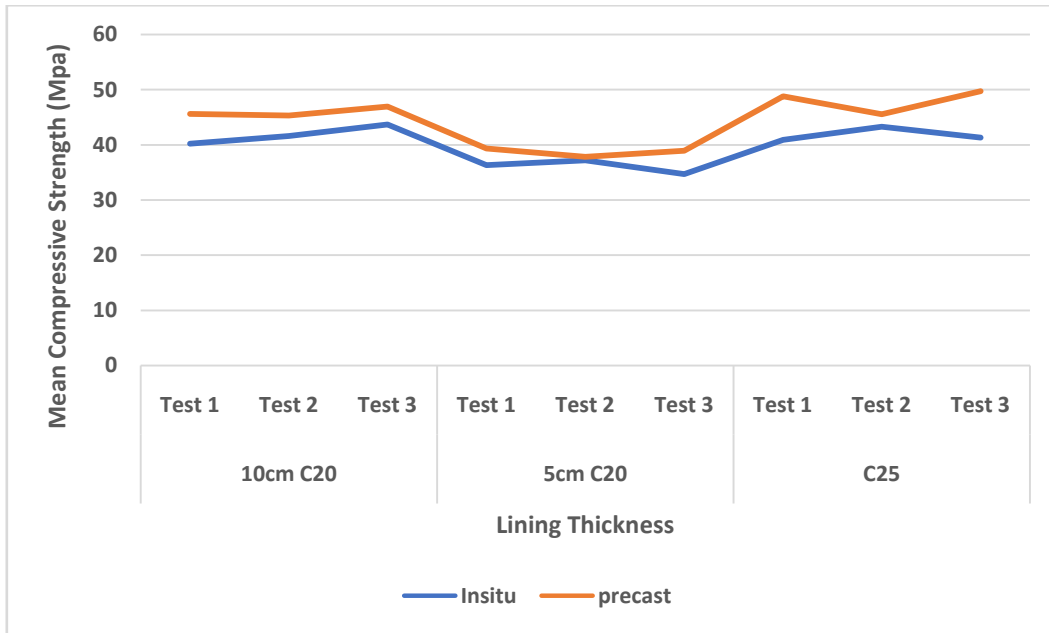
Figure 10: Insitu versus Precast Canal Lining Rebound Test (Compressive Strength)

The compressive strength results of the rebound hammer test for different thicknesses of plain and reinforced concrete canal structures are summarized in Table 6. Generally, the summary of the rebound test results from Fig. 10 shows that; the average compressive strength of the precast concrete part of the canal is much greater than that of the insitu concrete and the standard deviation of the compressive strength of the precast concrete is less than the insitu types of concrete.

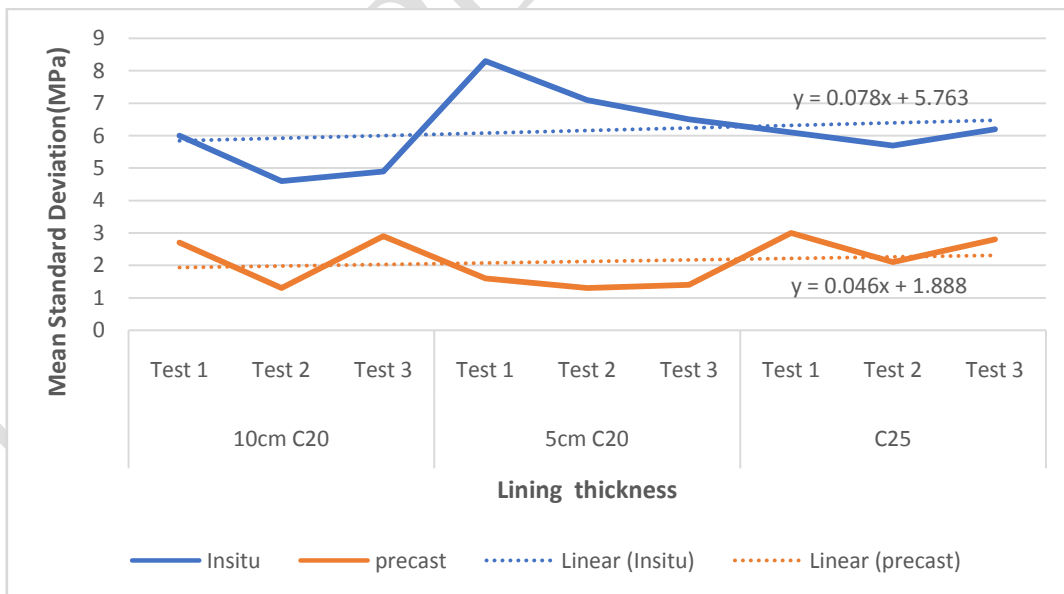
Figure 11: Uniformity of the Insitu versus Precast Canal Lining

Precast uniformity is higher when compared with insitu concrete. As shown in Fig. 11, the trend line of Insitu concrete is steeper than precast concrete. The standard deviation of the Insitu is higher than precast concrete lining in all thickness levels as stipulated in Table 6; implying that precast has higher uniformity.
