Original Research Article

Comparative Analysis of Precast and Insitu Concrete and Their Effectiveness on Koga Irrigation Structures

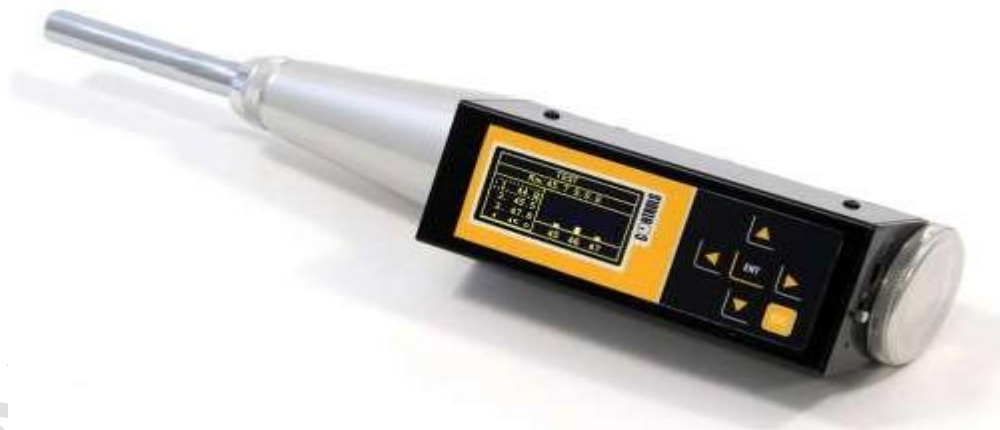
Figure 2: Digital Rebound Hammer Device

Among the other NDT tests, the rebound hammer test was conducted due to its availability in the Bahir Dar University laboratory. To get a precise result, several experimental data on CCS, and rebound numbers from rebound hammer tests are required. The rebound test apparatus which was used for this experiment is digital and it can directly display the CCS in MPa. The experimental data were collected from 6 points for evaluating the hardened compressive strength of concrete was tested from a concrete constructed 14 years ago and the compressive strength of concrete is taken as the output. The rebound value can be calculated using innovative technology by considering the anvil speed before and after the loading. This working principle is similar to the traditional measurement of maximum spring length after the impact, but it provides higher accuracy and stability of the readings.

The setting of the impact angle is no longer required and checking of the device's reliability can be performed during each impact, even without the calibration anvil. Digital Rebound Hammer Model 58-C0181/DGT with Accessories is used for the study as shown in Fig. 2.

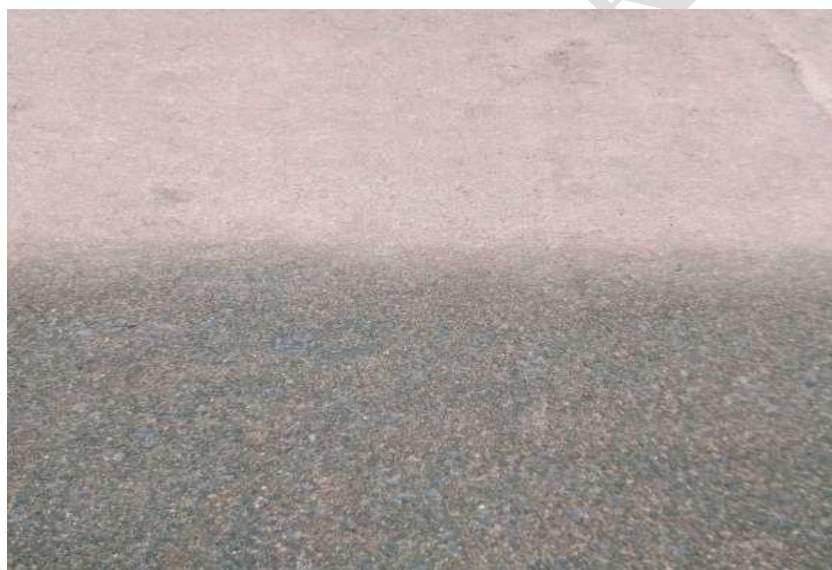
Figure 3: Observation of Concrete Face Above and Below the Free Board

From the visual inspection results, it was observed that all part of the lined canal under the freeboard is subjected to light scaling. So, the light defect category of scaling is generalized throughout the longitudinal section of the canal lining below the freeboard. But the severe loss of mortar and more exposure of coarse aggregate is observed more at the insitu linings.

The light scaling defects are very significant and observed on both precast and insitu concrete lining throughout the longitudinal section under the freeboard of the canals. But the severe scaling defect is observed more on the insitu concrete linings. This defect occurs in concrete that does not have proper air entrainment and is continuously saturated.

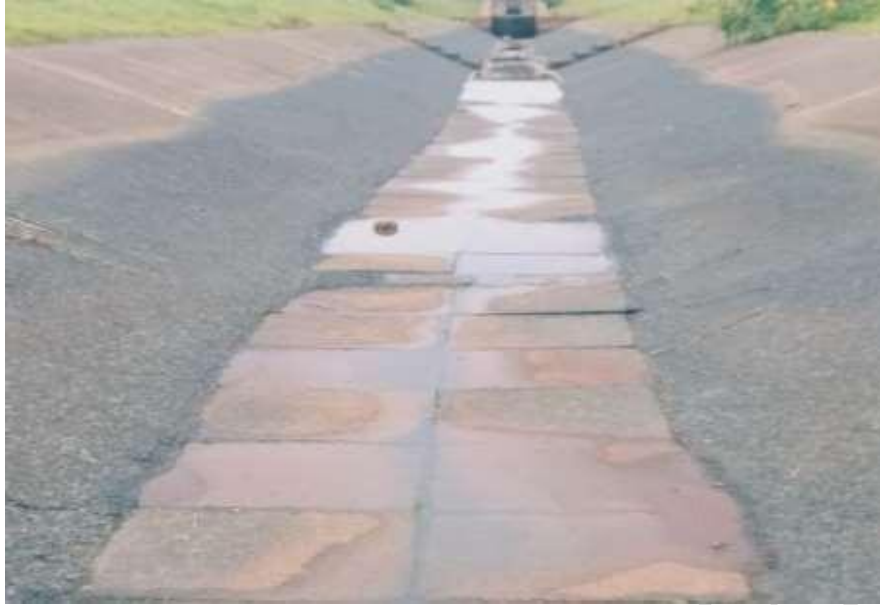
Figure 4: Differential Movements on the Precast Concrete

In most precast concrete canals, simple differential settlements were observed at the bed of the canal as shown in Fig. 4. But the insitu concrete passes the settlements as a slab.

The pop-outs and spalling defects can be taken as acceptable defects and insignificant problems. These problems will not further continue and are observed rarely in a few places only. In most precast concrete canals, simple differential settlements are observed at the bed of the canal. But the insitu concrete may bridge over those settlements.

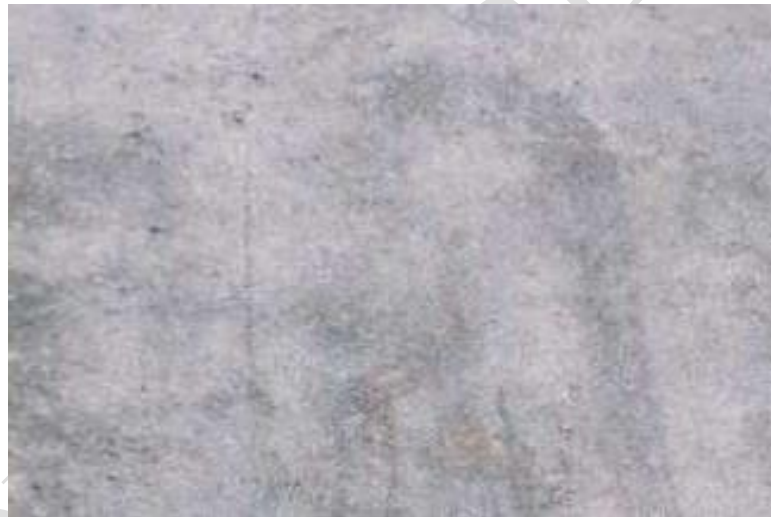
Figure 5: Effect of Rainfall on the Insitu Concrete

One of the main problems of insitu concrete construction is that, when the rain falls on concrete before its setting time in the summer season, the jell of the concrete mix will be washed away by the rainfall. But the precast elements were assembled after setting and curing time was finished in a controlled and protected room.

Properly placing, finishing, and curing concrete can have a big impact on service life. It is difficult to construct insitu concrete linings in the rainy season, because the rain may wash and erode the fresh concrete before its setting time. But in the case of precast concrete linings, the contractor can manufacture the precast elements in a rainy time in a protected room and assemble them during a dry time. Precast concrete linings are susceptible to the growth of grasses in the closely spaced joints. In the same manner, the cracks of insitu concrete are sensitive to the growth of grass and vegetation. The joints of precast concrete lining canals are scoured and removed.

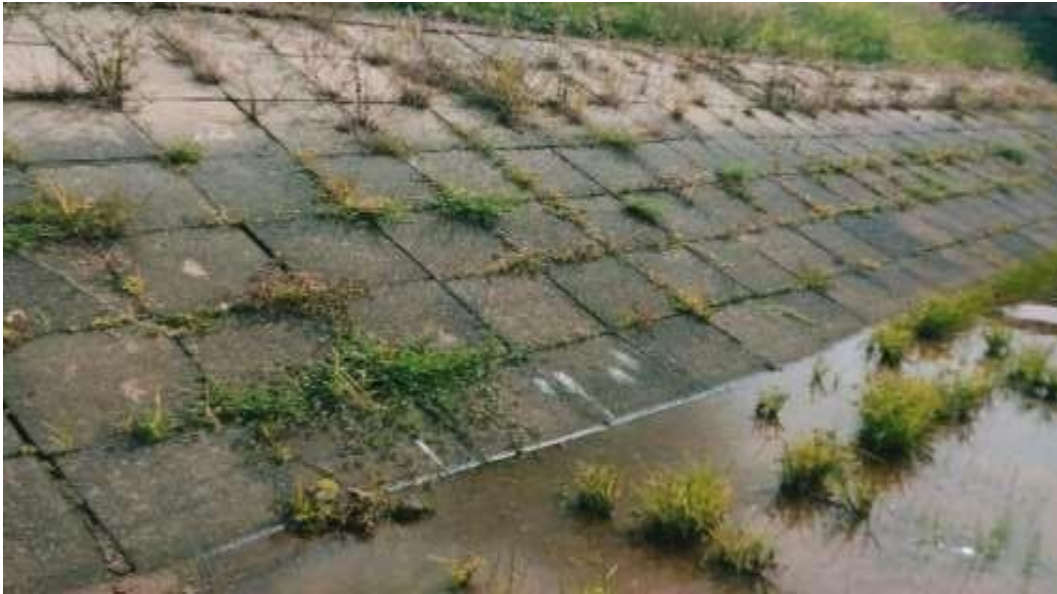
Figure 6: Vegetation and Grass Growth on the Joints of Precast Concrete

As shown in Fig. 6, the precast concrete part of the canal is sensitive to the growth of vegetation and grass at the closely spaced joints due to the accumulation of dust inside the openings.

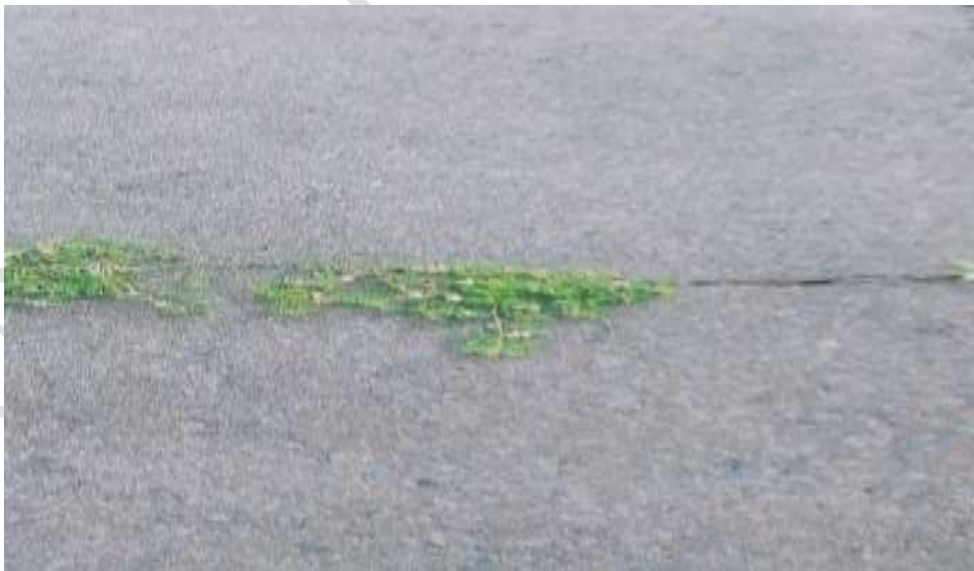
Figure 7: Vegetation and Grass Growth in the Cracks of Insitu Concrete

It was observed that Vegetation and grass have grown on the wider cracks of insitu concrete canal linings.

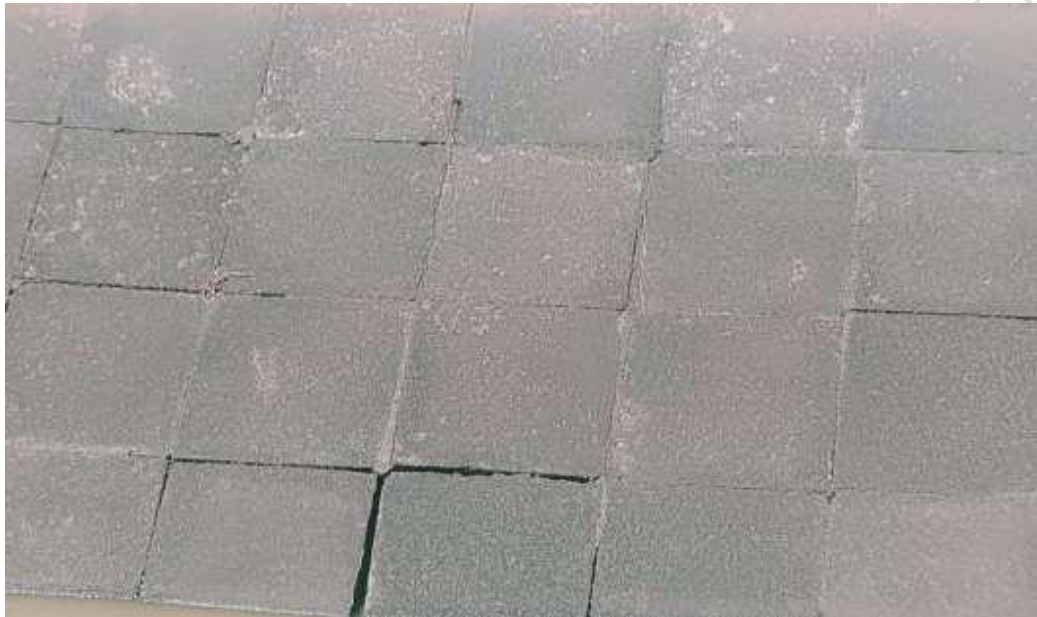
Figure 8: Removal of Joints between the Joints of Precast Concrete

Some of the mortar-filled joints, which are the weak points of precast concrete canals, were removed by the scouring action of water (Fig. 8).

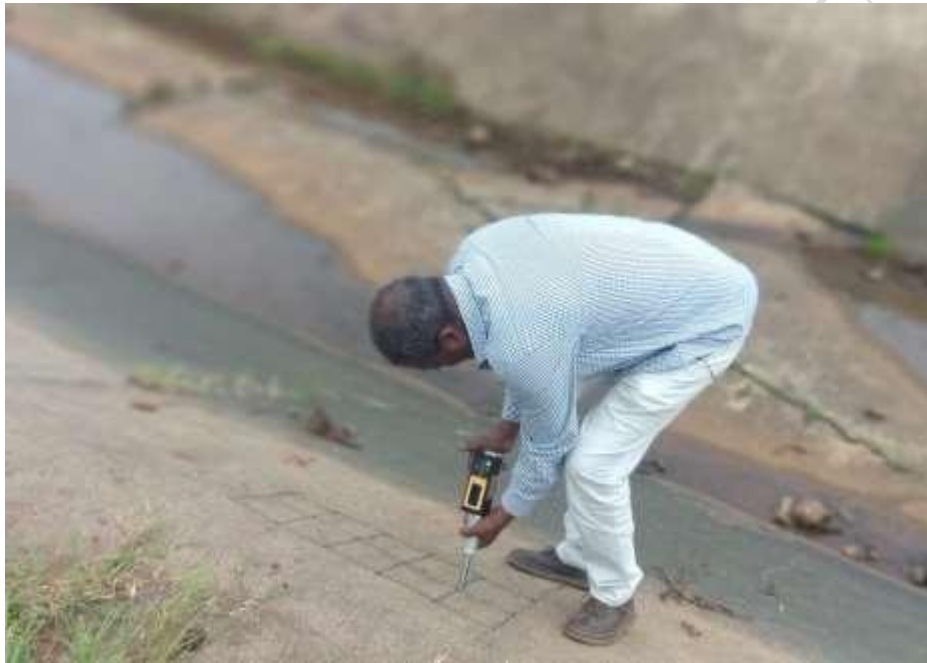
Figure 9: Conducting Rebound Hammer Test

According to the results of the rebound test, the compressive strength values are very much increased when compared with the design characteristic strength values. This situation is observed on both precast and insitu concrete elements. But, based on a comparison of the average and standard deviation of CCS results, the strength and uniformity of the compressive strength of precast concrete are much better than the insitu concrete. The rebound hammer test results, which are conducted by making grid squares at six places and 10 points at each place and their corresponding locations, are listed in Table 6.
