Physicochemical Characteristics of Water in the Bontanga Irrigation Dam in the Guinea Savannah Agro-Ecological Zone of Ghana

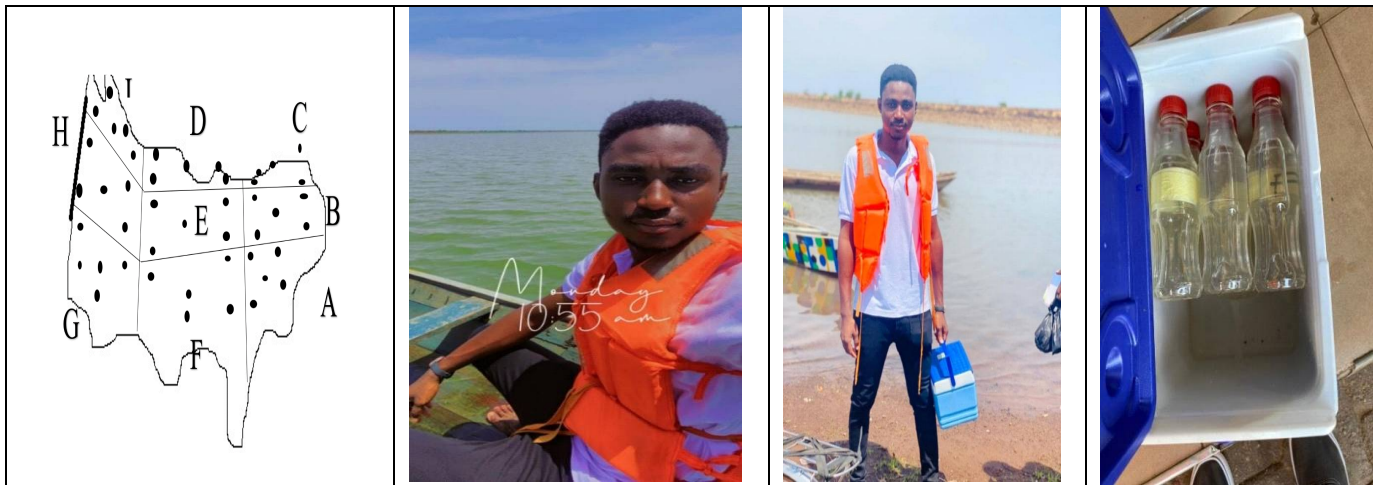
Plate 1. Water Sampling in the Reservoir of the Bontanga Irrigation Dam

strata and five (5) Sampling Points were purposively selected (Plate 1). Five (5) samples were collected from each stratum and were combined (composited) to give one sample each in each stratum reducing the number of samples from forty-five (45) to nine (9) (Plate 1). The sampling began at the lower section, then to the middle section, and finally to the upper section or the receiving point. The sampling was done in this way to avoid contamination or mixing of particulate matter from the upper section. Also, a field blank consisting of deionized water was added to the samples. To identify errors and contamination during sample collection and analysis, the pH and temperature of the samples were measured at the University of Ghana's Ecological Laboratory prior to statistical analysis. The nine (9) samples were carefully labelled using permanent marker and stored in an ice chest with ice cubes. The ice chest was securely sealed shut using duct tape. The samples were kept at approximately 4°C and transported to the Ecological Laboratory of the University of Ghana for analysis of 17 parameters including 3 physical parameters and 14 other nutrient and chemical parameters.
