# Accident Investigation using Event Tree Analysis, Root Cause Analysis and Threat Zone Determination Using ALOHA Software: A Case Study of Styrene Gas Vapour Release at Vishakapattinam

The Visakhapatnam gas leak incident happened on May 7, 2020, at LG Polymers chemical plant in RR Venkatapuram, Visakhapatnam district, Andhra Pradesh, India, resulted in fatalities and several injuries. This study is about a comprehensive analysis of the incident and also focuses on the causes of the gas leak, the nature of the chemical industry, the subsequent response and its impact on Environment and Human Health. A detailed study about styrene gas leaks, the chemicals involved, and also about styrene-related accidents, safety data, and relevant laws and acts governing chemical storage. The work identifies various factors contributing to the gas leakage, including tank design, temperature control, recirculation systems, inhibitor addition protocols, and the risk of polymerization and runaway reactions. Methodologies like ALOHA for threat zone determination, Event Tree Analysis (ETA) for consequence determination, and Root Cause Analysis (RCA) were employed to identify the causes and consequences

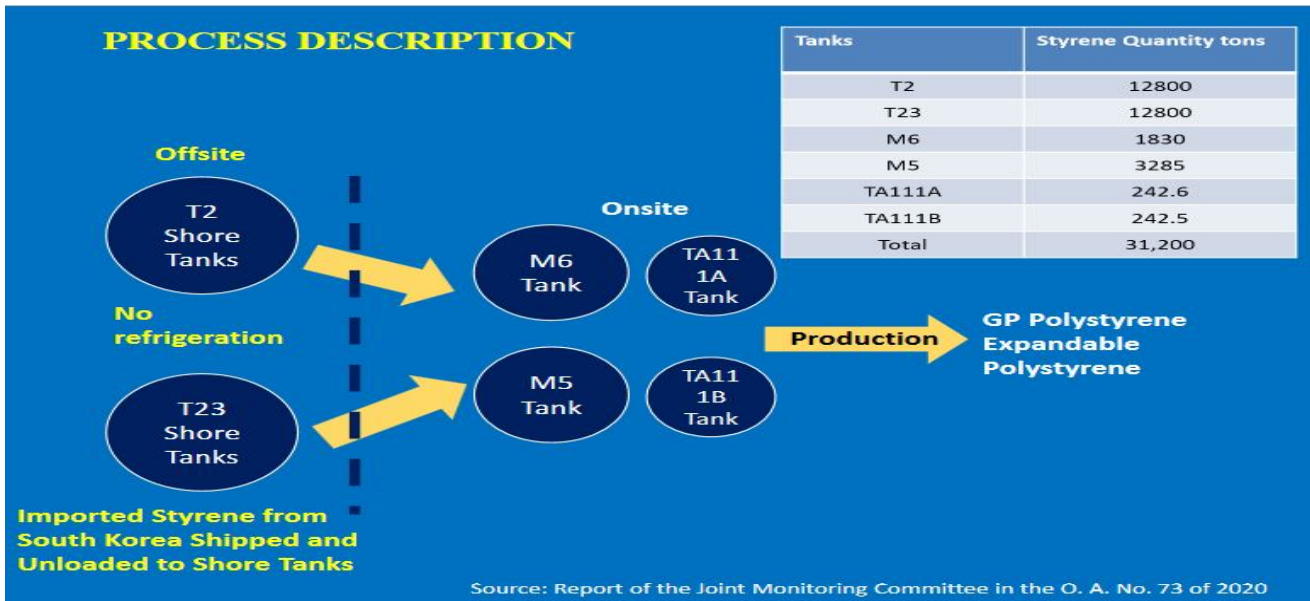
Fig.1 Process Description of Expandable Polystyrene

Styrene, poly butadiene (if an impact-grade product is desired), mineral oil (lubricant and plasticizer), and small amounts of recycled polystyrene, antioxidants, and other additives are charged from storage (1) into the feed dissolver mixer (2) in proportions that vary according to the grade of resin to be produced. Blended feed is pumped continuously to the reactor system(3) where it is thermally polymerized to polystyrene. (Fig.1 &2)[9].

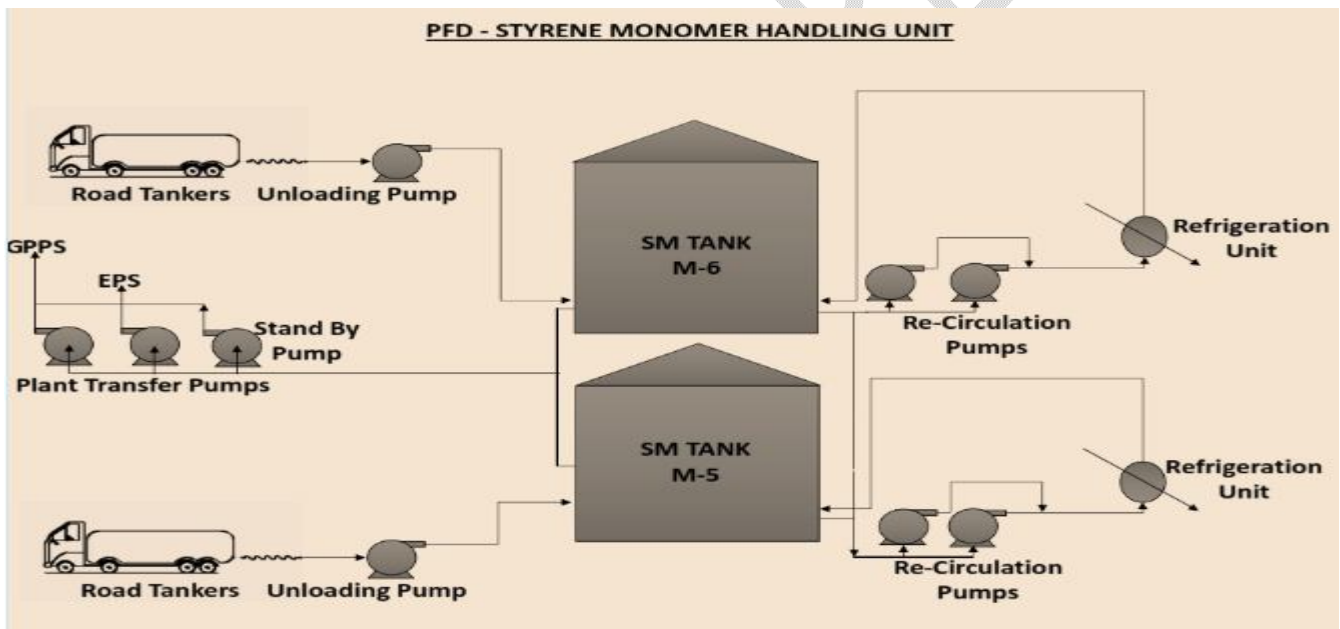
Fig.2 Schematic Diagram of Styrene Handling Plant

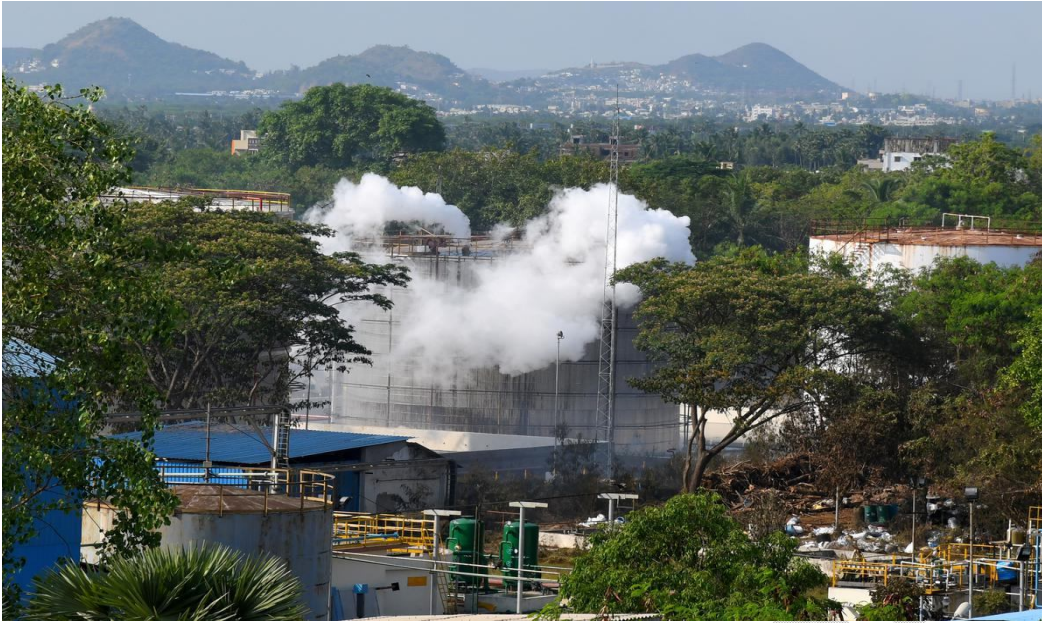
**Fig.3.A file photo of styrene gas leaking out of a tank in LG Polymers unit, in Visakhapatnam**

This Styrene vapour release, shown in Fig.3 widely referred to as “Vizag Gas Leak”, is a unique major Styrene vapour release incident from a bulk storage tank anywhere in the world. Nearly 20,000 people from 17,000 houses/residences of RRV Puram, Nandamuri Nagar, Kamparapalem, Padmanabha Nagar, SC/ BCColony, Meghadripeta Colony were evacuated, and arrangements were made at 23 rehabilitation centres maintained by GVMC as well Simhachalam Devasthanam authorities. [9] Major factors leading to Styrene gas leak accident were

A lined carbon steel tank is commonly preferred for the bulk storage of styrene monomers. But the M6 tank used in the process was constructed with mild steel without internal lining and is externally insulated, which is a non-conformance to the laid-down standards and guidelines. It operates at atmospheric pressure and is equipped with a flame arrestor/ventilator (N6) and a vent/dip hatch (N1). Additionally, it has a manhole/foam pourer (N2). To prevent dead packets filled with styrene, the number of nozzles must be kept to a minimum, but there are 17 nozzles in the M6 tank. The life extension program of the storage tank should be performed every 50 years as per PESO (Petroleum and Explosives Safety Organization), but the tank was 53 years old at the time of the accident. The literature on storage styrene monomer says that the tank should be cleaned once every 2 years, but the company informed us that their standard protocol is to clean tanks once every 5 years. The formation of rust took place, which inhibits the role of TBC mainly due to improper maintenance of the tank. The tank design does not have a flare system to burn styrene into carbon dioxide or a cryogenic system to condense styrene vapors. From all the above-mentioned factors, it clearly indicates that the tank is inferior to storing styrene in bulk amount.[10]

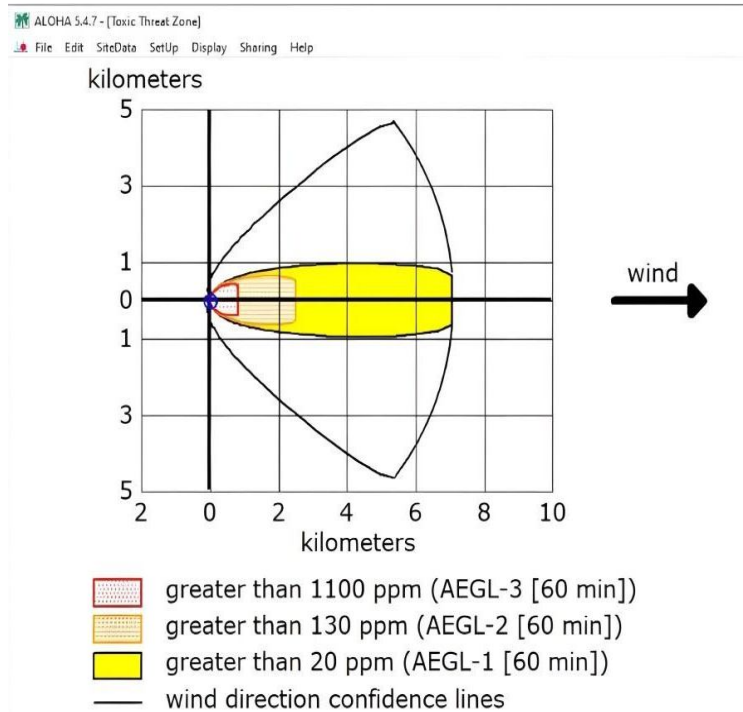
**Fig.4 Threat Zone Determination using ALOHA Software**

The total amount of styrene released from the M6 tank is 92,412 kilograms for a wind velocity of 3.22 mph from a south direction at a height of 20 m, an air temperature of 280 °C, and a relative humidity of 76%. The Red

Zone of Acute Exposure Guidelines Levels 3 (AEGL 3 = 1100 ppm) is around 864 meters, which is the airborne concentration of a substance above which it is predicted that the general population, including susceptible individuals, could experience life-threatening health effects or death. The Orange Zone of Acute Exposure Guidelines Levels 2 (AEGL 2 = 130 ppm) is around 2.5 km, which is the airborne concentration of a substance above which it is predicted that the general population, including susceptible individuals, could experience irreversible or other serious, long-lasting adverse health effects or impaired ability to escape. The Yellow Zone of Acute Exposure Guidelines Levels 1 (AEGL 1 = 130 ppm) is around 7.1 km, which is the airborne concentration of a substance above which it is predicted that the general population, including susceptible individuals, could experience notable discomfort, irritation, or certain asymptomatic non-sensory effects. However, the effects are not disabling and are transient and reversible upon cessation of exposure. (Fig. 4 and This threat zone determination is used to determine the evacuating region **and usage of personal protective equipment**. For concentrations of 20 ppm, use a National Institute for Occupational Safety and Health (NOISH)-approved respirator with an organic vapor cartridge and a full face piece. For concentrations of 200 ppm, use a National Institute for Occupational Safety and Health (NOISH)-approved air respirator with a full face piece. For concentrations of 700 ppm, which are immediately dangerous to life and health (IDLH), use a National Institute for Occupational Safety and Health (NOISH)-approved self-contained breathing apparatus (SCBA) with a full face piece operated in pressure demand or other positive pressure mode equipped with an emergency escape air cylinder.

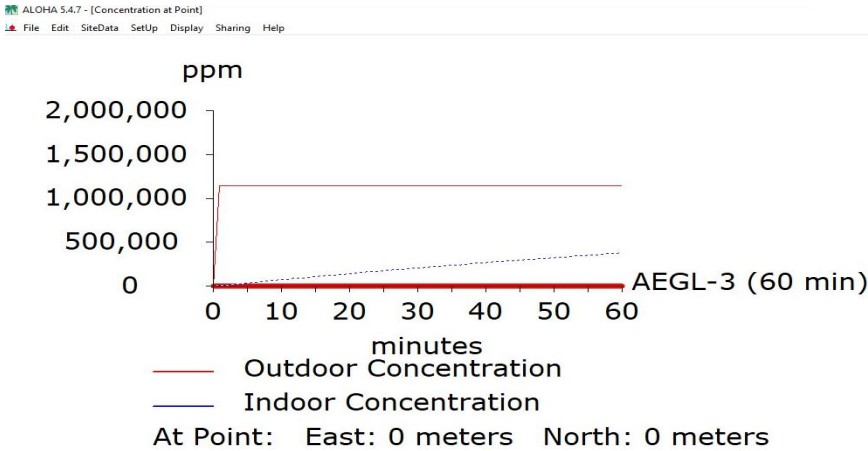
**Fig.6 Threat at Point using ALOHA Software**

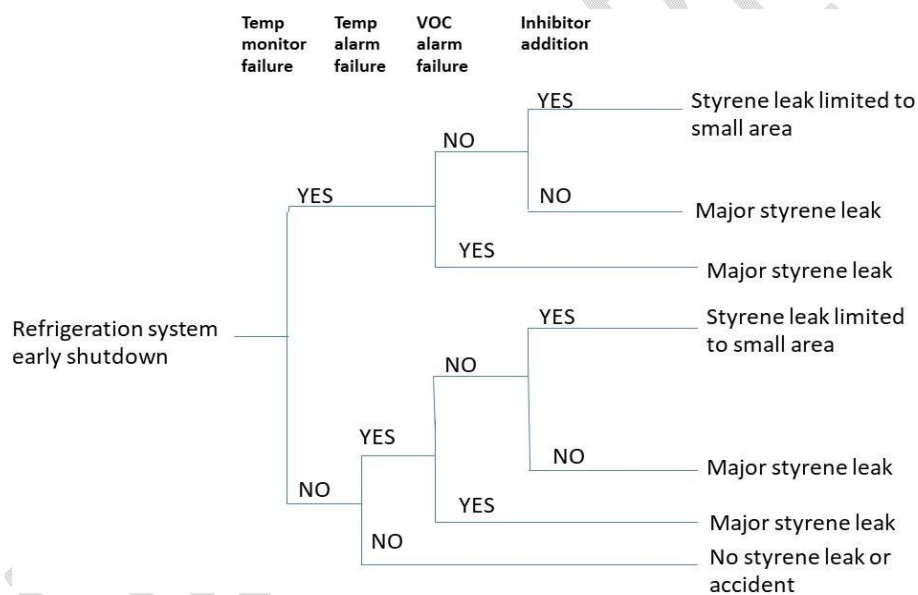
Event tree analysis was employed to investigate the Visakhapatnam gas leak incident. The initiating event of the Vizag gas leak was identified as the early shut-down of the refrigeration system of the styrene storage unit. Various safety barriers and monitoring systems were in place within the plant, including the temperature monitoring system, temperature alarm, VOC (Volatile Organic Compounds) alarm, and the use of inhibitors such as Tertiary Butyl Catechol (TBC). However, the accident investigation revealed significant flaws in the temperature monitoring system, as the temperature alarm did not activate during the incident. Fortunately, the VOC alarm functioned correctly, detecting the leak promptly. However, the last barrier, the inhibitor (TBC), was out of stock at the time of the disaster due to the lockdown, significantly exacerbating the incident's consequences. (Fig.7) This highlights the crucial role of the lockdown situation in contributing to the severity of the incident [18].

**Fig.7 Event Tree Analysis for Refrigeration System Shutdown**

ETA is used to predict the consequences of the initiating event (ie) early shutdown of refrigeration system which leads to the major accident if

- FailureofbothtemperatureandVOCalarms
- FailureofInhibitoraddition

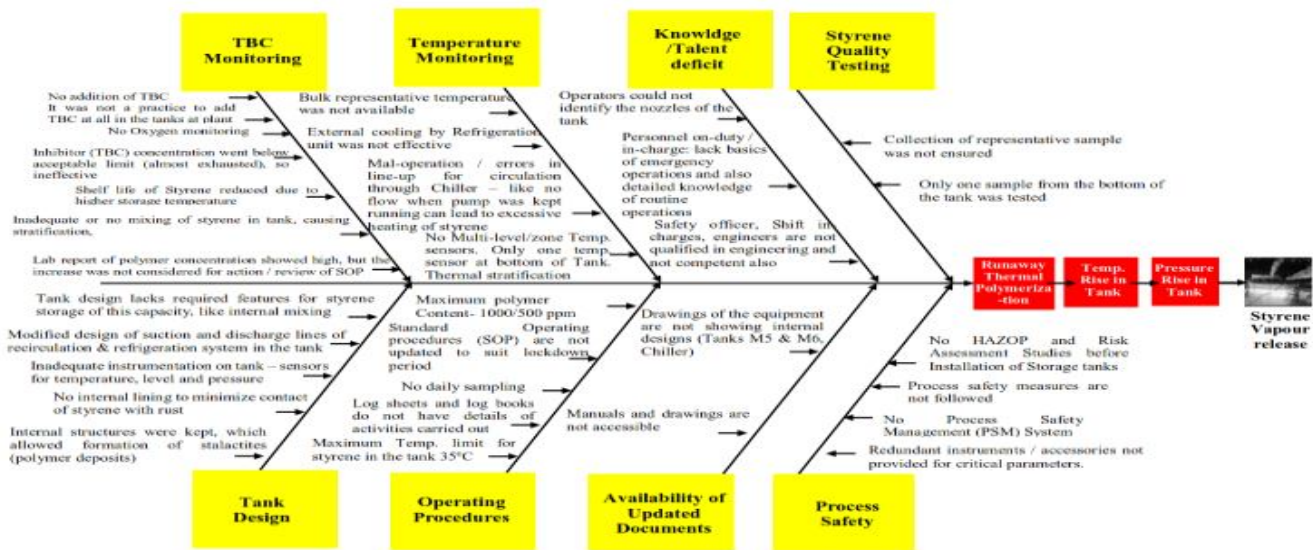
improvement and risk management in various fields, including manufacturing, healthcare, information technology, and quality management. (Fig.8) The major parameters that influenced the increase in temperature of styrene in the tank (M6) are mainly

**Fig.8 Ishikawa Fish bone diagram for Vizag Gas Leak**

- Incorporatesuctionsingpipeand educator systemforefficientmixing.
- Ensureeffectivcoolingsystemswithbackupcoolingtomaintaina maximum temperature of 25°C.
- Keepthenumberofnozzlesinthetanktoaminimumrequired.
- Constructthetankwithcarbonsteelandcoattheinsidewithrust- resisting inorganic zinc silicate material.
- Supportthetankroofwithoutsidestructures.
- Painttheoutsideofstorage tankswhiteoraluminumandconsider insulating them.
- Definetanklifeandcarryouttankcleaningandcoatingeverytwoyears.

- Review Standard Operating Conditions with upper and lower parameter limits.
- Implement High Critical Standard Operating Procedures if there is high polymer content.

- Maintain understandable, clear, and concise logbook entries.
- Increase sampling frequency during dormant periods (pandemic, turnaround, business cycles).

- Review and update procedures after any Management of Change.
- Thermal radical polymerization occurs
- Avoid overlooking increases in polymer level
- Prevent the formation of condensed styrene without TBC in the top layer of the tank.

- Monitor and control temperatures to ensure they stay below 35°C (Estimated 41.7°C on 28.04.2020).
- Be vigilant as the runaway polymerization reaction can start at about 34°C (Harold Fisher).
