Case report

Nine months Follow-Up of Root Perforation Repair Using MTA-HP in a singleretreatment session: A Case Report

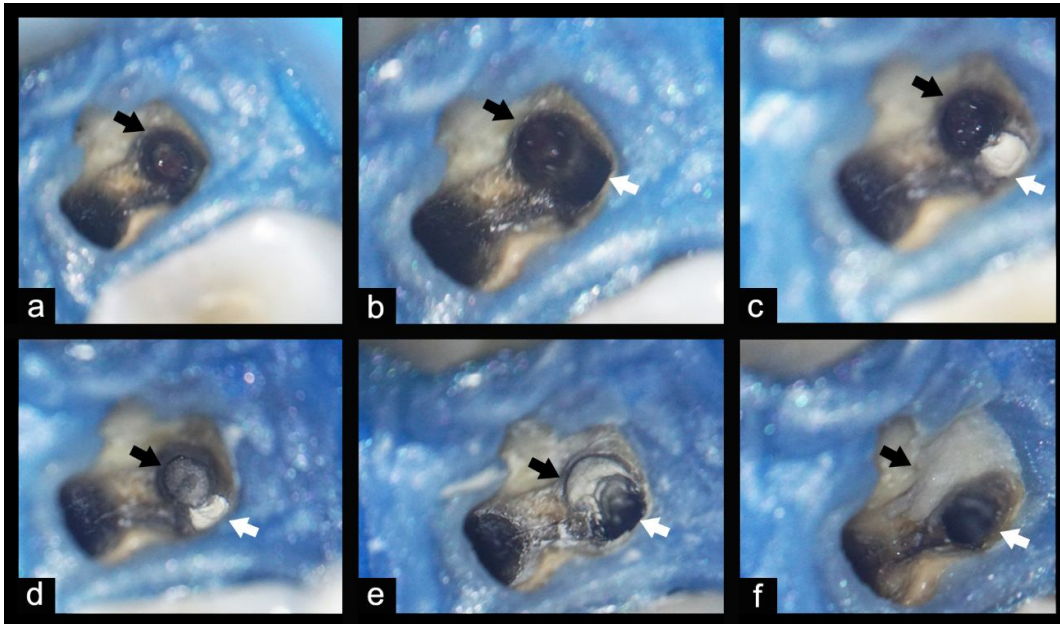
Figure 4. Perforation in the palatal root - black arrow (a). Radicular perforation – black arrow; palatal canal – white arrow (b). Radicular perforation – black arrow; palatal canal protected with Coltosol – white arrow (c). Collagen sponge barrier – black arrow; palatal canal protected with Coltosol – white arrow (d). Perforation filled with MTA HP – black arrow; palatal canal – white arrow (e). MTA superficially protected with a layer of glass ionomer – black arrow; free palatal canal – white arrow (f).

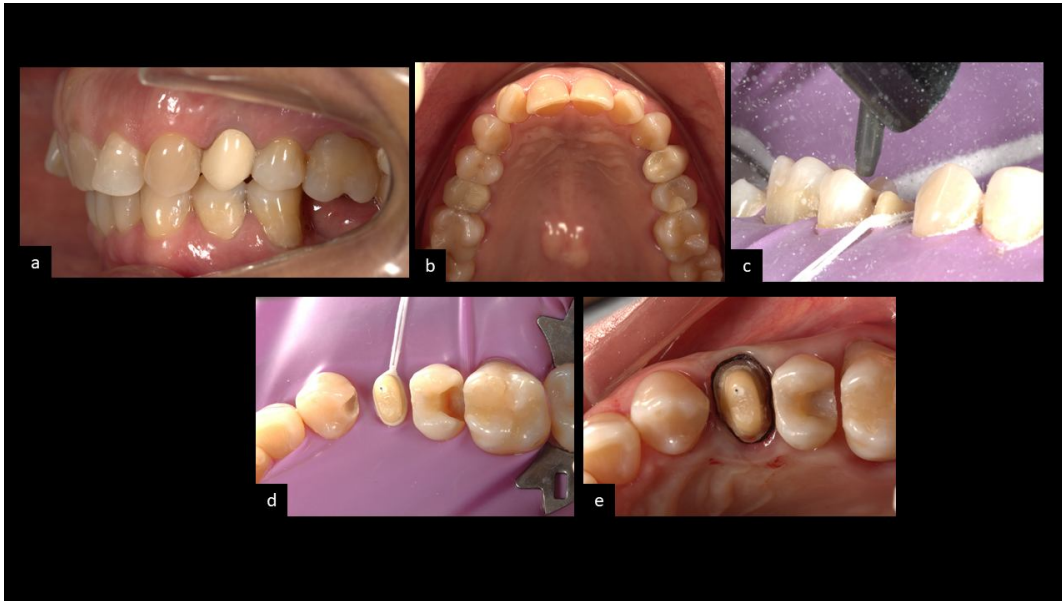
Figure 5. Initial aspect of temporary restoration - lateral view with retractors (a). Initial aspect of temporary restoration - occlusal view with retractors and mirror (b). Aluminum oxide sandblasting of preparations (c). Aspect of preparations after aluminum oxide sandblasting (d). Crown preparation margin in triple cord retraction technique after removal of thicker cords (e).

In the initial restorative appointment, a sequence of three intraoral scans was performed (Primescan, Dentsply Sirona, Bensheim, Germany). The first scan, referred to as the preoperative scan of the maxilla, was conducted with the provisional crown in place, allowing its functional anatomy to be later replicated during the digital design phase. Subsequently, the scan of the antagonist arch was carried out. Following these initial scans, the crown was removed, and final preparation was performed using high-speed diamond burs of fine and extra-fine grit (KG Sorensen, São Paulo, Brazil), aimed at achieving better margin delineation for the restoration (Renne et al., 2012). The scanning of the arch with the final preparation was performed using the triple cord retraction technique (Ultradent, South Jordan, United States), wherein a sequence of three retraction cords of increasing diameters is placed between the gingiva and preparation, with removal of the largest cord immediately before scanning. The scan files were exported in STL format at maximum resolution (100%).

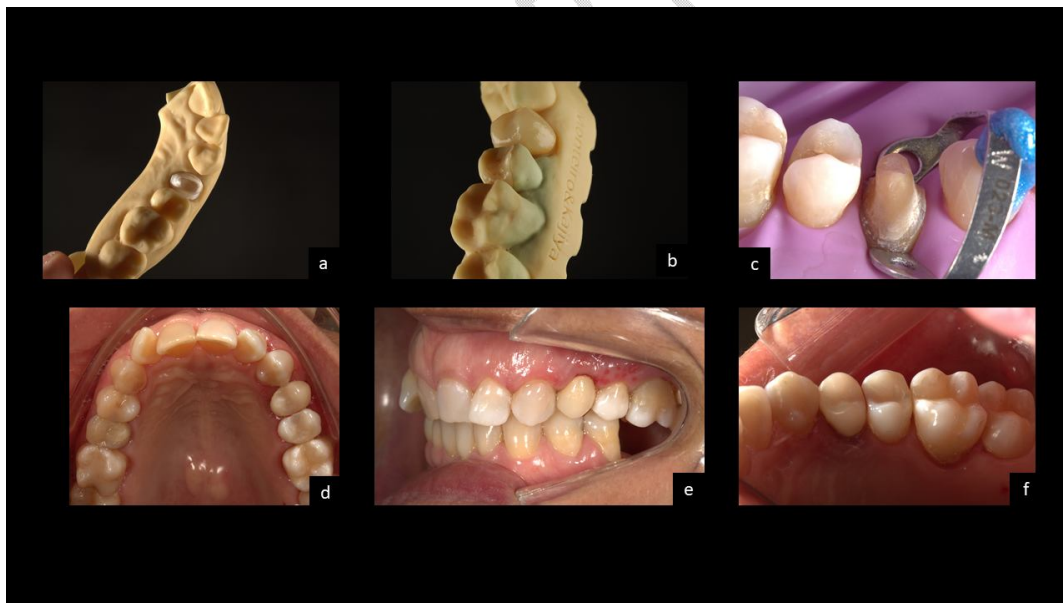
Figure 6. Occlusal view of 3d-printed model with Geller die (a). 3d-Printed restorations adapted to 3d-printed rigid model (b). Isolated crown preparations with rubber dam and stabilized clamp (c). Final aspect of 3d-printed restorations - occlusal view with retractors and mirror just after adhesive cementation (d). Final aspect of 3d-printed restorations - lateral view with retractors immediately after adhesive cementation (e). Final aspect of 3d-printed restorations (f).

In the final restorative session, the printed restoration was adhesively cemented. Initially, the provisional crown was removed, and the dental preparation was cleaned with 0.12% chlorhexidine and pumice (Biodinâmica, Paraná, Brazil) using a Robinson brush (American Burrs, Santa Catarina, Brazil). The preparation was isolated with rubber dam and stabilized with a modified clamp. Then, the surface of the preparation was sandblasted with 50-micron aluminum oxide (BioArt, São Carlos, Brazil) at a controlled distance, pressure, and time. Next, 37% phosphoric acid (Biodinâmica, Ibiporã, Paraná) was applied to the enamel for 30 seconds and rinsed abundantly with a water jet for the same conditioning time. Excess moisture was removed with a light air jet at a controlled distance. A layer of Single Bond Universal adhesive (3M, São Paulo, Brazil) was applied to the enamel and dentin using a microbrush (Kg Sorensen, São Paulo) for 20 seconds. Then, a light air jet was applied. For cementation, RelyX Ultimate cement (3M, São Paulo, Brazil) was dispensed onto a glass plate, and the pastes were mixed. The cement was applied inside the restoration, which was seated onto the remaining dental structure, and the excess resin cement was removed with a brush. The light-curing (Radii Cal, SDI, São Paulo, Brazil) was done following the manufacturer's recommendations. After photopolymerization, occlusal adjustment was performed with a 3118FF diamond bur (KG Sorensen, Espírito Santo, Brazil), and the restoration was finished with a 30-blade multilayer
