Flexural Behaviour and Environmental Impact of African Fan Palm Reinforced Concrete Beams under Symmetrical Loading Conditions.

The paper presents the results of investigation on reinforced beams adopting eco-friendly materials for sustainable concrete. The use of African fan palm is explored to mitigate the environmental impact aimed at reducing carbon emissions associated with the production and use of steel reinforcement. The beams were tested under a four-point loading system with the ends simply supported. The test comprised twenty-three beams that were reinforced with African fan palm bars whilst two beams were reinforced with mild steel bars to serve as control beams. The study investigated the flexural strength and deformation characteristics of the beams under monotonic loading. Two concrete strengths of 15.34N/mm^2 or 22.37N/mm^2 were adopted and proposed optimal tensile ratios for an under reinforced fan palm section. The parameters considered included the tension bars ratio (ρ), concrete compressive strength, span-to-effective-depth ratio and loading conditions. A linear elastic behaviour of both fan palm and steel reinforced concrete beams was observed to the point of

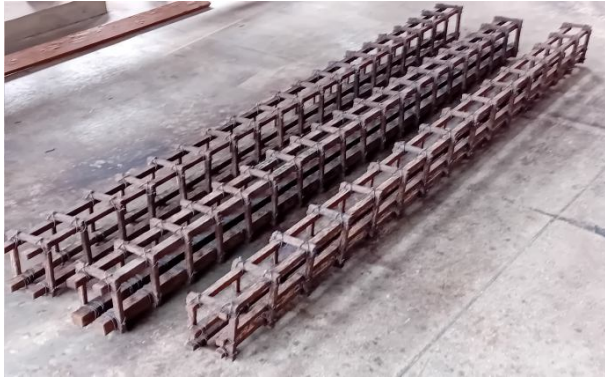
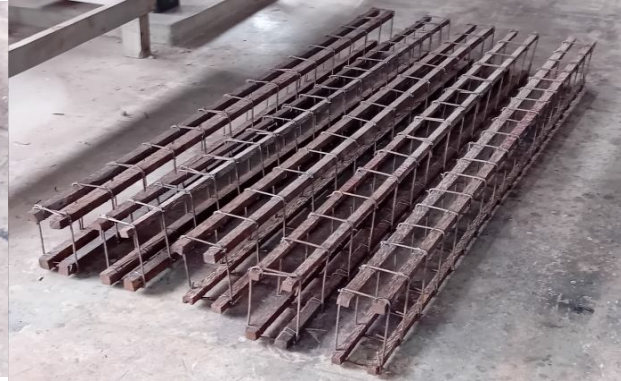
Figure 1: Skeletal framed beams

(a) Fan palm bars and stirrups

(b) Fan palm bars and steel stirrups

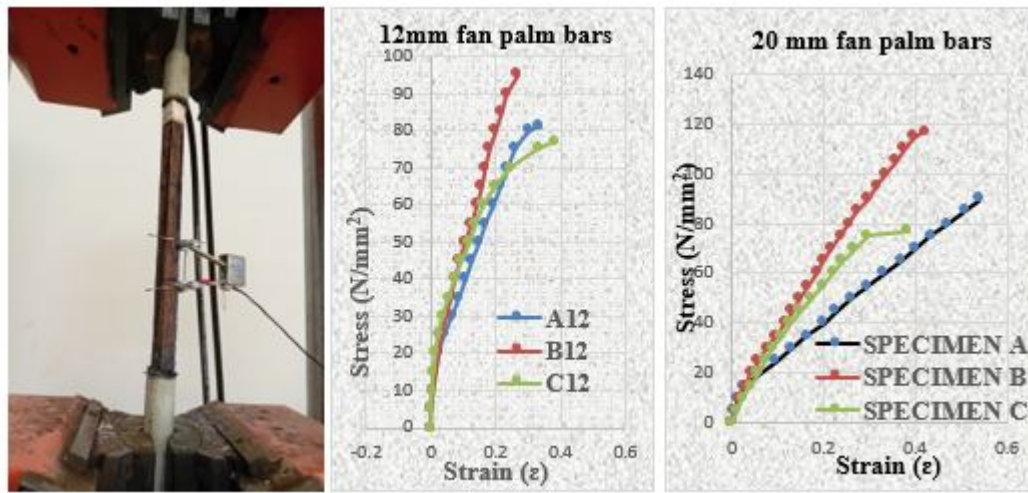
Figure 2: Tensile strength of fan palm specimens of 12mm and 20mm (Mansal et al.,2024)

(a) Fan palm specimen (b) Stress – strain curve of the 12mm and 20mm fan palm bars

Six (6) samples for the tensile strength of the fan palm reinforcing bars of square cross-sectional areas of 12mm x 12mm and 20mm x 20mm were randomly selected from the stack of seasoned fan palm bars and cut to lengths of 600mm(Mansal et al., 2024). These specimens were subjected to a computerized Universal Testing Machine (UTM) with a load capacity of 2000kN in accordance with the BS EN 1008 (2002). The test specimens were gripped inside a 150mm long hollow metal bar at both ends using epoxy mixture of resin and hardener and allowed to dry for 24 hours. The epoxy resin had an excellent bond property with other materials when dried with less shrinkage. The glued metal bars enhanced the grip and prevented crushing of the fibres

of the fan palm bars during the test process, thus eliminating the tendency of premature failure leading to incorrect results. An extensometer with a 50mm gauge length was attached to the test specimen gripped into the jaws of the UTM (Fig.2a). The extensometer was then connected to the computer monitor and as load was applied, the latter automatically recorded the ultimate failure load and elongation as well as the stress versus strain curve and the Young's modulus of elasticity of the test specimen. A plot of the tensile stress-strain curve in Figure 2b shows linear relationship of the specimens with mean ultimate tensile failures and Young's modulus of elasticity of 94.67N/mm^2 and 20kN/mm^2 for the 20mm fan palm bars and 84.33N/mm^2 and 26.71kN/mm^2 for the 12mm bars respectively (Mansal et al., 2024). Similar findings were reported by Samah et al. (2015), Kone et al. (2021) and Adedeji. (2020).
