Environmental Impact of River Bank Erosion on Stream Morphology: A Study of the Mini Piti Stream, Obio-Akpor, Nigeria

This study was designed to assess the impact of river bank erosion on the environment and the channel morphology for the Mini-Piti stream in Obio-Akpor local government area of Rivers State, Nigeria. This study determined the depth variations from width measurements due to bank erosion activities and the impact of indiscriminate waste dumps on the river channel. Physical water quality parameters of temperature, turbidity, transparency and TSS were determined using standard methods. The stream was divided into three stations; upstream 2.5km, midstream 2.5km, and downstream with intervals of 1km measured to differentiate each station as 5 samples were obtained per station at intervals of 0.5km apart. The flow velocity and discharge were estimated as the average depth recorded upstream being DS 0.9m, WS 1.4m, Midstream DS 1.3m, WS 1.7m, and Downstream=DS 1.5m WS 1.7m. The maximum width of 11m and minimum of 0.1m were recorded though natives confirmed that the stream is closing up unless maintenance dredging to expand the depth and width, the loss of this channel canno

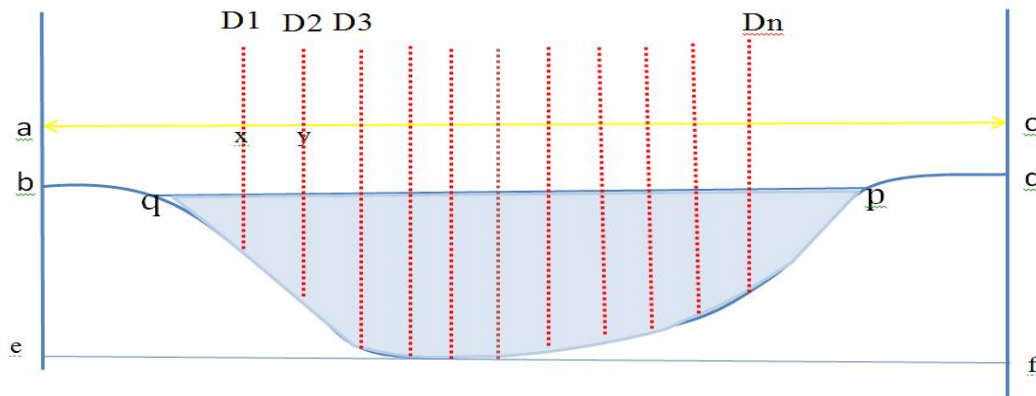
Fig. 2: The Cross Section of the Stream

Bathymetry Survey was carried out with the help of Echo sounder and the meter rule was to measure the depth of the stream. In order to facilitate the river bed profile, the study area was divided into three stations.

The upstream extended from upper Egbelu to New road and cuts across Mgaraja. The depth profile was carried out in 5 sampling locations at intervals of 500m apart and labeled as location 1 to 5 during dry and wet seasons. The bathymetry data obtained was properly recorded, after the last location at the upstream, a distance of 1000m was measured to begin midstream profiling for 5 sampling at intervals of 500m. The midstream section covered Mgbuakara community at right bank and Egbelu community at the left bank. The downstream section covered Elioparanwo, upper Egbelu and Iwofe. The same method for upstream and midstream was used at the downstream for five sample points. Figure 2 above shows the cross section of the stream, a calibrated rope **ab** from right to left bank to measure the width of the stream. **D1** to **Dn** indicate depth sounding at every 0.5m intervals to measure the stream depth, **qp** which is the water level, while **bq** and **pd** represent the right and left bank. This procedure was applied to the upstream, midstream and downstream during the dry and wet season to generate bathymetry data as shown in Tables 1 to 7. In the measurement of depth and width, the discharge or flow rate is determined from the cross-sectional area and the mean velocity. The area of cross-section of the river is determined from the profile of the river bed obtained by lead lines (Otuagomaet *al.*, 2015). This lead line is made of heavy weight attached to the lower end of a rope. The depth of water is measured when the lead touches the river bed. A small canoe was used to navigate the Mini Piti stream holding the lead line vertically.

The river cross-section is divided into a suitable number of vertical segments. The total discharge in the stream was computed as the sum of the discharges in various segments and each segment is equal to the area of the segment multiplied by the mean velocity of flow (Arora, 2009).

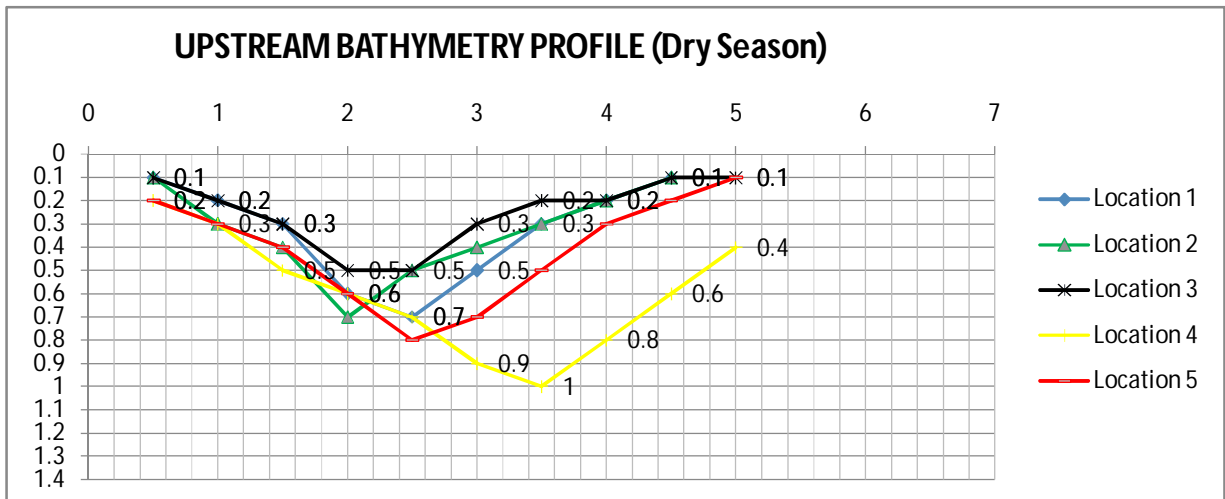
Figure 3: Graphical interpretation of upstream dry season bathymetry profile

The chart in Figure 3 shows the cross sectional depth profile of the upstream of the study area during the dry season where a total of five stations were surveyed across the channel. Maximum depth of 1m was recorded at location 5 indicated in the graph as red line and 0.5m depth observed at location 3. Observation at field indicated an average of 1.4m of water regression from the bank full stage and point bar. No serious bank erosion was recorded at the upstream of the study area, and is highly vegetated with farmland and distance built houses. The profile shows a well-defined, uniform and undisturbed channel basin.

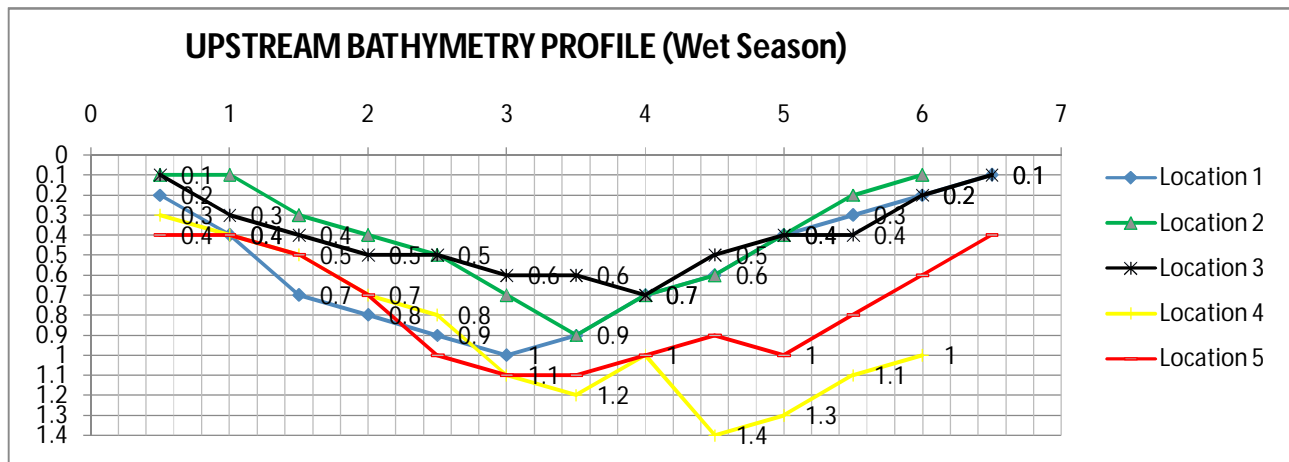
Figure 4: Graphical interpretations of wet season upstream bathymetry profile

There were significant changes in the depth and width of the upstream of the study area during the wet season as shown in Figure 4, the maximum width of the stream was 6.5m at location 5 and maximum depth of 1.4m at location 5. The changes in depth and width of the channel is as the result of input from the rain and runoff from the watershed which is between 1.2m and 1.4m depth. There was deposition of about 0.2m height of sediment in the stream bottom and bed erosion at location 5.

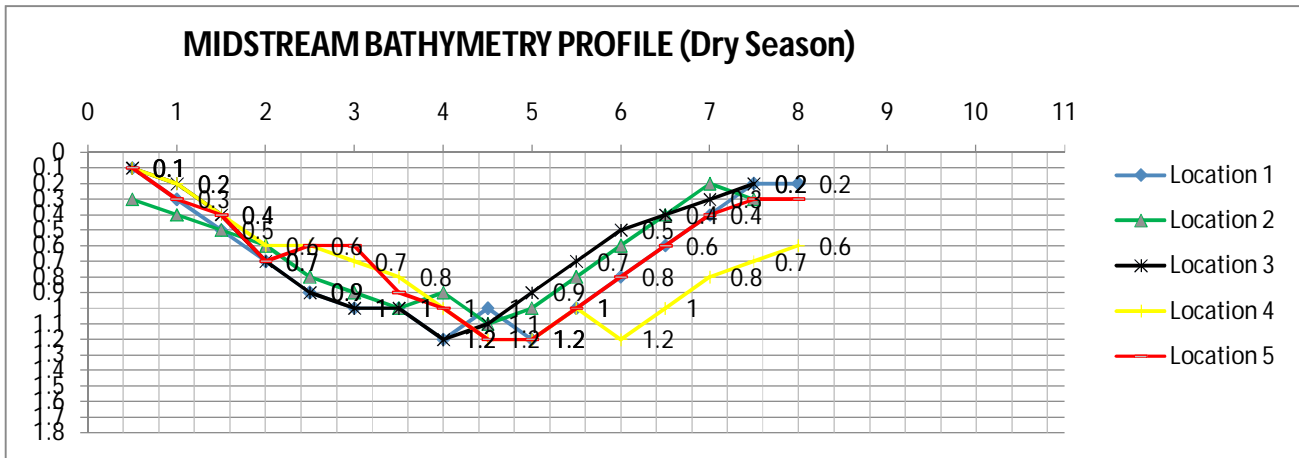
Figure 5: Graphical interpretations of dry season midstream bathymetry profile

The midstream of the study area covered five sample locations. The eroded zone of the bank was well exposed during the dry season as waste and debris dumped along the bank extended about 1.5m into the water channel, scarp, and bank full dimension was observed during the study (Figure 5). The maximum depth of the stream was 1.2m at location 2, 3, 4 and 5 and maximum width of 8.5m during the dry season.

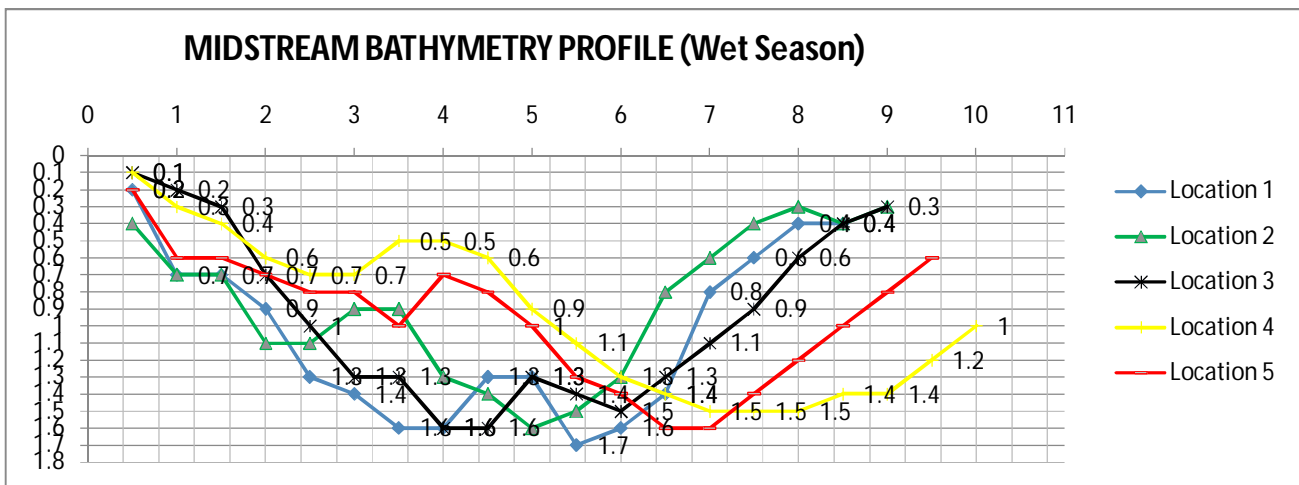
Figure 6: Graphical interpretation of midstream wet season bathymetry profile

The horizontal distance of about 2m from the floodplain exposed during the dry season was completely covered at the wet season as shown in Figure 6. The width distance of 0-2m at 0.2-0.6m depth showed bank erosion across the five locations of the midstream at the right bank. The scarp that was visible at the dry season was completely submerged during the wet season and for locations 1 and 3 at 1.3m depth, there was sediment accumulation on the bed of the stream and bed erosion at 1.6m depth and at location 1 and 1.7m depth at location 2. The maximum depth of the midstream during the wet season was recorded at location 1 and the width of 10.5m at location 4. From the field observation, the midstream was characterized by sharp sand.

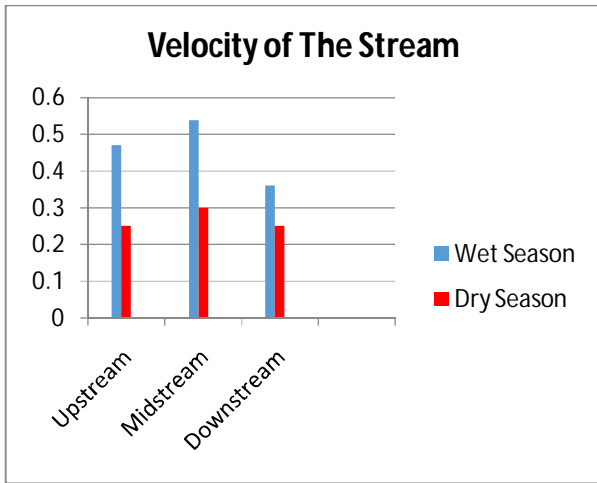
Fig. 9: Wet & dry season velocity

The flow dynamics are shown in Figures 9, 10 and 11 from Table 7 below where BH and AVBH are bathymetric heights and average bathymetric heights respectively.

High velocity and discharge were recorded at midstream station of the study area during the wet season. The statistical t-test analysis showed that there was a significant difference in values of the depth of the upstream alongside the width of the Mini Piti stream for the wet season ($W = 0.61$, $SD = 0.18$) compared to the dry season ($D = 0.37$, $SD = 0.08$), $T(8) = 2.1$, $p = 0.036$. Similarly, for the midstream, that there was a significant difference in values of the depth of the midstream alongside the width of the Mini Piti stream for the wet season ($W = 0.88$, $SD = 0.03$) compared to the dry season ($D = 0.71$, $SD = 0.08$), $T(8) = 2.36$, $p = 0.023$.

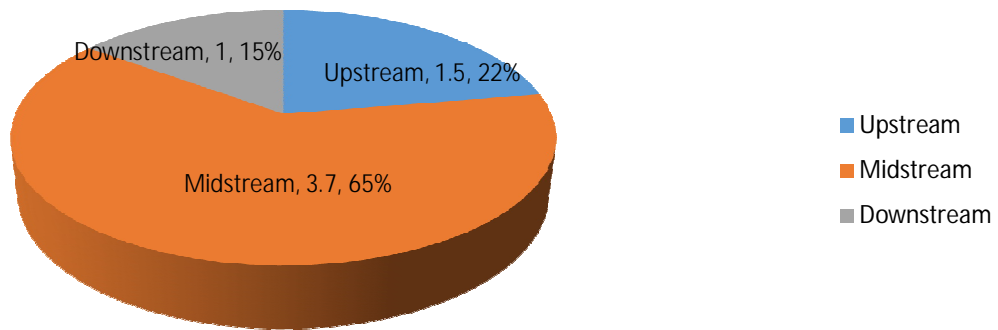
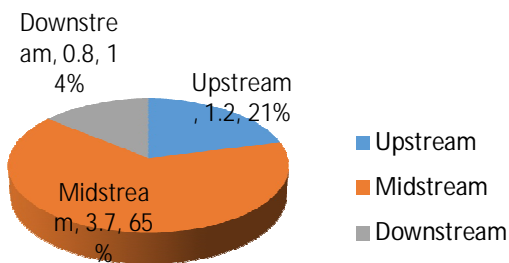
Fig.11: Average Bank Height

Average Bank Height (Dry Season)

Average Bank Height (Wet Season)

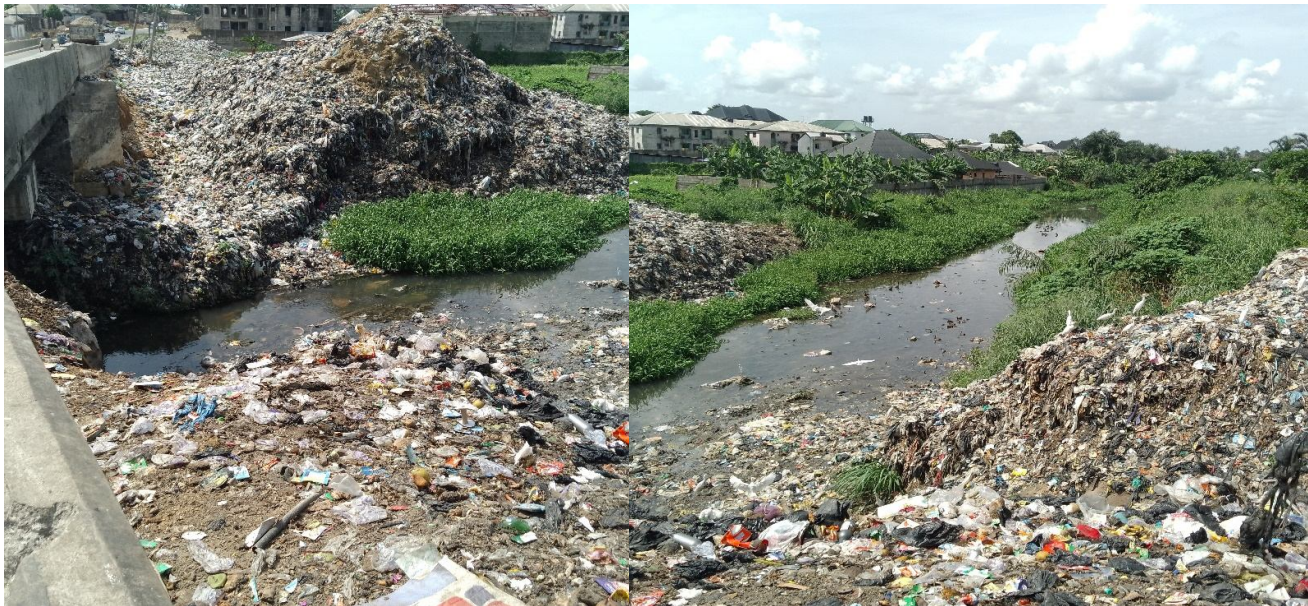
Figure 12: Cross section of the Mini Piti Stream by Egbelu Bridge, Port Harcourt

The impact of river bank erosion on water quality has been examined in the study area by comparing the variation in water quality of the upstream, midstream and downstream and also using seasonal variation in the physical parameters of 15 sample locations during the wet season and 15 samples location during the dry season. The concentrations of physical parameters (temperature, turbidity, transparency and total suspended solids) of midstream (Figure 12) and downstream of the study area were generally well above World Health Organization (WHO, 2017) standards for drinking water during wet season indicating that eroded materials could have contaminated the midstream and downstream of the study area especially by the habitual and indiscriminate waste dumps even at the foundations of the bridge. According to unconfirmed sources from the locals and natives, about 40-50 years ago, the Mini Piti stream was their major source of drinking and domestic water and the best stream for swimming and recreation which has been absolutely lost to urbanization and poor waste management practices.

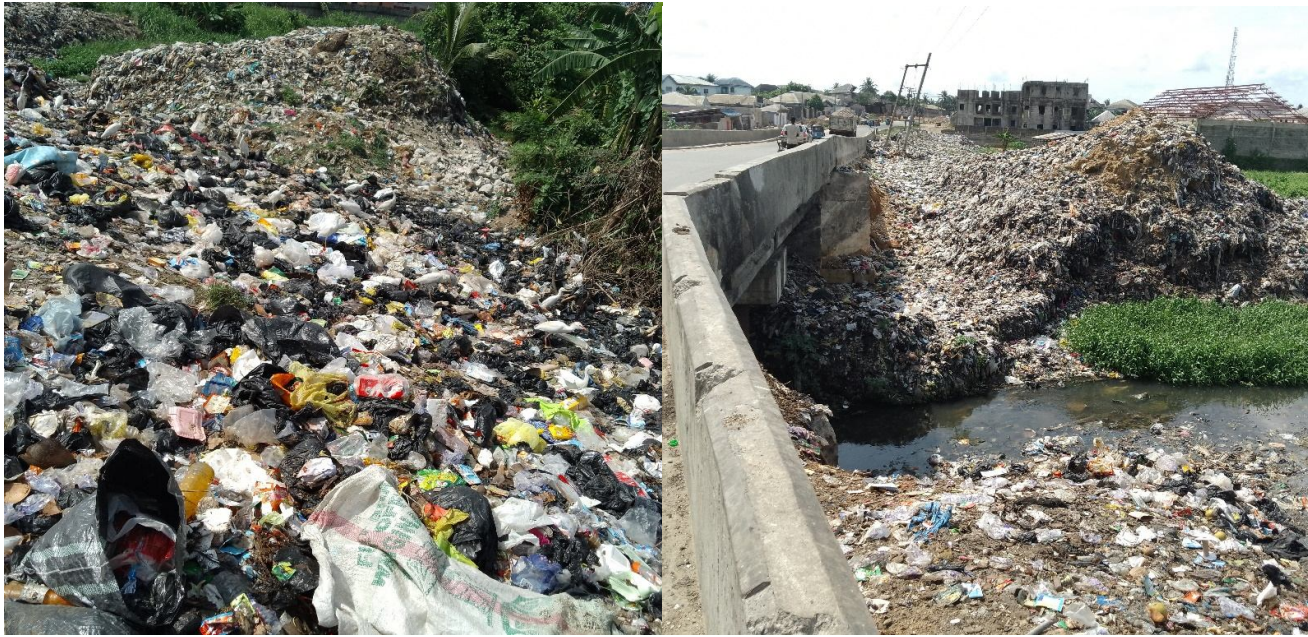
Figure 13: Waste Dumps into Channels of the Mini Piti Stream Bank

of more volume of water during the wet season and so more waste was dumped into the stream with the thinking of pushing it into the bigger river known as the Bonny River to which the Mini Piti stream empties and finally into the Atlantic Ocean. This has caused a lot of flooding issues as most of these wastes end up blocking the entire channel leading to flooding and its associated public health concern due to pollution. Many persons have literally parked out of their houses during this period even though flooding is expected as this area is below sea level. This was similar to water level variation from less than 1.5 m in the estuaries to about 8 m at the apex of the delta, with Nun River having a slightly higher elevation compared to Forcados River. This implies that canals connecting both rivers at the same reach would experience water movements from Nun to Forcados River (Abam&Fubara, 2022). The flow rate of the stream was high during the wet season which increased the stream water column as this also has significant impact on the stream bank. This also had an impact on the shear stress exerted by the water volume as velocity increase exceeded the strength of the bank material causing erosion (Hagerty *et al.*, 1981). The height of the bank and slope are the critical factors responsible for erosion of the bank along the midstream station of the stream with average height of 4.5m and upstream of 0.9m. The absence of much vegetation (except shrubby types due to urbanization) by the river bank has immensely contributed to Mini Piti riverbank erosion as was confirmed by Arora and Kumar (2024) as morphological analysis showed complete riverbank erosion in both cases of the un-vegetated riverbank (without or with an upstream pit).

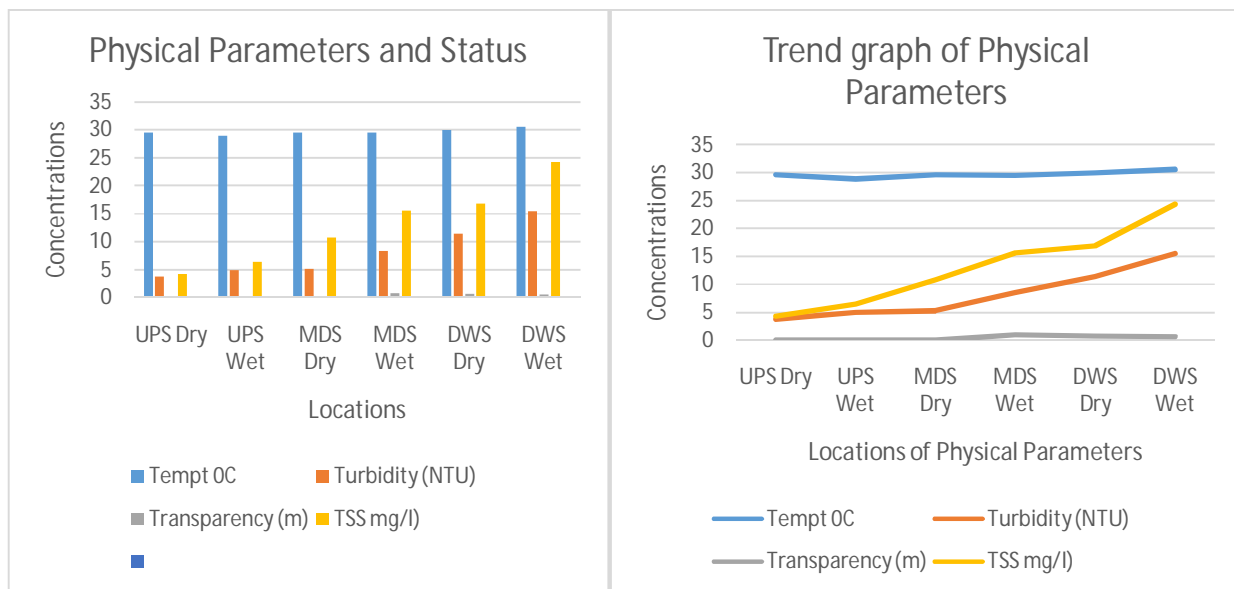
Figure 14: Trend of the Physical Parameters for the Mini Piti Stream

The concentrations of the TSS in the midstream and especially the downstream were all higher than the WHO permissible limits but lower than the FEPA standards. This is the local permissible limit hence is threatening especially that recorded downstream during the wet season. This is similar to results of TSS during dredging around the Isiodu river axis of the New Calabar River (Iyama&Edori, 2014a and 2014b). This was at variance with the works of Yeole (2021) earlier which could be attributed to the influence of water turbulence during rains and the flow regime towards the downstream direction. The trend pattern of the physical parameters of the Mini Piti stream is shown in Figure 14.

Table 8 gives the results of the physical parameters for both seasons in the study stream. The result showed that temperature (°C) recorded for dry and wet seasons respectively for the upstream 29.66 ± 0.152 and 28.92 ± 0.335 ; midstream as 29.66 ± 0.114 and 29.58 ± 0.083 and downstream as 30 ± 13.416 and 30.62 ± 0.383 . Similarly, the turbidity (NTU) for upstream in dry and wet seasons were 3.718 ± 0.065 and 4.916 ± 0.211 ; midstream were 5.196 ± 0.393 and 8.432 ± 0.452 ; downstream were 11.386 ± 0.732 and 15.454 ± 0.510 respectively. The transparency of the stream was not visibly captured in the upstream (both dry and wet seasons) and also during the dry season midstream but 0.89 ± 0.042 by the wet season midstream. The both seasons (dry and wet) downstream recorded 0.72 ± 0.057 and 0.584 ± 0.060 . The total suspended solids (TSS) in the upstream for both dry and wet were 4.31 ± 0.317 and 6.48 ± 0.350 ; midstream were 10.79 ± 1.161 and 15.646 ± 1.049 ; downstream were 16.87 ± 7.810 and 24.318 ± 1.517 respectively.
