Immediate And Successful Management Of Avulsed Teeth –Case Reports

Case Report 1 -

Case report 2 -

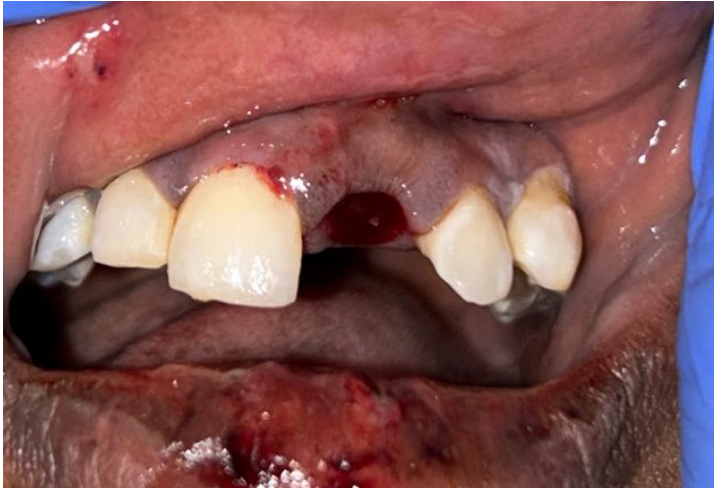
Intraoral Examination showed empty socket-21(fig-1), tender on percussion -11 and 22. Laceration of the gingiva and lips are noted. Pulp vitality was negative for 11,21. Grade 1 mobility noted -22

Fig 1- Preoperative picture of empty bleeding socket -21

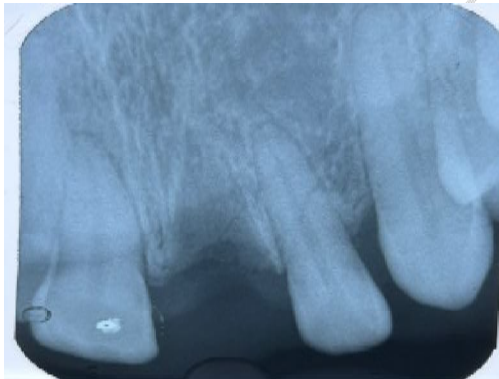
On Radiographic examination- empty socket without any root fragment was noted-21, Middle third root fracture -22(fig-2)

Fig 2 – preoperative radiograph showing empty socket without any root fragment-21, horizontal root fracture in middle third of -22

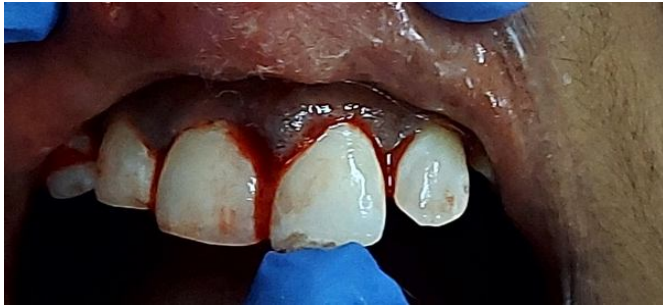
Fig 4 – Repositioning of the Avulsed tooth into the socket

Procedure- Avulsed tooth(fig-3) was irrigated with saline to remove the dust and debris, by holding only the coronal portion of the tooth , the socket was irrigated with the saline , extraoral root canal treatment of 21 was done. After the completion of root canal treatment-21 the tooth was gently inserted back to the socket and radiograph was taken-21. After the radiographic confirmation of the position of the tooth and occlusion was checked to avoid any traumatic contact with the opposing teeth.(fig-4,5) Then the splinting was carried out from 13 to 23, Using splinting wire and the composite.(fig-6,7) Instructions were given to the patient and recalled next day for the treatment of 22.

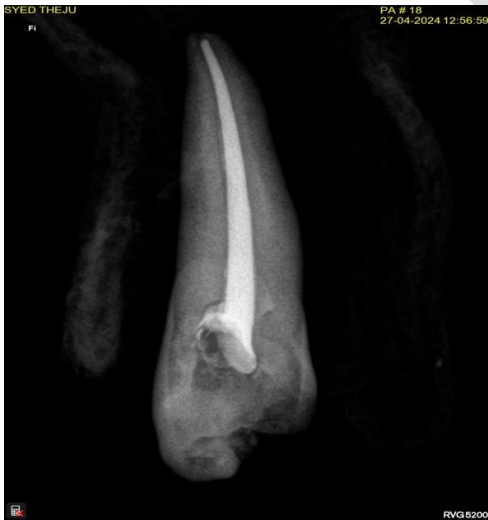
Fig 14- Extraoral RCT-22

Procedure- Avulsed tooth(fig-13.c) was irrigated with saline to remove the dust and debris, by holding only the coronal portion of the tooth , the socket was irrigated with the saline , extraoral root canal treatment of 22 was done(fig-14). After the completion of root canal treatment-22 the tooth was gently inserted back to the socket(fig-15) and radiograph was taken-22(fig-16). After the radiographic confirmation of the position of the tooth and occlusion was checked to avoid any traumatic contact with the opposing teeth. Then the splinting was carried out from 12 to 23(fig-17), Using splinting wire and the composite. Instructions were given to the patient and recalled after 1 month for followup.

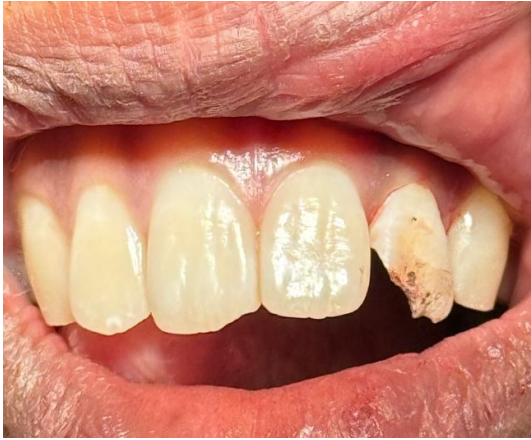
Fig-15 Reimplantation of 22 into the socket

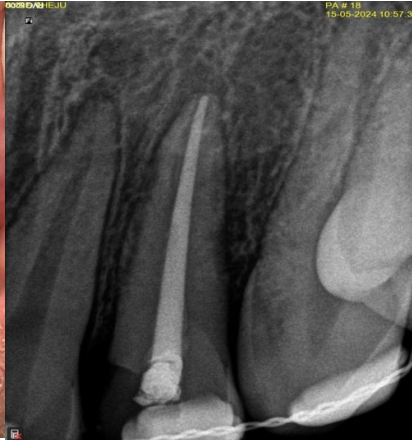
Fig-16 Radiographic confirmation of 22 position in the socket

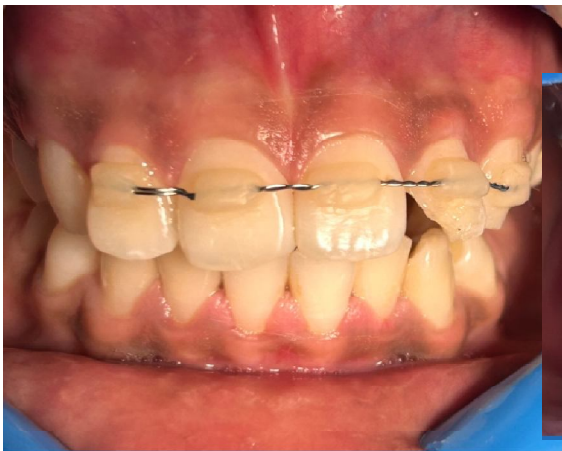
Fig -17 Splinting from 12 to 23

Treatment plan- Reimplantation of the avulsed tooth-22 followed by splinting from 12 to 23.

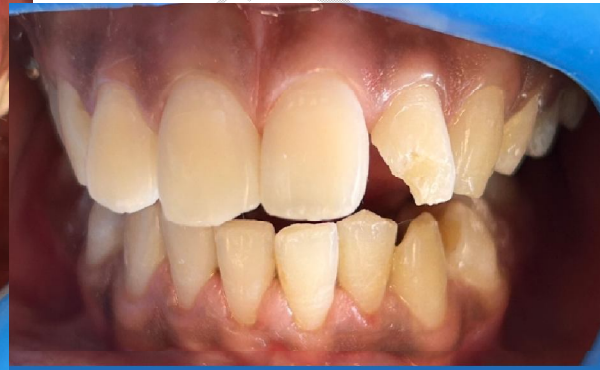
2nd appointment - 1 month followup radiograph showed non periapical changes -22. And patient was symptom free. Patient asked to report back after 2 weeks for splint removal. (fig-18)

Fig - 18 Splint removal done after 6 weeks

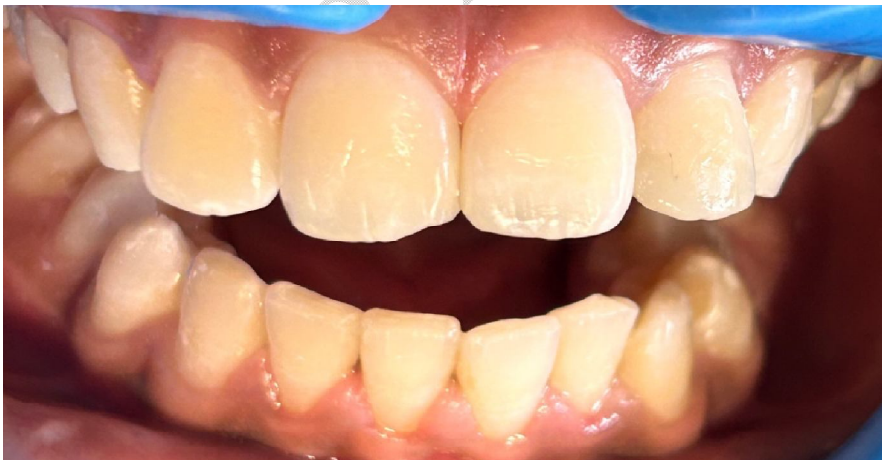
3rd appointment – Followup radiograph was taken which showed no signs of resorption or radiolucency-22, splint removal done and Composite restoration done – 22(fig-19).

Fig-19 Composite restoration done -22
