Case report

Immediate And Successful Management Of Avulsed Teeth: A Case Reports

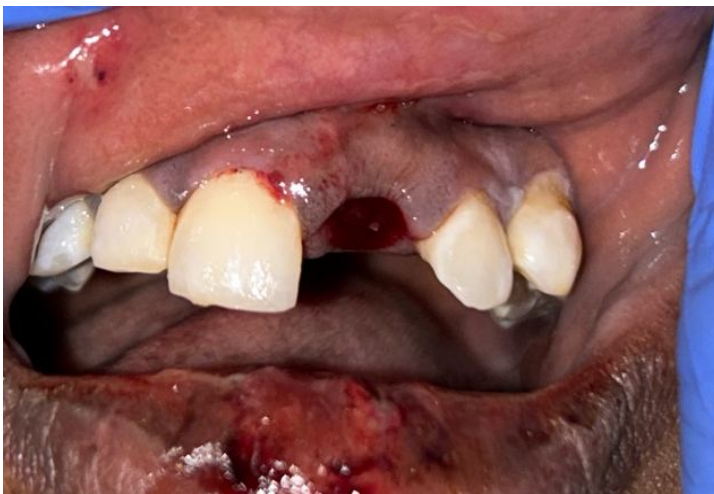
Fig 1- Preoperative picture of empty bleeding socket -21

Clinical examination - showed empty socket-21(fig-1), tender on percussion -11 and 22. Laceration of the gingiva and lips are noted. Pulp vitality was negative for 11,21. Grade 1 mobility noted -22

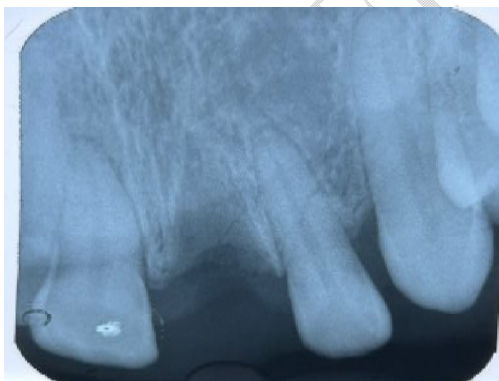
Fig 2 – preoperative radiograph showing empty socket without any root fragment-21, horizontal root fracture in middle third of -22

Radiographic findings- empty socket without any root fragment was noted-21, Middle third root fracture -22(fig-2)

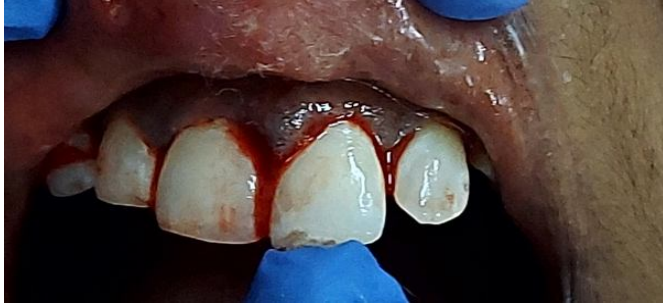
Fig 4 – Repositioning of the Avulsed tooth into the socket

Procedure- Avulsed tooth(fig-3) was irrigated with saline to remove the dust and debris, by holding only the coronal portion of the tooth , the socket was irrigated with the saline , extraoral root canal treatment of 21 was done. After the completion of root canal treatment-21 the tooth was gently inserted back to the socket and radiograph was taken-21. After the radiographic confirmation of the position of the tooth and occlusion was checked to avoid any traumatic contact with the opposing teeth.(fig-4,5) Then the splinting was carried out from 13 to 23, Using splinting wire and the composite.(fig-6,7) Instructions were given to the patient and recalled next day for the treatment of 22.

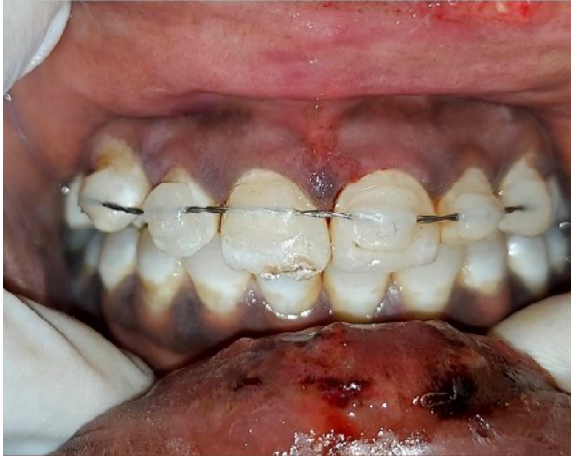
Fig-7 Intraoral picture of splinting from canine to canine

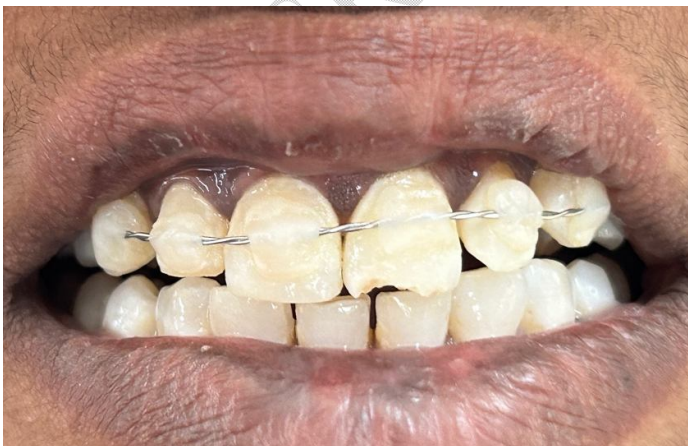
Fig – 9- One month post operative intraoral picture showing healing of lacerations

Follow-up -1 month followup radiograph showed non periapical changes -21,22. Laceration on the gingiva and lips were healed.(fig-9,10) And patient was symptom free. Patient asked to report back after 2 weeks for splint removal.

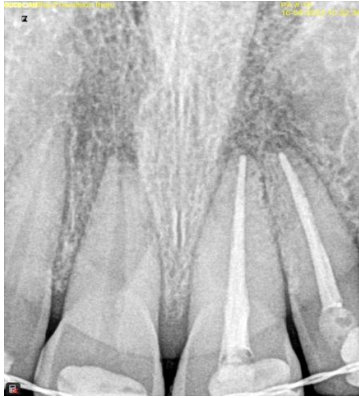
Fig-10 - One month followup radiograph

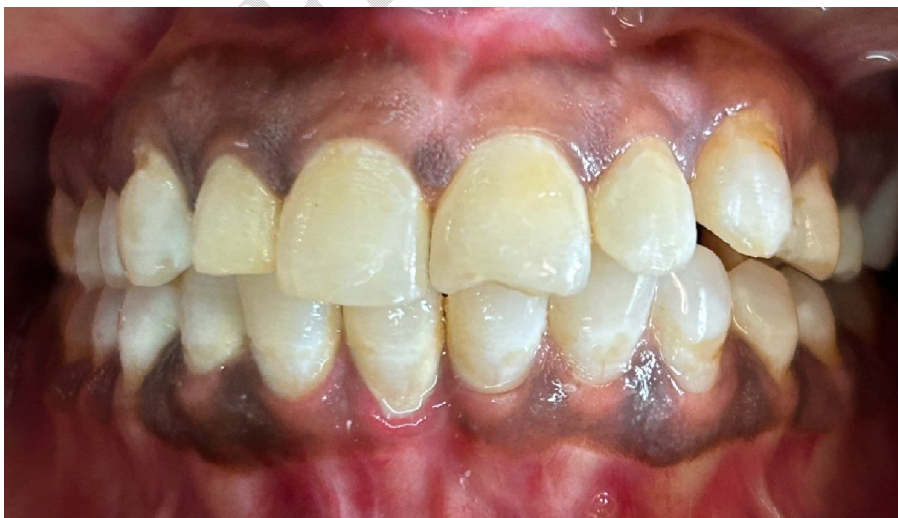
Fig-12 Intraoral picture after splint removal.

6 month followup showed no mobility and on radiographic examination no sign of resorption, no periapical changes noted. (Fig-11,12)

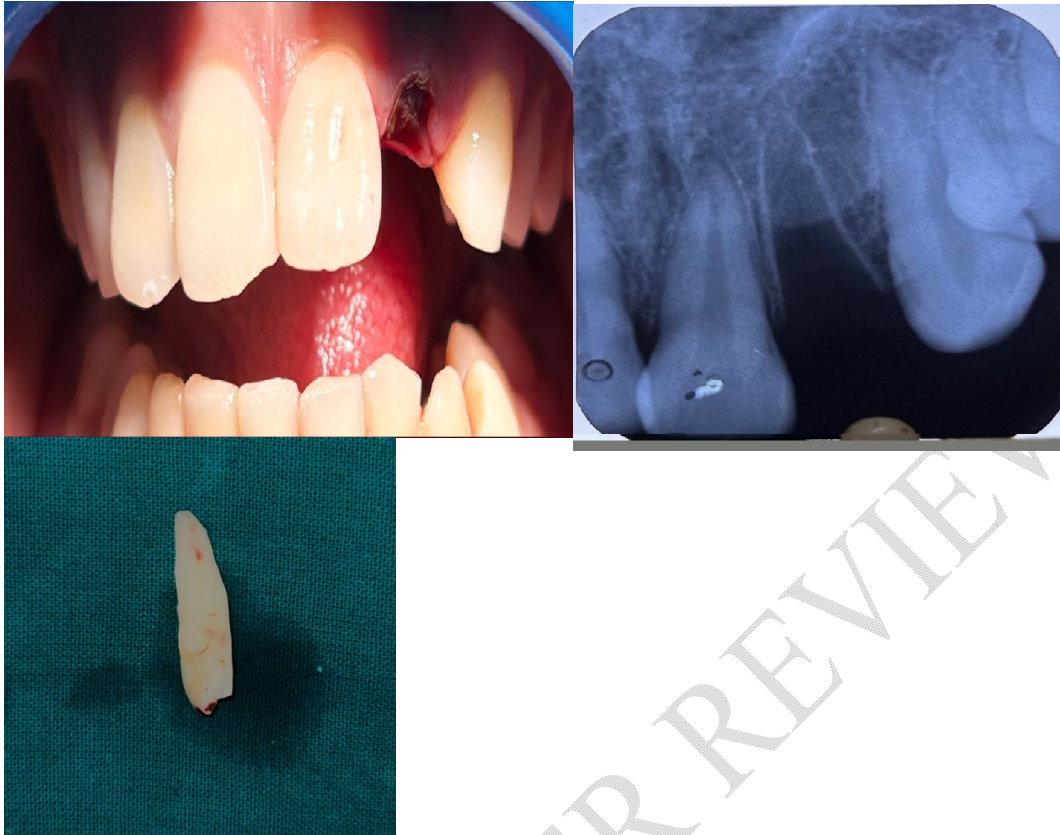
Clinical Examination showed empty socket with blood clot -22 . (fig-13.a)

Radiographic findings- empty socket without any root fragment was noted-22.(fig-13.b)

Fig 13.a preoperative picture showing empty space near 22 region 13.b shows empty socket without any fractured root fragment, 13.c Avulsed tooth

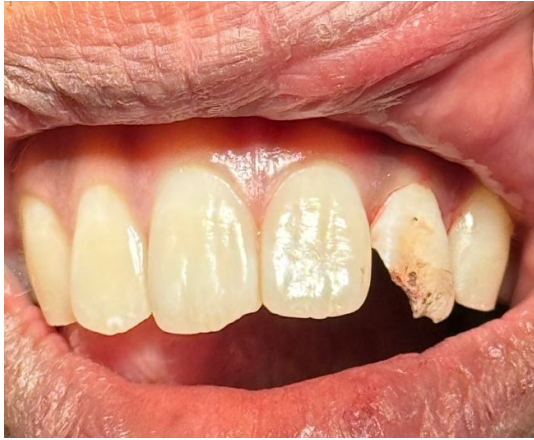
Fig-15 Reimplantation of 22 into the socket

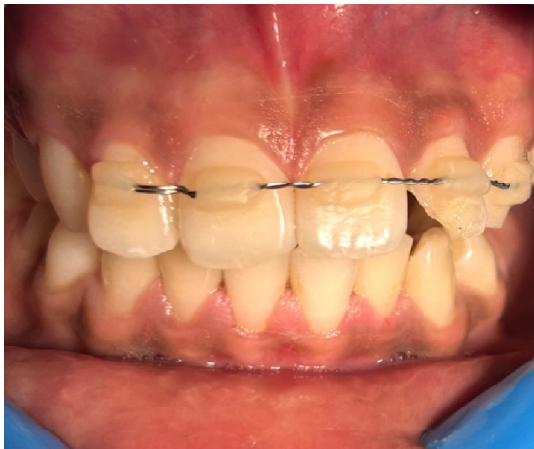
Fig -17 Splinting from 12 to 23

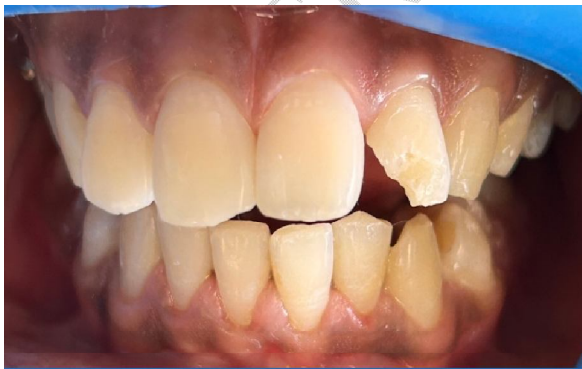
Fig - 19 Splint removal done after 6 weeks

Follow-up- 1 month followup radiograph showed non periapical changes -22(fig-18). And patient was symptom free. Patient asked to report back after 2 weeks for splint removal. (fig-19) Next appointment – 3 months Followup radiograph(fig-20) was taken which showed no signs of resorption or radiolucency-22, Composite restoration done – 22(fig-21).

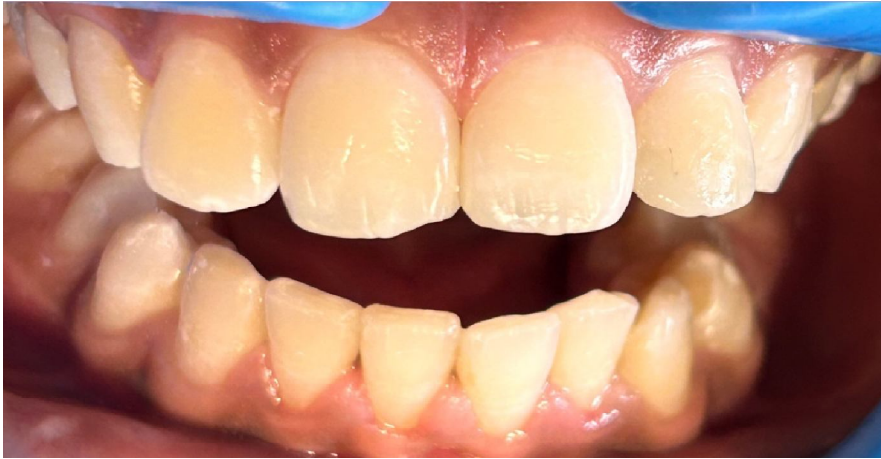
Fig-21 Composite restoration done -22
