# Effects of Time and Land Use Land Cover Change (LULCC) in the Dimension of the Gully Expansion and Soil Particles Loss at Ibeziako Erosion Site in Nsukka Urban, Enugu State, Nigeria

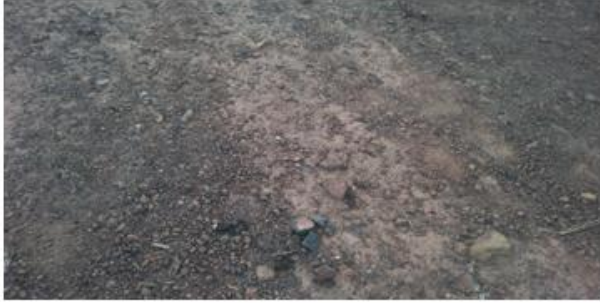
Plate A: Sheet and Splash erosion at the base of northeastern slope of Aso Hill in 2016

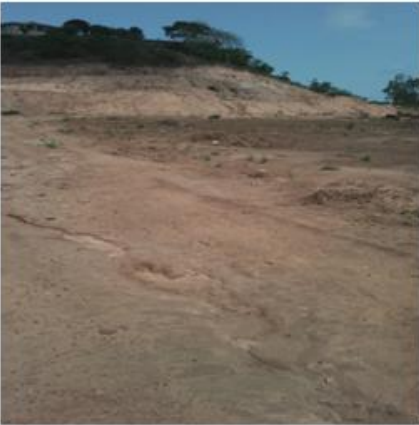
Plate B: Rill erosion at the base of northeastern slope of Aso Hill in 2016

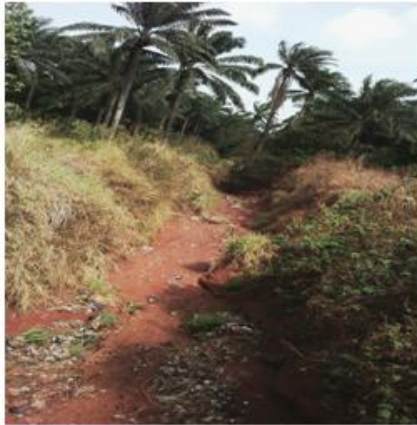
Plate C: Gully erosion section at Onuiyi in 2016

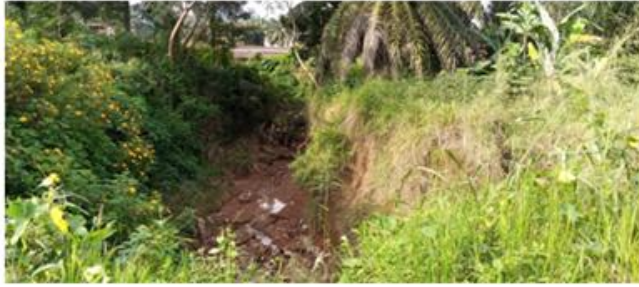
Plate D: The same gully erosion section at Onuiyi in 2020

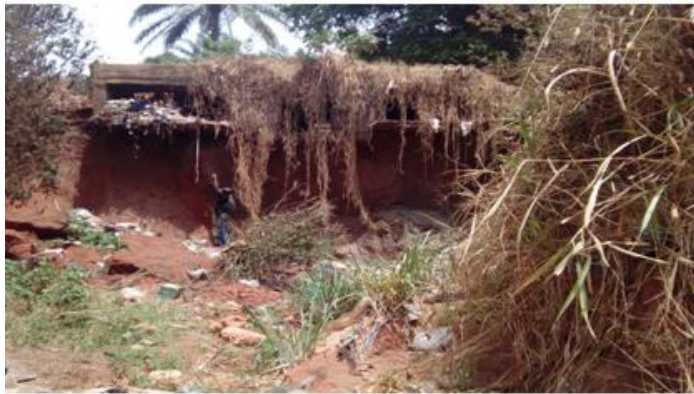
Plate E: Gully erosion at Onuiyi Road Culvert in 2016 (Note the author, whose height is almost half way the gully depth at 1.9 m)

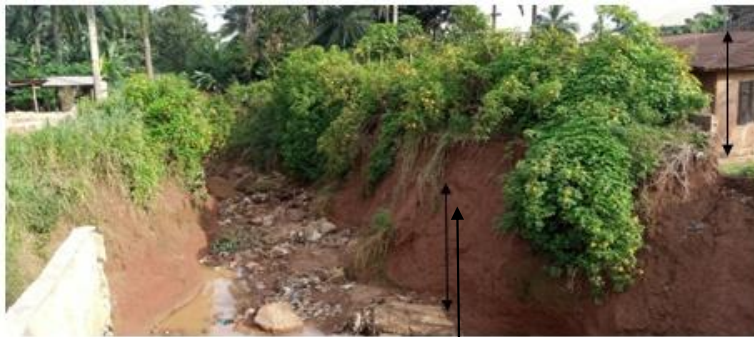
Plate F: The same gully erosion at Onuiyi Road Culvert in 2020 (Note the house around the gully site, with the height of the house about half of the gully depth at 3.84 m)

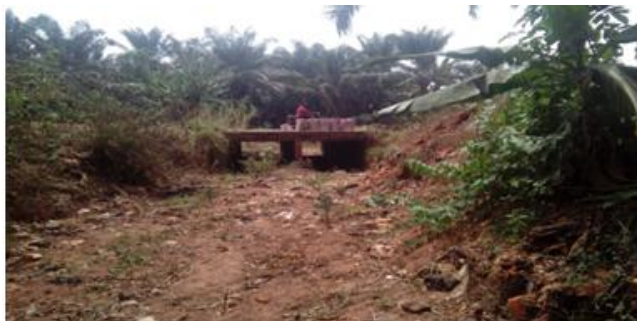
Plate G: Ibeagwa Road Culvert at the AlorUnoend of the gully depositional plane in 2016  
Source: Authors Fieldwork, (2016 and 2020)

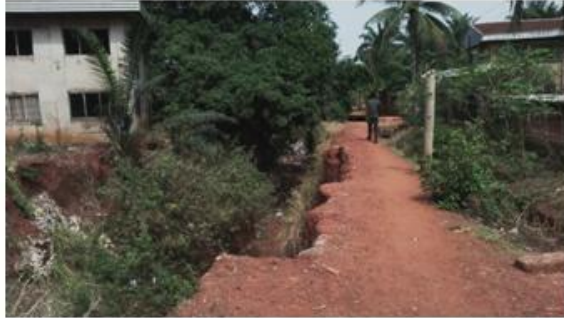
Plate H: Gully cut at Ibeziako Street with the street reduced to a footpath and house endangered by the gully in 2016

**3.3.3 Destroys social infrastructure:** Erosion affect human life negatively, destroy properties, cut off roads, brought down electricity poles, collapsed pipe lines, culverts and bridges, etc (Plates H - L)

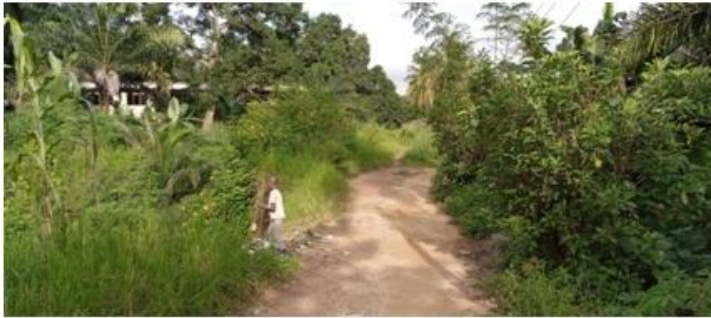
Plate I: The same gully cut at Ibeziako Street with the reduced street totally cut off and the endangered houses abandoned in 2020

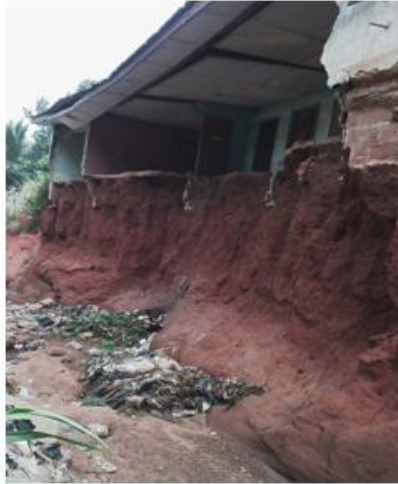
Plate J: Property partially destroyed by the gully in 2016

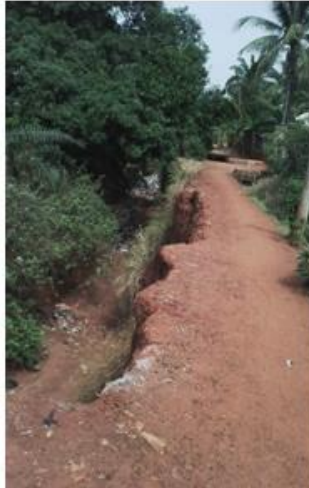
Plate K: A full size street reduced to foot path

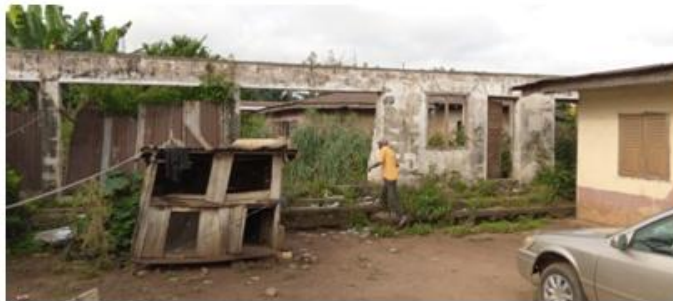
Plate L: The same property completely destroyed by the gully in 2020
