Effect of an Active Open Dumpsite on the Earth's Subsurface and Groundwater Resource

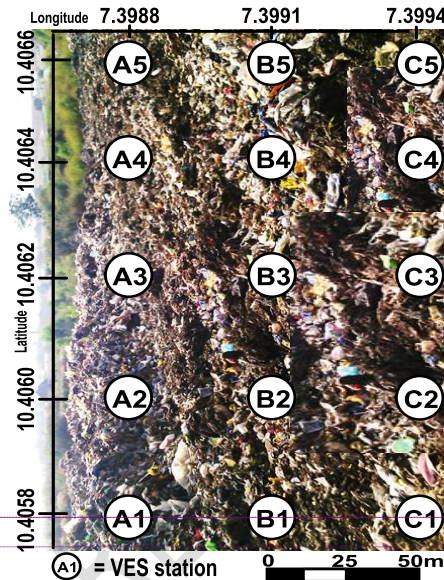
Fig. 1: Image of the Case Study Active Open Dumpsite Showing all the VES Points

Fig 1 shows a typical uncontrolled and active open dumpsite located at Goni-Gora, Kaduna, in the basement complex basement of Nigeria. The dumpsite lies on the geographical coordinates of Latitudes and longitudes 10° 24.393'N to 10° 24.351'N, and 007° 23.955'E to 007° 23.926'E respectively with a total landmass of 24,500 square metres. The open dumpsite consists of heterogeneous waste materials that has been in operation for more than two decades. The landfill is an undersigned unstandardized sanitary landfill that is predominant in most parts of the country. The dumpsite is estimated to have contained about 56,250 m³ of municipal solid wastes. The open dumpsite contains various all

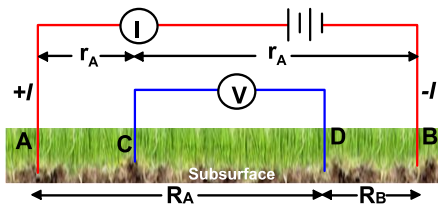
Fig. 2: Schlumberger Configuration

An Electrical Resistivity Meter was used to acquire a total of fifteen (15) vertical electrical soundings (VES) data set using a Schlumberger array to determine the subsurface resistivity and map conductivity, as well as the vertical extent of leachate plumes contamination of a dumpsite. Another four (4) VES sample stations were occupied taken, which are about 200 m away from the open dumpsite to serve as a control station for this research. Fig. 2 shows the Schlumberger arrangement of the four

Where R is resistivity, and K is a geometrical factor that depends on the arrangement of the four electrodes as shown in Fig. 2 and can be expressed as:

$$K = \frac{2\pi}{\left[\left(\frac{1}{r_A} - \frac{1}{r_B}\right) - \left(\frac{1}{R_A} - \frac{1}{R_B}\right)\right]} \quad (iii)$$

Comment [O21]: What you display here is not a Schlumberger array that requires AB to be greater than or equal to 5CD. No sir!

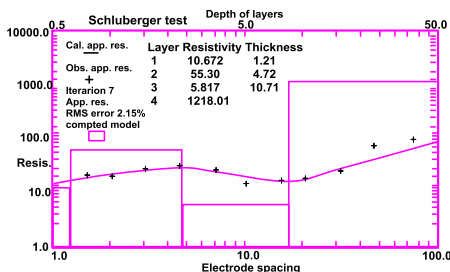
Fig. 3: Typical resistivity curves of VES A2

The first stage in the any interpretation of apparent resistivity sounding curves is to note the curve type shape before applying a more complicated method of interpretation [22, 30]. The Micro-soft excel to initiate the rough idea of the expected curve after the data collected was reduced and computed. Consequently, The subsurface geo-electrical data collected were interpreted utilizing the computer software called Res ID version 1.00.07 Beta. Fig 3 shows one of the resultant curve for the VES station B3 along with profile B (Fig. 3). However, the measurement of resistivity is based on the difference in the subsurface resistivity values of the model blocks between the measured and calculated apparent resistivity values from the field. Consequently, the accuracy of fit is expressed in terms of the root mean square (RMS) error [12, 13, 22, 23, 26].

Comment [O23]: What you have displayed in Fig. 3 is VES A2 (not B3) along Profile A (not B). It really would have been nice if the author(s) present(s) VES curves B1-15 taken within the dumpsite. The data quality will be awful because of the heterogeneous nature of the dumpsite fill. Don't know what magic the author(s) has (have) performed here!

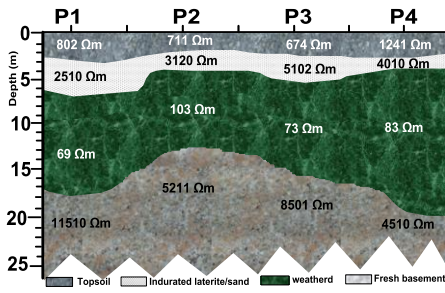
Fig 4: Goelectric/geologic section along control Profile P profile of the sample station (about 200 m away from the dumpsite)

Fig 4 shows the Goelectric/geologic profile of the controlled (sample) station which is about 200 m away from the open dumpsite. This was established to compare the results of the dumpsite with to the controlled (sample) station as a means of evaluate the vertical extent and the degree of the dumpsite impact on the ground conductivity and the groundwater resources of the study area. From the four (4) investigated VES stations, the results show that the topsoil is highly resistive with an average resistivity and the thickness values of 857 Ωm and 1.8 m respectively. The next preceding highly resistive indurated laterite/sand layer was found with an average resistivity value of 3686 Ωm. The third layer which also represents the water-bearing unit has an average resistivity and thickness value of 82 Ωm and 12 m respectively. However, [8, 29], noted that the regions with overburden thickness (> 12m) may likely be considered as an area with high groundwater potential, and is highly protective from the near-surface contamination. This implies that a deeper aquifer, with a highly compacted, resistive, indurate laterite and impermeable clay topsoil could be significantly protected. provide an additional protective cover for any region's groundwater. The bedrock is highly resistive and impermeable. , which indicates that there is no or little action of leachate plumes contamination on the basement rocks

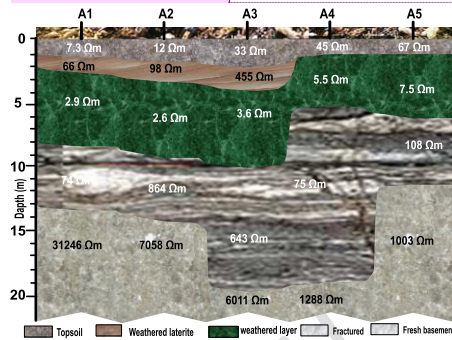
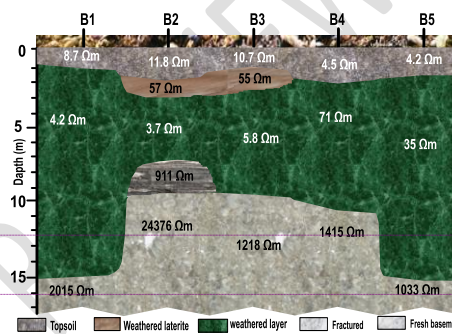
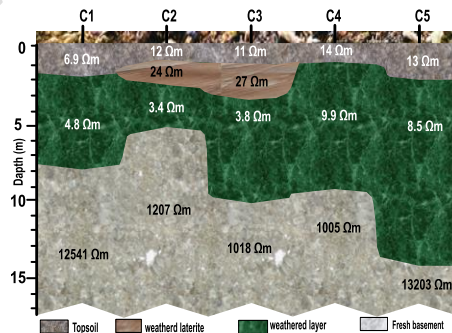
Figures 5-7 show all the profiles taken across in the dumpsite. The results show that the dumpsite is highly conductive to the current flowing into the ground. This suggests that the leachate plumes contamination at the dumpsite has infiltrated the subsurface according to its resistivity layered values. The first layer has an average resistivity and thickness values of 17 Ωm and 1.9 m respectively (Table 1), while the preceding second layers of resistive laterite as observed in the controlled station has been weathered (Table 1). The aquifer unit as observed in the controlled station has an average resistivity of 82 Ωm and thickness of 13 m. However, the aquifer unit of the dumpsite has a very low resistivity value with an average of 17 Ωm and a thickness of 15 m approximately. These resistivity values suggest one thing, that is, the leachate plumes contaminations have highly penetrated the soil down to the water-bearing unit. The second layer which is believed to have been made up of compacted laterite and impermeable clay, also indicates that the leachate plumes contamination have deeply penetrated the soil. A fractured basement was encountered with an average resistivity value of 353 Ωm is also threatened. The bedrock of the dumpsite and the sample station were found with average resistivity values of 7433 Ωm and 7042 Ωm respectively. This suggests fresh basement rock has not been affected by the leachate plumes contamination.

[8, 13], are of the view that any terrains with the bedrock resistivity $\geq 2000\Omega m$, are undoubtedly considered unfractured. Based on the variation in the resistivity values of the dumpsite, the

leachate contamination has little or no effect on the fresh basement rock.
