AN ASSESSMENT OF CAUSATIVE FACTORS OF BUILDING COLLAPSES USING DESTRUCTIVE AND NON-DESTRUCTIVE PHYSICAL ANALYSIS TESTS: A CASE-STUDY OF OKO, ANAMBRA STATE, NIGERIA.

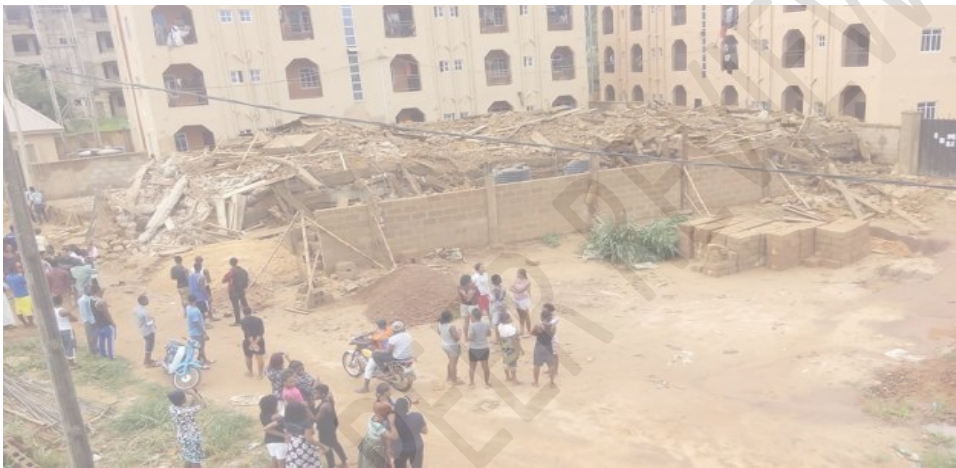
Plate 1: Picture of the 3-Storey- Collapsed Building at Oko, Anambra State Nigeria.

1. Foundations were on individual footings where the load of the building was carried by the columns. The footings were resting directly on the floor without adequate concrete screeding, they were not connected by any plinth or horizontal beams to allow for even settlement of the structure.
2. The load bearing walls were grossly inadequate in compressive strength.

3. The internal partitioning acted as load bearing walls. The building did not have decking beams causing the suspended slabs to rest directly on the weak sandcrete block walls as there were no beams/girders to help transmit the floor loads to the columns.
4. The reinforcement bars used on the columns were inadequately sized, and the columns were found to be inadequately reinforced to safely accommodate the transmittable loads of the structure. The sizes of the stirrups were also inadequate and were widely spaced on the reinforcement bars.
5. The concrete compressive strength values from the tested cored concrete were far below the required concrete compressive strength of 25N/mm² which means that the concrete used was of low grade and unfit for a structural frame of that number of floors.

This research therefore attributes the probable causes of building collapse to poor foundation structures, structural defects, poor concrete mix and inadequate reinforcement.
