Case report – Accidental Epidural Catheter breakage and its management

ABSTRACT:

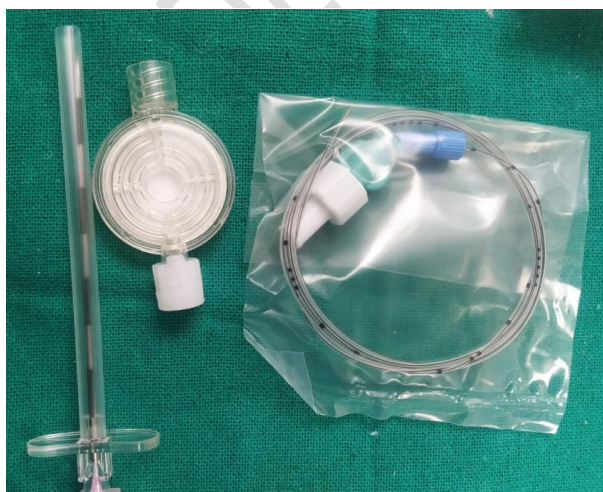
Figure: 1 - MEDITECH Epidural Minipack Set which was used

After confirming NBM status and written informed consent, the patient was taken for surgery. Under all aseptic precautions and local infiltration of skin with 2ml of 2% lignocaine , an 18 gauge, 80 mm Tuohy needle (MEDITECH Epidural Minipack System-Figure:1) was inserted to access the epidural space in L2-L3 intervertebral space with loss of resistance technique in the sitting position. The epidural space was encountered 5 cm from skin through a midline approach, and an 18-gauge close-ended multihole epidural catheter advanced up to 12 cm after which a resistance was felt. Hence, the both catheter and needle were simultaneously removed using minimal force but the catheter sheared off , it was found that the catheter was broken from almost 7 cm mark. Immediately, operating

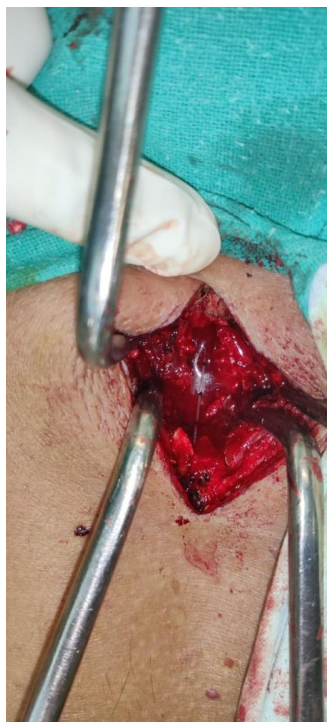
Figure 2:- The broken catheter found during surgical exploration

An exploratory laminectomy under general anesthesia in prone position was planned. A 5 cm incision was taken at L2-L3 space . The surgeons gently dissected through layer by layer and a catheter was found lying in paraspinal muscles. A total length of 7 cm of epidural catheter was retrieved(Figure-2).

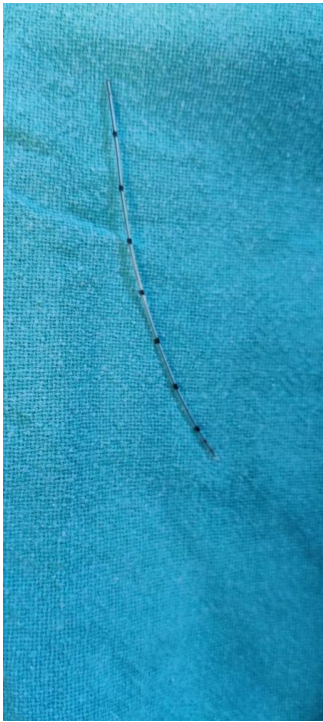
Figure 3 :- Broken epidural catheter retrieved after surgical exploration which is about 7.5cm

Since the part of the catheter which broke is large (almost 7 cm, Figure-3) and causes complications in future like infection and neurological complications, foreign body removal was planned by spine surgeons immediately after discussing with patient and patient's relative and the whole operating team.
