An Assessment of Causative Factors of Building Collapse using Physical Analysis Tests: The Case of Oko, Anambra State, Nigeria.

Therefore, this study deems it very important to unravel the causative factors of a collapsed 3-story on-going building which was reported in Oko town, Anambra State, Nigeria.

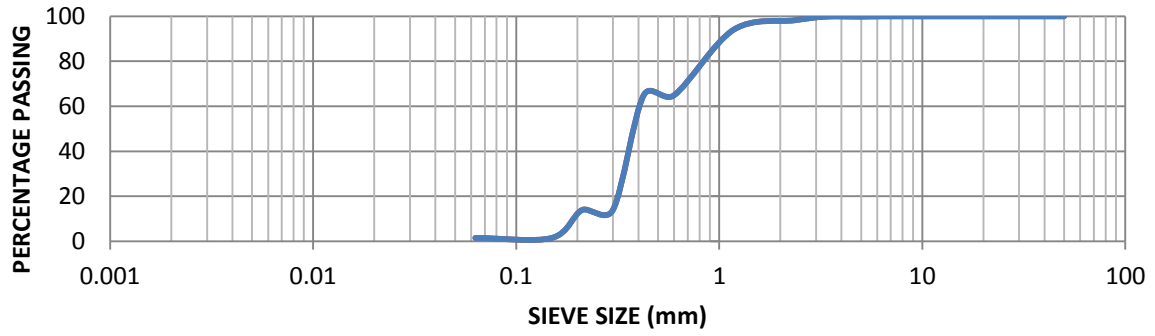
PARTICLE SIZE DISTRIBUTION CURVE

SAMPLE DESCRIPTION: MEDIUM TO FINE SAND

Soil Analysis (%)	
Coarse Gravel -	
Fine Gravel -	0.00
Coarse Sand -	1.75
Medium Sand -	33.36
Fine Sand -	63.41
Fines -	1.48

B. Geotechnical Tests: The sieve analysis of the fine aggregates (sand) shows that it falls within the grading zone 3 and is predominantly fine to medium grain size, which is poor for concreting. Fine aggregates (sand) that falls within the grading zone 2 are considered good for concreting. The value of the bulk density (1.46Mg/m^3) for sand did not fall within the required specification. Bulk density of value (1.7Mg/m^3 - 1.8Mg/m^3) for fine aggregates fall into the required specification. The Particle density test of the sand shows an unsatisfactory result with 2.59Mg/m^3 which does not fall within the required specification.

2. The sieve analysis of the fine aggregates (sand) shows that it falls within the grading zone 3 and is predominantly fine to medium grain size, which is poor for concreting. The value of the bulk density (1.46Mg/m^3) for sand did not fall within the required specification. The Particle density test of the sand shows an unsatisfactory result with 2.59Mg/m^3 which does not fall within the required specification.
