Analysis of Critical Risk Factors in Five Iconic Major Accidents in Petroleum and Chemical Industries

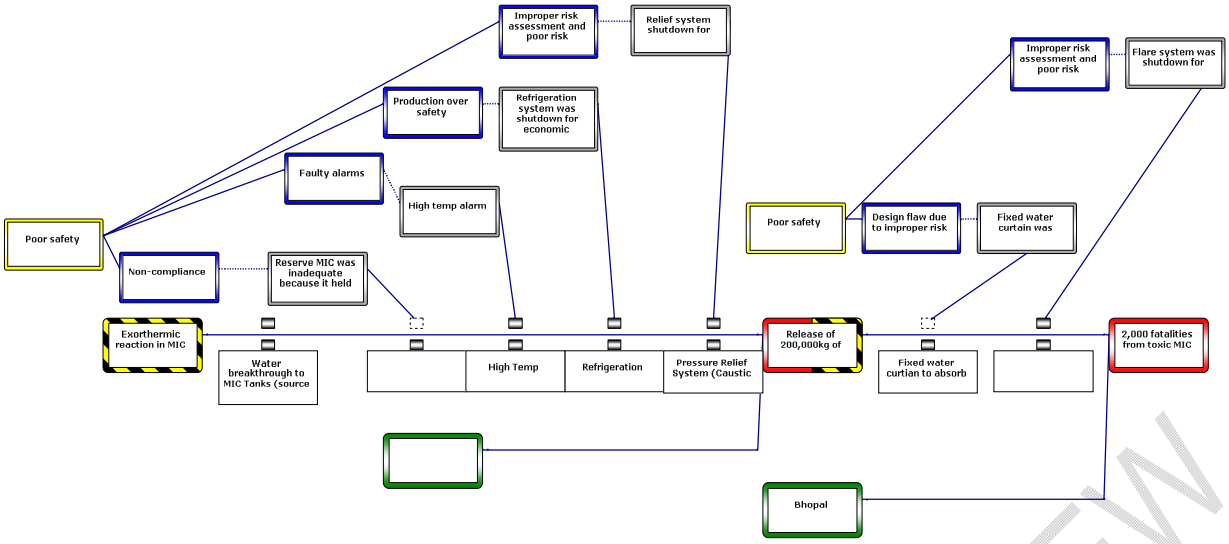
Figure 1: Tripod Beta Tree for Bhopal Incident

For example, on the Bhopal incident, Barrier 1 preventing water breakthrough into the MIC tanks failed (source of the water is unknown). MIC tank as Barrier 2 failed due to the fact that it could not quench the exothermic reaction because it was containing some inventories. The pre-condition for this Barrier 2 failure is non-compliance with procedures on inventory management in MIC tanks and this is traceable to poor site safety management. Barrier 3 failure was the failure of the high temperature shutdown system. The high temperature alarm was known to be faulty but it was ignored, again traceable to poor site safety management. Barrier 4 failure was the refrigerant system installed to handle the heat from the exothermic reaction. It was shutdown for economic reasons as the company justified production over safety considerations, again traceable to poor site safety management. Pressure relief system failure as Barrier 5 failed because it was shutdown for maintenance and no proper risk assessment was carried out to mitigate the risk of the shutdown of the pressure relief system. This is again traceable to poor site safety management. On the consequence mitigation side,

Barrier 6 is the fixed water curtains which were provided to absorb MIC vapour. However, it was insufficient to absorb the vapour due to inherent design flaws. Barrier 7 is the flare system provided to incinerate the MIC vapour but this barrier was shutdown for repairs and no proper risk assessment was carried out to mitigate the risk, again traceable to poor site safety management.

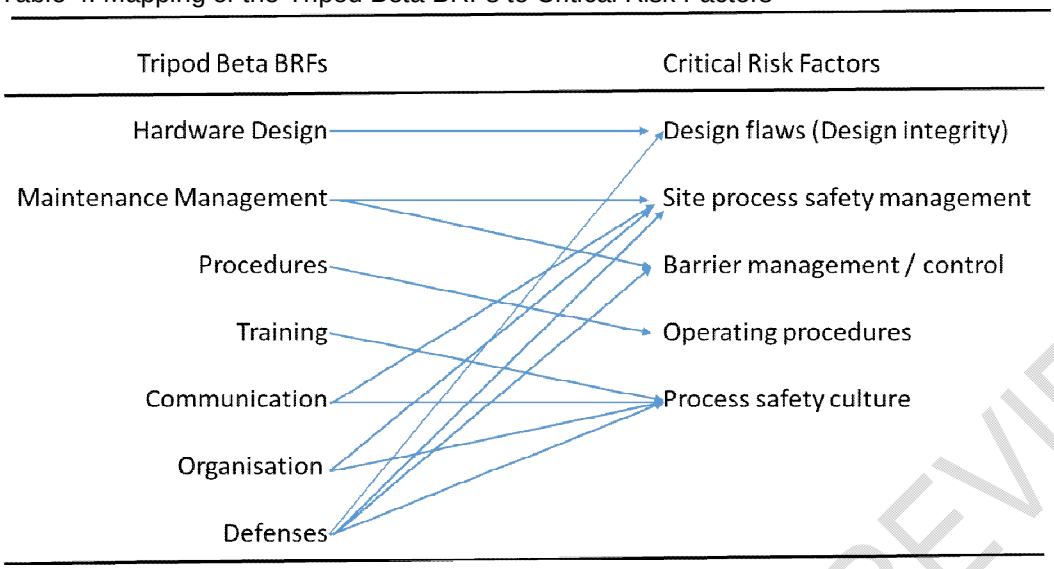
Table 4: Mapping of the Tripod Beta BRFs to Critical Risk Factors

a) Design flaws (design integrity)
b) Site process safety management (inadequate risk assessment including cumulative risk, poor permit to work management, management of changes, incompetence)

c) Barrier management/control (ineffective management of impaired and down-graded barriers, overrides /inhibits)
d) Plant operating procedures (no-compliance with procedures, obsolete procedures)
e) Process safety culture (Audits/reviews findings not implemented, poor risk appreciation)
