Case study

Diagnosing High Water Production in Kalama Field, Niger Delta

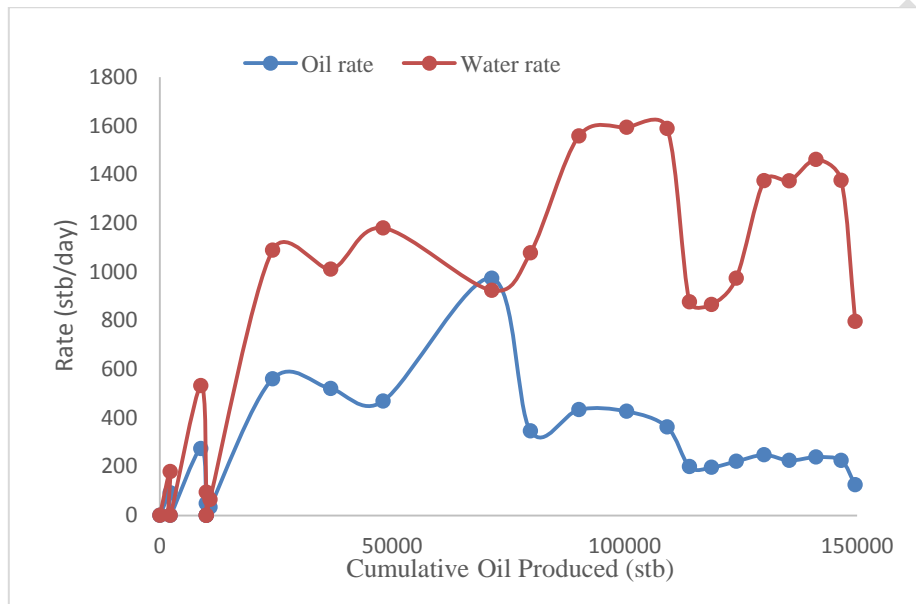
Oil and water rates from well 3S in Kalama field are shown in Figures 1 and 2. Figures 1 is a plot of cumulative production against oil and water rates while figure 2 is a performance plot of oil and water rates against time. From Figures 1 and 2, it is obvious that well 3s experienced high water-cut at different times during its productive periods which has led to a reduction in oil production.

Fig. 1. Oil and water Rates Production against Cumulative Oil Production. (Well 3S)

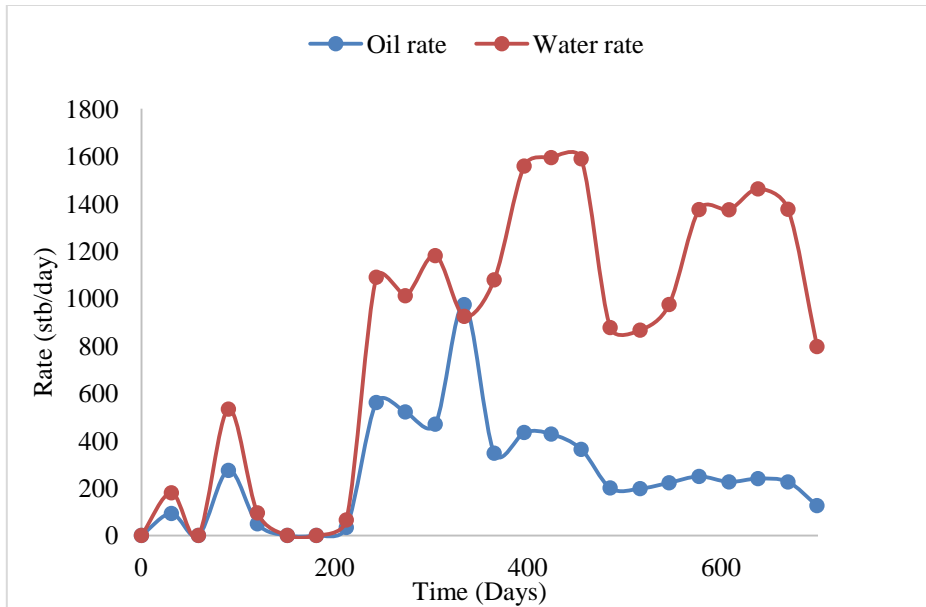
Fig. 1. Oil and water Rates Production against Time. (Well 3S)

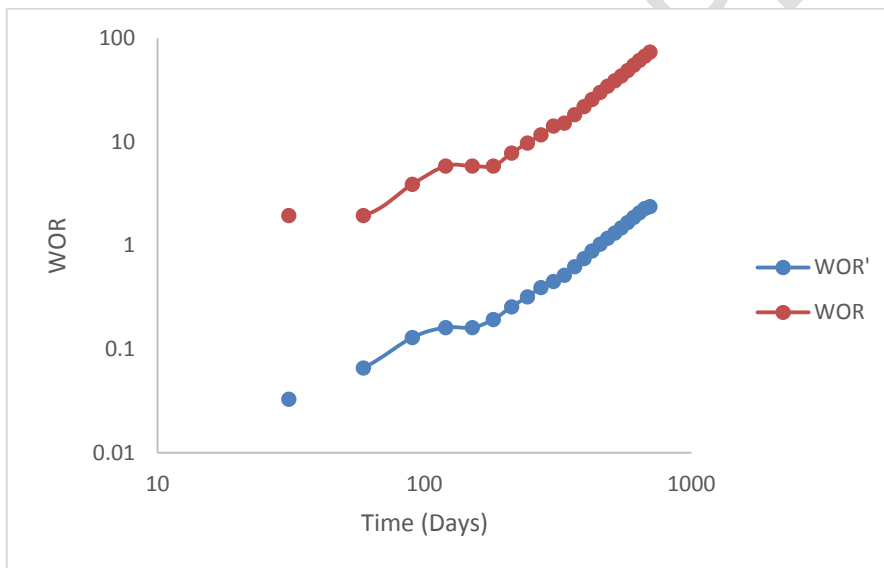
Figure 3 shows diagnostic plots of water-oil ratio (WOR) and WOR derivatives (WOR') against time. The upward sloping is an indication and confirmation that channeling behind casing is the cause of high water-cut in Well 3S. The major cause of channeling behind casing is compromised cementing/casing bond [14]. This can be remedied with a workover operation that could seal off the leak behind casing to provide more formation-casing integrity.

Fig. 3. Log-Log Plot of WOR and WOR Derivative against Time. (Well 3S)

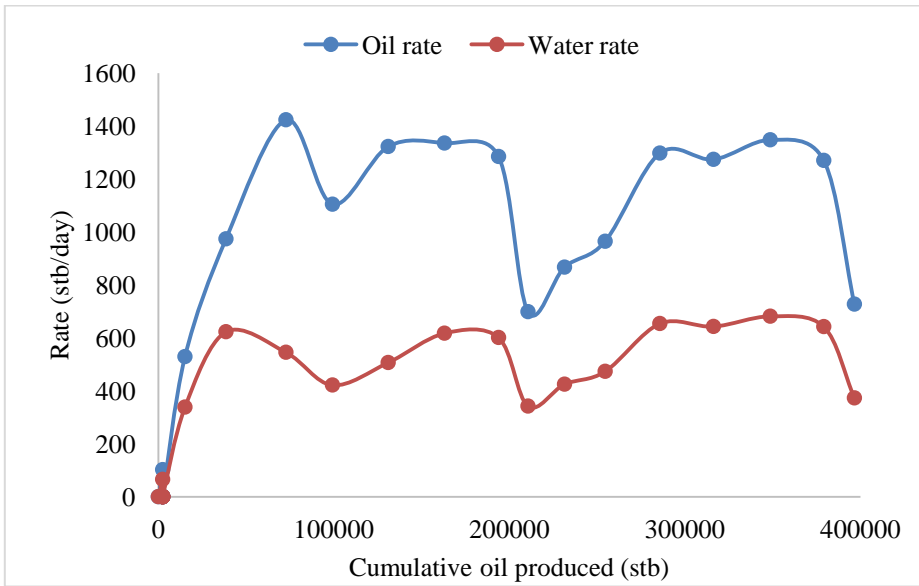
The performance plots for Well 3L in Kalama field are shown in Figures 4 and 5. Unlike Well 3S, water breakthrough in Well 3L is delayed and much less compared to well 3S. From Figure 5, it can be seen that it took more than 7 months before the emergence of water breakthrough. Moreover, well 3L was producing at a good condition with more oil production than water production. This water production represents 34% of gross production. From the company standard, any well that has gross production of more than 30% water production is considered a high water producer. So, there is great

Fig. 4. Oil and water Rates Production against Cumulative Oil Production. (Well 3L)

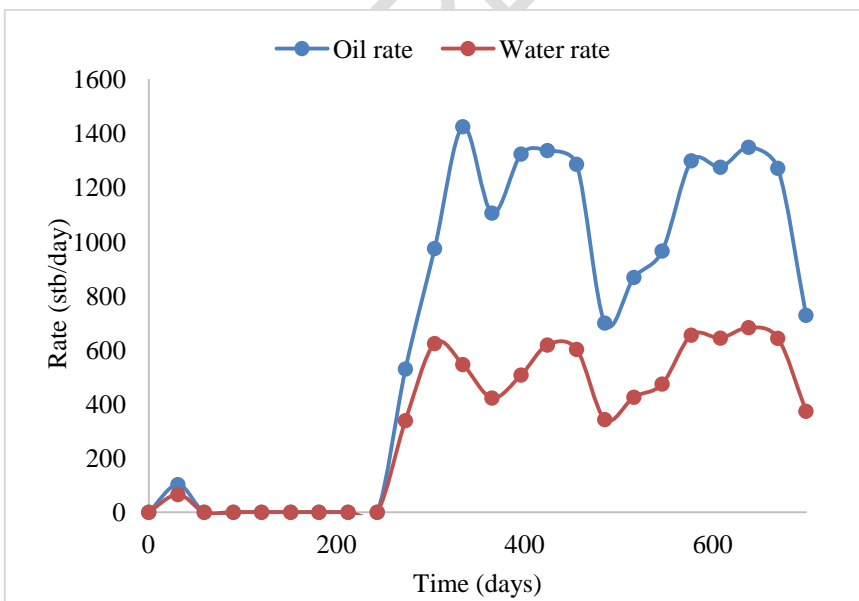
**Fig. 5.** Oil and water Rates Production against Time. (Well 3L)

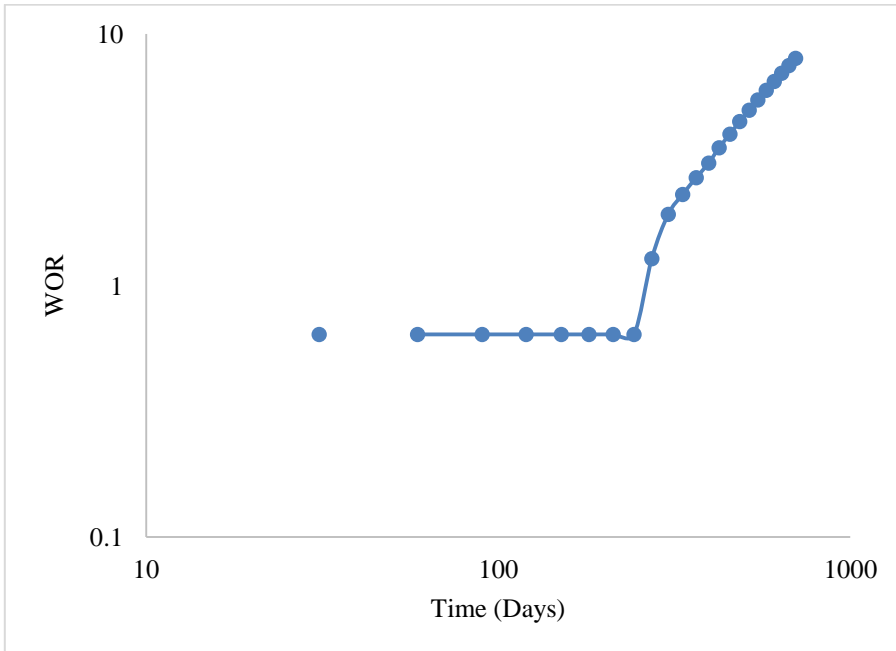
The diagnostics plots of WOR and WOR' against time are shown in Figures 6 and 7. Obviously, the cause of the increasing water production is multilayer channeling.

Fig. 6. Log-Log Plot of WOR against Time Showing Multilayer Channeling (Well 3L).

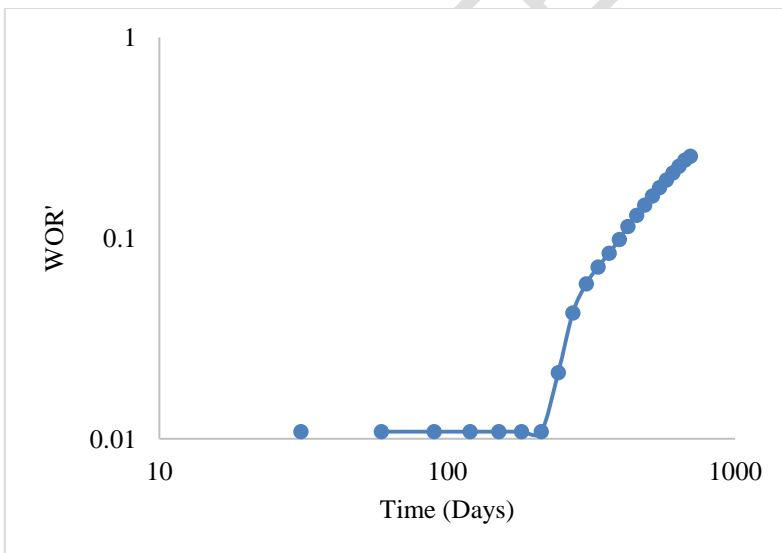
Fig.7. Log-Log Plot of WOR Derivative against Time Showing Multilayer Channeling (Well 3L).
