POPULATION MITIGATION STRATEGIES TO GEOMORPHIC HAZARDS IN LIMBE WEST COAST, SOUTH WEST REGION OF CAMEROON

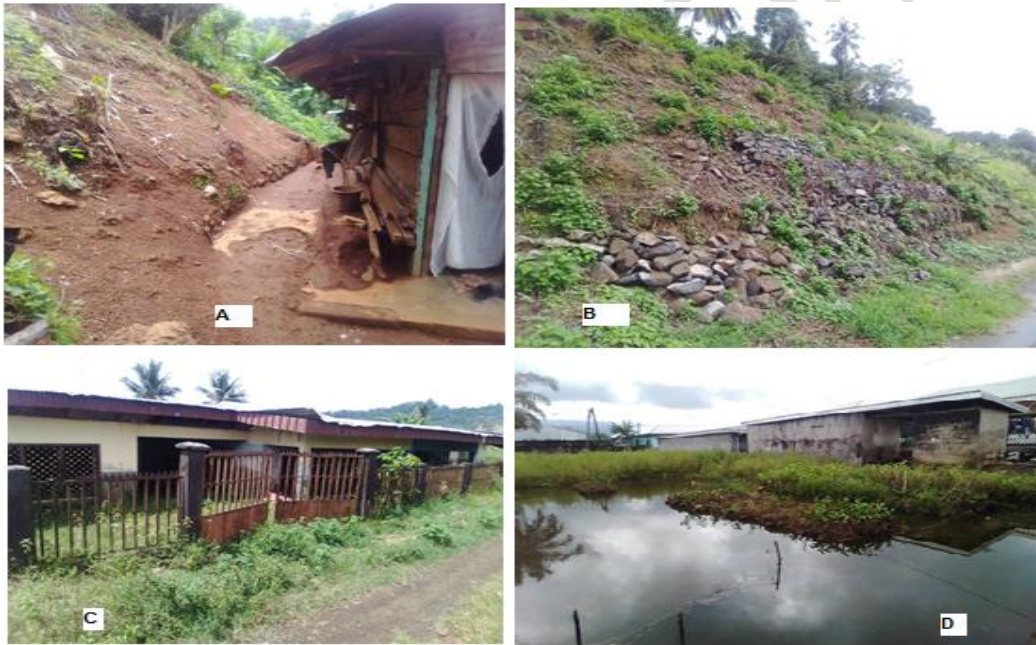
Plate 1. Some effects of hydrogeomorphic hazards
Source: Fieldwork, 2022

Some effects of hazards were observed in the study area. Destruction of houses as was observed at Mbende hill (A), and other landslide areas like Mabeta and Mbonjo Hill. Roads destruction/blockage by landslide were noticed at Mbonjo Hill (B) and in some severe landslide areas. Some houses were observed to be sinking as a result of flood and mostly abandoned in Clerk's quarters, Mbonjo, and Down Beach (C). Farms, particularly gardens around the houses are most at times covered by flood water as noticed in Banjo, Clerk's Quarter and Down Beach (D).

The impacts of floods and landslide in Limbe, is illustrated on plate 1 which clearly shows some of the destruction caused hydro-geomorphic hazards.

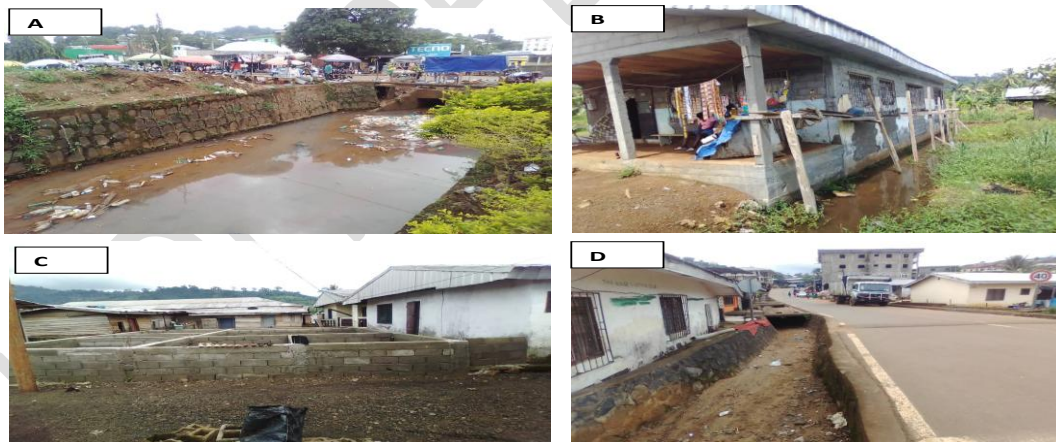
Plate 2. Some Flood control measures in Limbe.

Some of the observed measures put in place to combat flood in Limbe include channel modification (A) which has to do with construction of stone wall along the river channel course in order to contain flood water. Sinking houses which are refilled and raised up again (B) to solve to the problem of flood water entering the house. Raised foundation and scoria deposit filling (C) in down beach to combat flood water.

There is also storm drain enlargement and paving in cassava farm (D) to increase the carrying capacity of the channels (Plate 2).

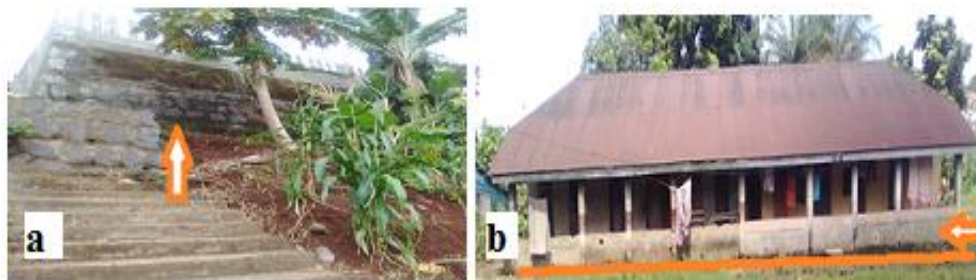
Plate 3. Other strategies against landslide and floods
Source: Fieldwork, 2022

a) Solid embankment to Combat landslide coconut Island, Limbe; b) Raised verandas to combat flood at Clerk’s Quarter Limbe

Landslide is also combated particularly by building very solid embankment to hold the unconsolidated soil (Plate 3). However, this is not very common as it is very expensive and only the “well to do” can carry on with that. This therefore has forced the poor to construct weak embankment which often collapse at time with heavy rainfall.
