POPULATION MITIGATION STRATEGIES TO GEOMORPHIC HAZARDS IN LIMBE WEST COAST, SOUTH WEST REGION OF CAMEROON

Key Words: *Geomorphic Hazards, Population Vulnerability, Mitigation strategy, Limbe West Coast*

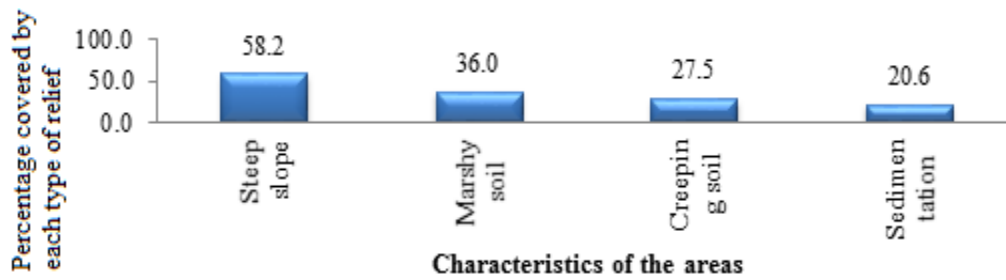
Figure: 2. Factors of geomorphic hazards in Limbe

The study site is characterized by Steep slopes 58.2%, marshy soil 36.0%, creeping soil 27.5% and sedimentation 20.6% (figure 2). Steep slopes are in areas of landslide and is a major problem because it retards construction and movement and also contribute highly to landslide together with high rainfall and human impact. Marshy soil is mainly in the low-lying areas affected by flooding and this has witnessed the

sinking of most houses in the area particularly where houses are constructed on the marshy soils like in the case of Clerk's quarter, Mbonjo and Down Beach.

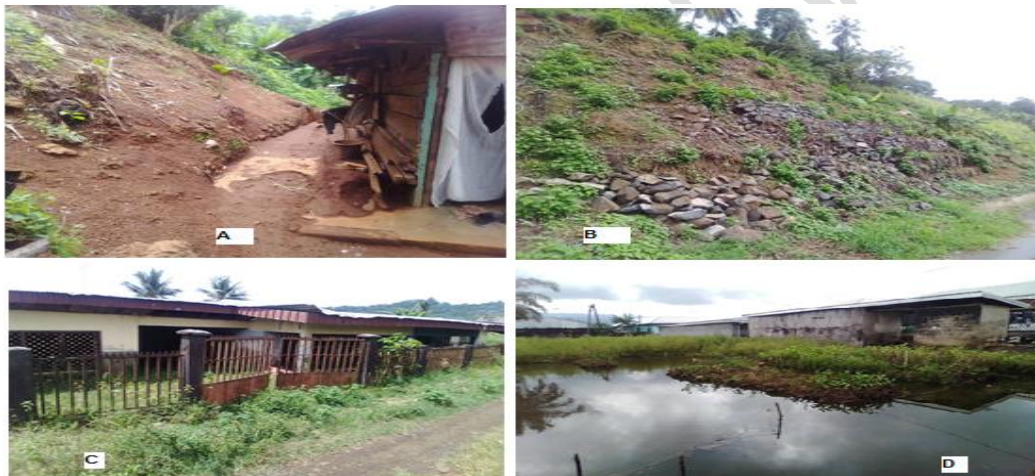
Plate 1. Some effects of hydrogeomorphic hazards
Source: Fieldwork, 2022

- a) Destruction of a house by landslide. b) Road blockage by rockslide.
c) Abandoned house because of floods. d) Floods covering houses' yard.

Some effects of hazards were observed in the study area. Destruction of houses as was observed at Mbende hill (A), and other landslide areas like Mabeta and Mbonjo Hill. Roads destruction/blockage by landslide were noticed at Mbonjo Hill (B) and in some severe landslide areas. Some houses were observed to be sinking as a result of flood and mostly abandoned in Clerk's quarters, Mbonjo, and Down Beach (C). Farms, particularly gardens around the houses are most at times covered by flood water as noticed in Banjo, Clerk's Quarter and Down Beach (D).

The impacts of floods and landslide in Limbe, is illustrated on plate 1 which clearly shows some of the destruction caused geomorphic hazards.

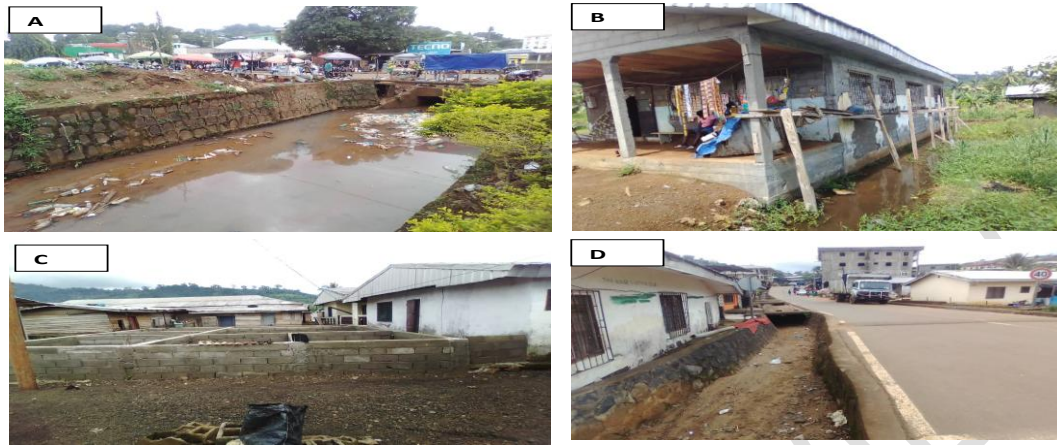
Plate 2. Some Flood control measures in Limbe
Source: Fieldwork, 2022

- a) Widened channel to content river flow. b) Refilled and Raised up of house foundation.**
c) Use of volcanic scoria to fill and raise up depressed land. d) Widened gutter beside paved road.

Some of the observed measures put in place to combat flood in Limbe include channel modification (A) which has to do with construction of stone wall along the river channel course in order to contain flood water. Sinking houses which are refilled and raised up again (B) to solve to the problem of flood water entering the house. Raised foundation and scoria deposit filling (C) in down beach to combat flood water. There is also storm drain enlargement and paving in cassava farm (D) to increase the carrying capacity of the channels (Plate 2).

landside. Plate 2 shows the various ways adopted by the indigenes to combat flood in the affected areas within the town of Limbe.

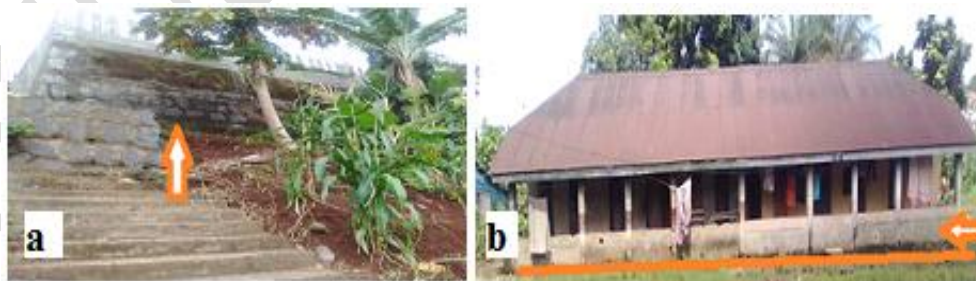
Plate 3. Other strategies against landslide and floods
Source: Fieldwork, 2022

- a) Solid embankment to Combat landslide coconut Island, Limbe
- b) Raised verandas to combat flood at Clerk's Quarter Limbe

Construction of solid embankment is a very good strategy commonly used within the Landslide areas in Limbe to combat Landslide. However, this kind of engineering work required much financial cost which few can afford for it because of their low level of income. Though most flood inhabited areas are declared as risk zones, the majority who persevere to stay there particularly in Clerk's Quarter for cheap houses have involved in raising of the verandas as an indigenous way of reducing the impact of floods (Plate 3).

Landslide is also combated particularly by building very solid embankment to hold the unconsolidated soil (Plate 3). However, this is not very common as it is very expensive and only the “well to do” can carry on with that. This therefore has forced the poor to construct weak embankment which often collapse at time with heavy rainfall.
