**EVALUATION OF TITANIUM MINI PLATES FOR
REPAIR OF MANDIBULAR FRACTURES IN
CLINICAL CASES OF DOGS**

Abstract: The efficacy of straight, 4 holed titanium miniplates for repair of mandibular fractures in six dogs was evaluated. Mandibular fractures accounted for about 4.8% in the present study, commonly occurred in shih tzu and non-descript, male dogs of less than one year of age. The common site of fracture was the premolar region and unilateral fractures were more compared to bilateral fractures. The physiological and hematological parameters were within normal physiological range and statistically non-significant, except the leucocyte count, which showed significant variations and higher values at the beginning of the study due to presence of infection, which reduced with administration of antibiotics. Biochemical parameters namely serum calcium, phosphorous, creatinine and ALT showed non-significant variations. However, alkaline phosphatase showed significant variations. Immediate post-operative radiographs showed good alignment of the fractured mandible with adequate reduction. At the end of the study the mandible healed with minimum or no callus formation. This technique provi

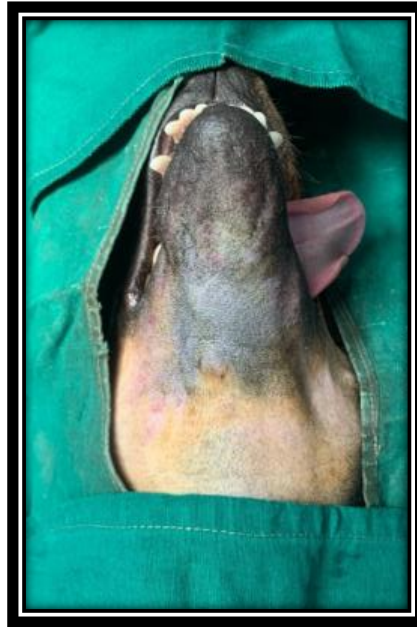
fig1: **Dorsal recumbency of dog for repair of rostral mandibular body fracture.**

In this study straight Titanium miniplates of sizes 1.5 mm and 2 mm, four holed and the screws were selected depending on the size of the plate with a diameter of 1.5 mm or 2 mm with varied lengths of 6 mm, 8 mm, 10 mm, 12 mm depending on the thickness of the mandible. All the dogs were withheld food for twelve hours and water for six hours prior to surgery. All dogs were premedicated with atropine sulphate and Xylazine hydrochloride at the dose of 0.04 mg / kg and 1 mg / kg body weight I/M (intramuscularly) respectively. After 15 minutes, the general anaesthesia was induced with intravenous (I/V) administration of 2.5% solution of thiopentone sodium at the dose of 12.5 mg / kg body weight and maintained to effect with the same. All the animals were administered with ceftriaxone at the dose rate of 25 mg / kg body weight I/V as prophylactic antibiotic and tramadol was given as pre-emptive analgesic at the dose rate of 2 mg / kg body weight I/V. The surgical procedure required the dog to be positioned in dorsal recumbency with head extended for fracture repair of rostral shaft of the mandible.

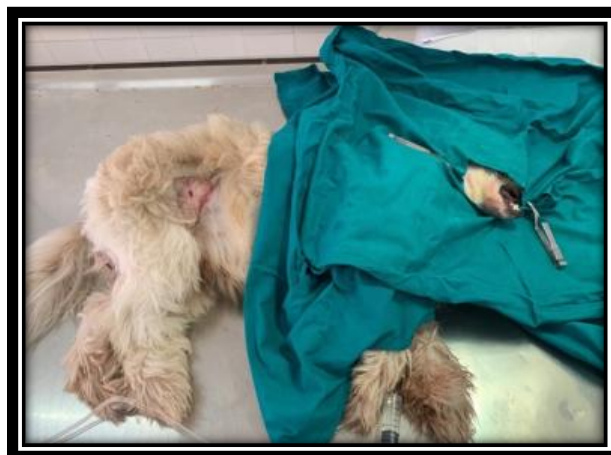
fig 2: **Lateral positioning of the dog with the affected mandible at the top**

and lateral recumbency with affected side upper most for ramus of the mandible.

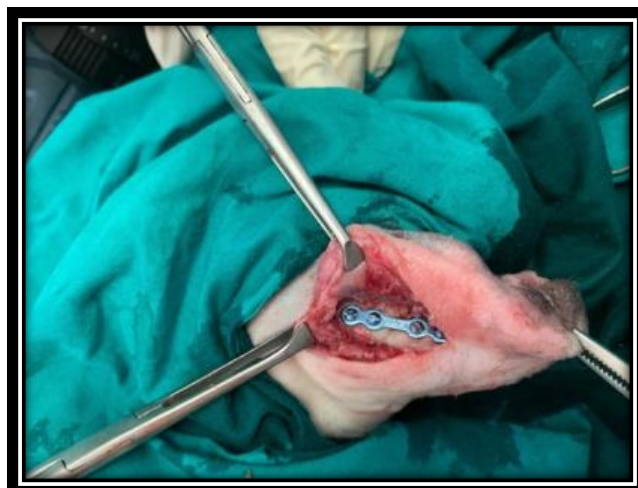
On exposure of the fractured segments the titanium miniplate was applied to the caudal fracture segment near the alveolar margin of the mandible by positioning the plate and drilling holes into the cortex of the bone using 1.5 mm drill bit. The plate was fixed to the fractured segment using 2 mm screws into the pre drilled holes using special screw driver for mini screws *i.e.* screw driver with sleeve. Size of the screw (length) was relative to the thickness of bone, thicker the bone lengthier screws were placed and the screw placement up to a 30° angle relative to the plate avoided impingement to the tooth roots. Further the rostral segment was aligned to anatomical alignment and the screws were applied in the similar manner to stabilize the fractured bone.

fig 3: Titanium miniplate fixed at the fractured site after tightening of screws.

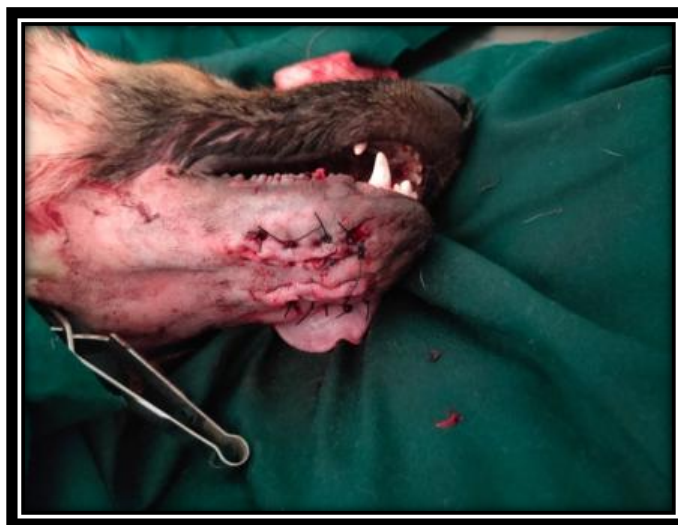
fig 4: Closure of skin using non – absorbable suture after stabilization of mandibular fracture using titanium miniplate

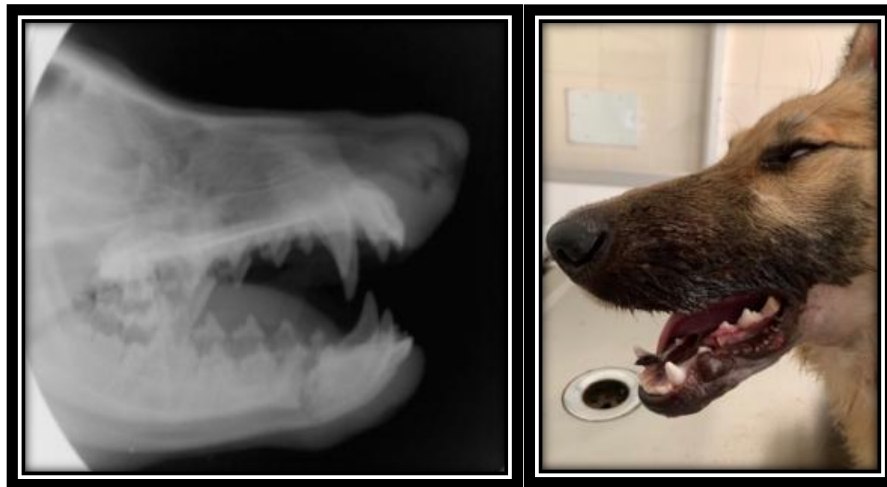
The preoperative radiograph showed bilateral transverse fracture at the level of 405 and 406 on right side, and between 305 and 306 on left side of case (iv). There was drooping of mandible and blood tinged saliva. The immediate post-operative radiograph showed adequate fixation of fractured fragments with titanium miniplate. There was perfect alignment of fractured mandible.

fig 8: Day 0 The pre-operative radiograph showing complete transverse rostral mandibular body fracture (left) and drooping of mandible (right)

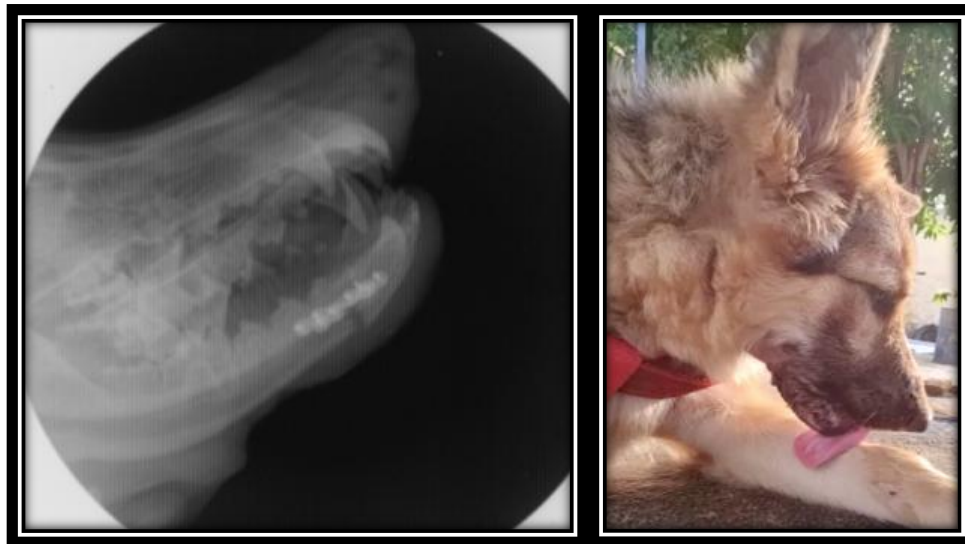
fig 10: Day 7

Day 7: There was no alteration in alignment of the miniplate and fractured bone and dog was able to close the mouth. Slight discharge was noticed from surgical site. In case 5 there was loosening of plate and displacement of screw.

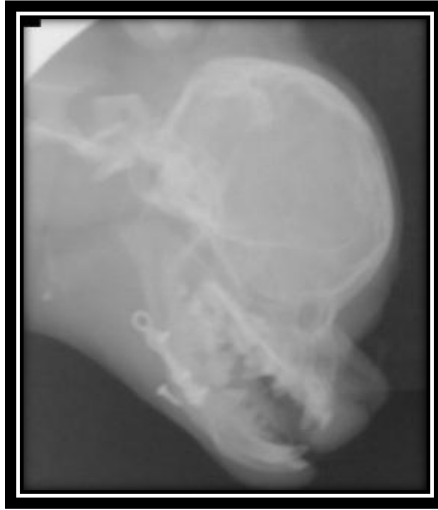
fig 11: **Displacement of screw and displacement of plate in case 5**

In present study there no collateral damage to adjacent anatomical structures and there was no plate exposure through oral mucosa. In present study there was loosening of screw in two cases, one due to continuous champing of the jaw and the stability of the fracture fixation was lost and in other case due to improper drilling of the holes led to screw displacement and implant loosening. In present study non-union was noticed in one case and oval shaped holes led to screw loosening. In all other cases there was adequate soft tissue covering the fracture site which led to satisfactory healing of the mandible fractures.

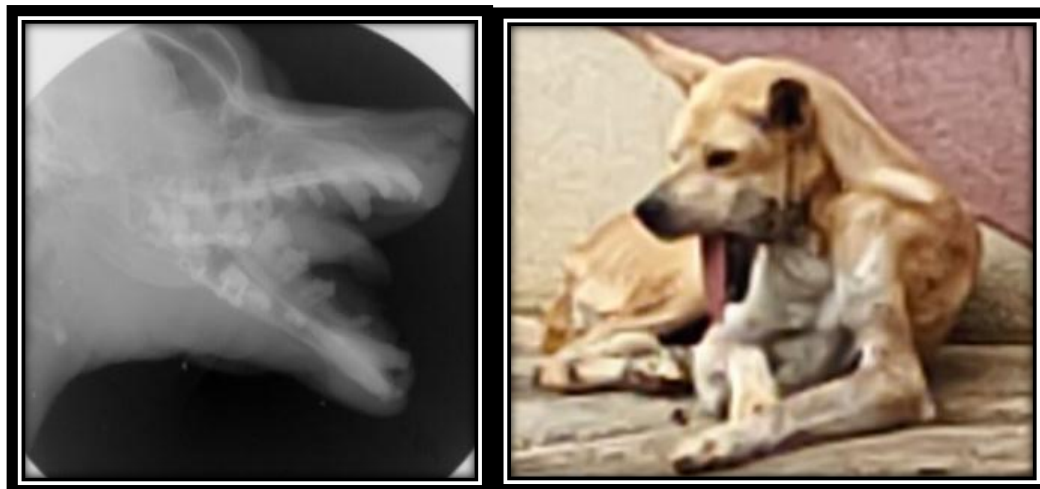
Day 15: There was no alteration in alignment of the miniplate. There was appearance of decrease in the width of fracture line which indirectly indicated the initiation of endosteal and periosteal callus. No discharge from surgical site. Dog started taking soft food. However in case 3 due to continuous champing of the jaw loosening of screws was observed along with displacement of the plate.

fig 13: Radiograph of case 3 (complication)

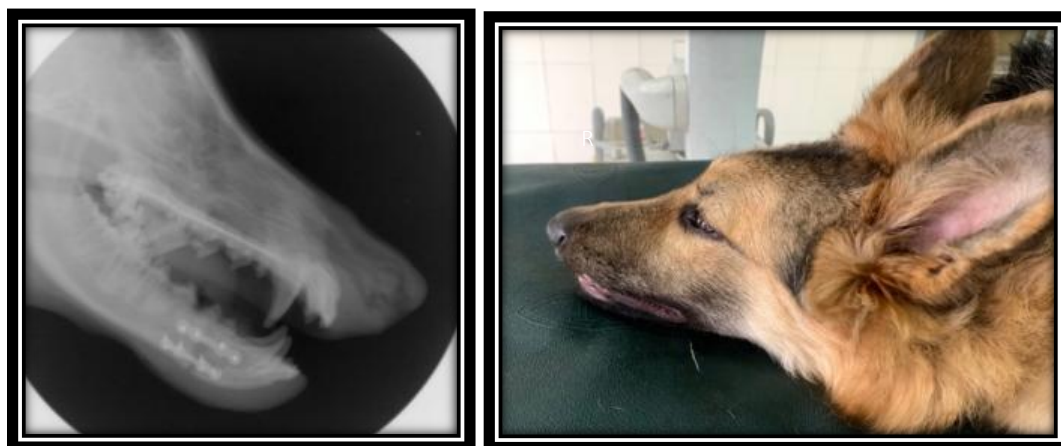
fig 15: Day 30

Day 30: The radiograph of 30th post-operative day showed further decrease in size of fracture gap. There was apparent filling of fracture line with feathery callus and there was perfect alignment.
