# **Heavy Metal and bacteriological status of Groundwater in some Coastal Areas of Akwa Ibom State, Nigeria**

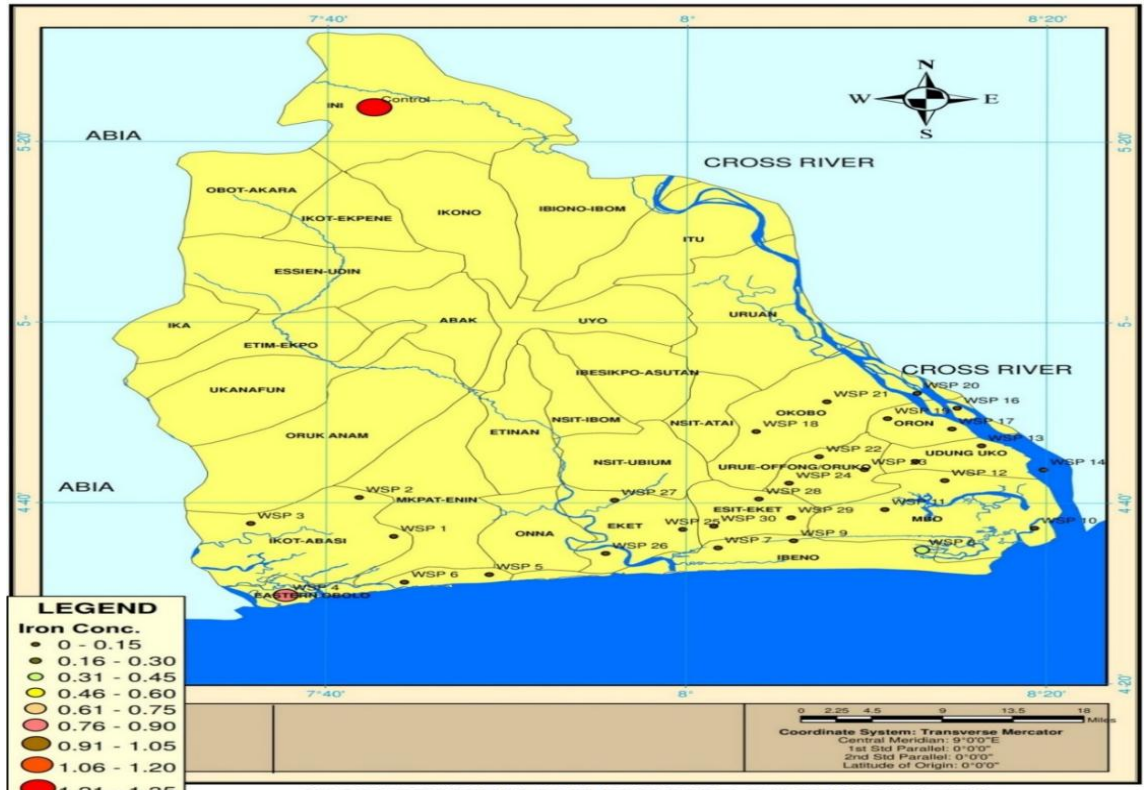
Figure 2: Iron Concentration Distribution Map of Study Area

The spatial interpolated values of iron in the groundwater of the study area (shown in Figure 2) ranged from <0.01mg/l to 0.90mg/l. The highest interpolated value of iron was obtained in Eastern Obolo on the eastern part of the area. In a similar study, Beka et al.[9] reported iron concentrations ranging from 0.01mg/l to 8.5mg/l in groundwater in Akwa Ibom State; while [16] reported iron concentration as high as 0.38mg/l in groundwater in Port Harcourt. Again, in a similar study carried out by Nwankwo et al. [17] mean iron concentrations of 0.18 mg/l and 0.168 mg/l were obtained in groundwater in Ghana and Tanzania respectively. The spatial interpolated values of magnesium in groundwater of the study area (shown in Figure 3) ranged from <0.01mg/l to 9.88mg/l, which are below permissible limit. The maximum interpolated value (9.88mg/l) was found in well WSP 8 (Ibeno) on the eastern part of the area. These values agree with the studies by Edet [10] and Sokpuwu[18]. In another related study, Meride, and Ayenew [19] reported an average value of 13.67mg/l for magnesium in groundwater in Wondo Genet campus, Ethiopia.

groundwater through the use of fertilizer and the decomposition of animal waste [20]. Iron concentrations were high in many of the groundwater boreholes. The mean value of iron in the groundwater ((Table 2) exceeded Nigerian permissible limit by 150% and WHO limit by 650%. In related studies, Beka et al. [9] and Ukpaka and Ukpaka[16] reported high iron concentrations in groundwater in Akwa Ibom State and Port Harcourt City respectively. This implies that the groundwater in the Niger Delta region is generally high in iron. The concentrations of zinc in the groundwater samples were generally low below permissible limits (Table 2).

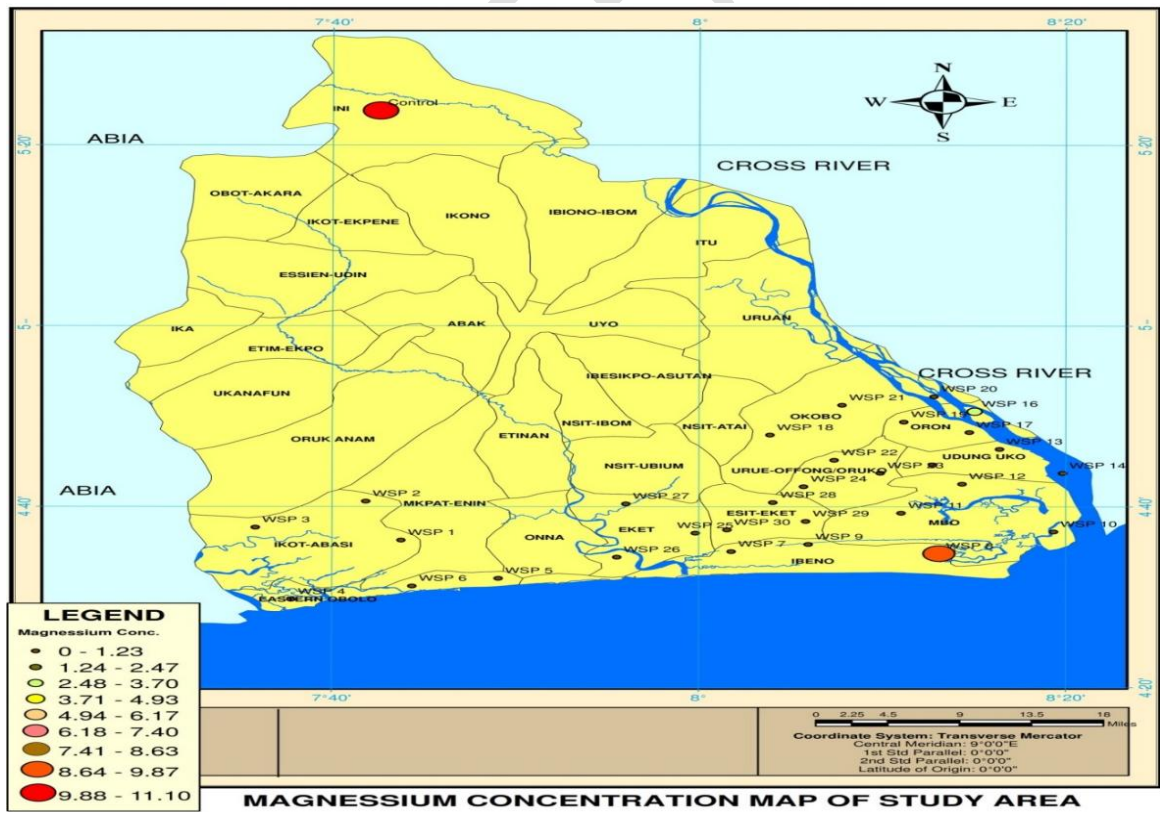
Figure 3: Magnesium Concentration Distribution Map of Study Area

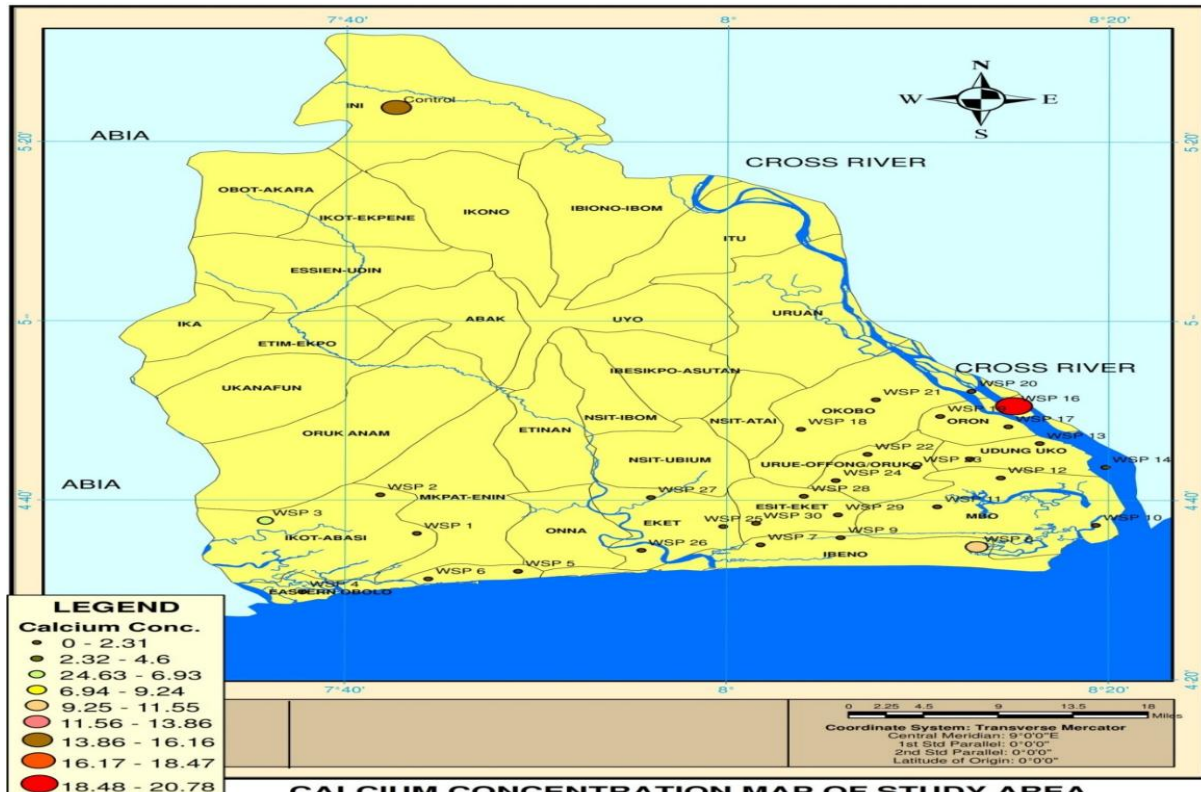
Figure 4: Calcium Concentration Distribution Map of Study Area

The spatial interpolated values of calcium in the groundwater of the study area (shown in Figure 4) ranged from <0.01mg/l to 20.78mg/l, which are below permissible limit. The highest value was found around Oron Beach and Catholic Road CreekIbeno. These values agree with the study by Edet (2017) who reported a calcium ranging from 0.1 to 26mg/l in groundwater in southern Akwa Ibom State. Also, Beka et al. [9] reported a calcium range of 33.4mg/l to 1.6mg/l in groundwater samples in Akwa Ibom State. In another similar study, Sokpuwu[18] reported an average Calcium value of 7.21mg/l in groundwater samples within Eleme, Rivers State; while Meride, and Ayenew [19] obtained calcium concentrations ranging from 2.2mg/l to 7.3 mg/l in groundwater in Wondo Genet campus, Ethiopia. The spatial interpolated values of sodium in the groundwater of the study area (shown in Figure 5) ranged from 1.1mg/l to 10.3mg/l. The maximum interpolated value of sodium (10.3mg/l) was found at well WSP 26. As indicated in Figure 5, low sodium levels were observed around EsitEket, Urue-Offong/Oruku, Okobo and parts of Oron and Mbo located within the eastern part of the coastal area. Maximum sodium levels were observed around the Eket and Oron located border areas to the Atlantic Ocean and its major tributaries as shown in the sodium spatial distribution in Figure 5. This shows the possible migration of sodium contaminants from the Atlantic Ocean towards the coastal groundwater system. In similar studies, Edet [10] reported a sodium concentration ranging from 0.6 to 120mg/l in groundwater in southern Akwa Ibom State.

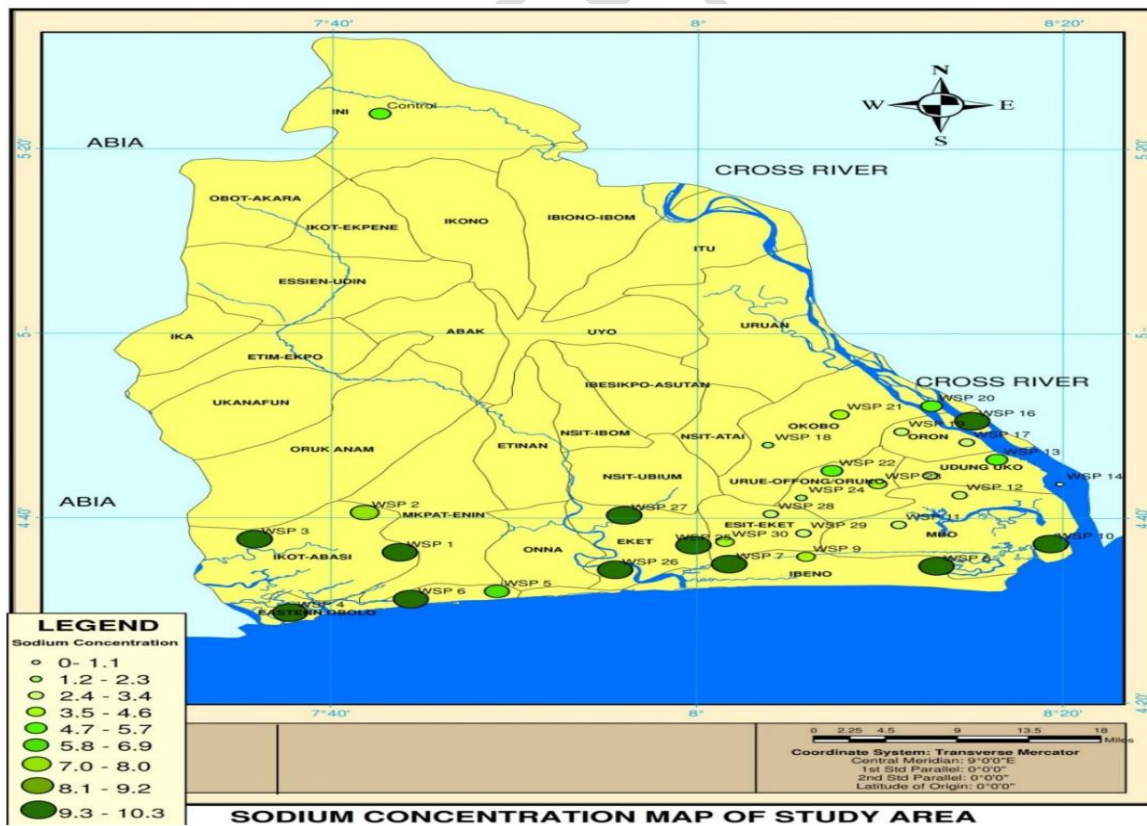
Figure 5: Sodium Concentration Distribution Map of Study Area

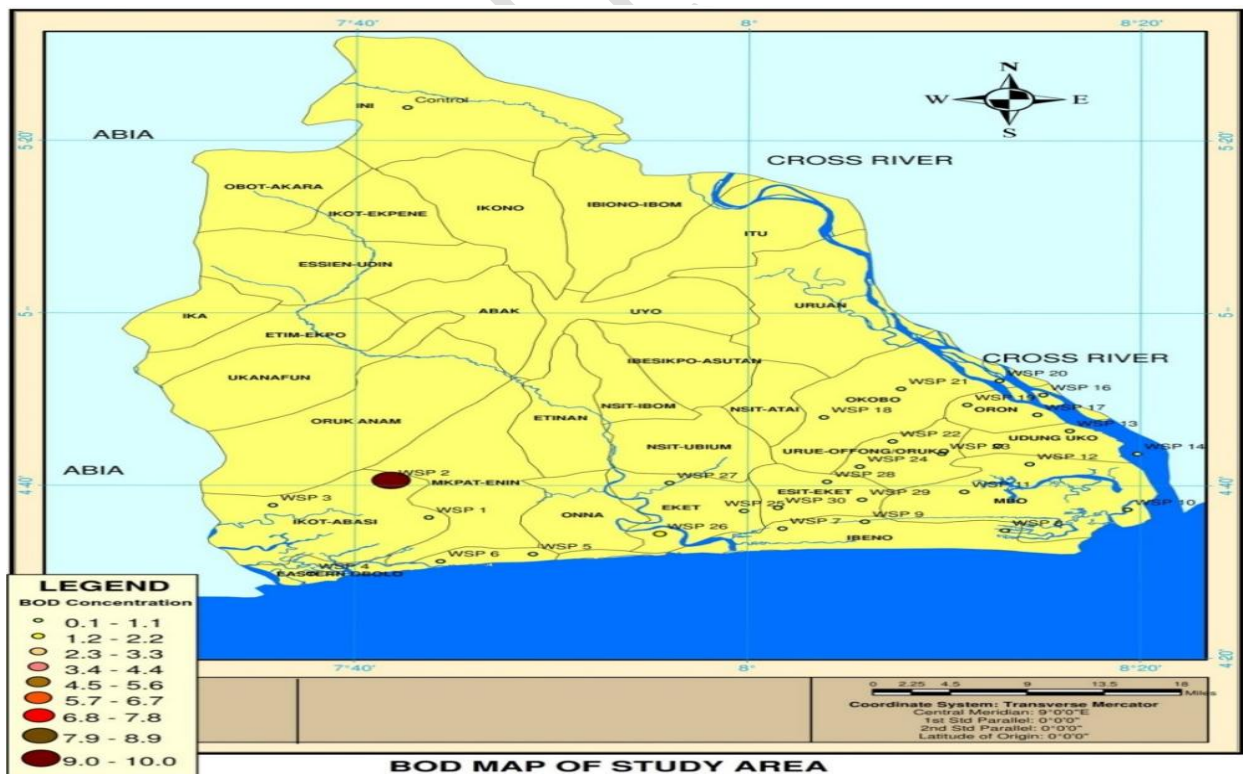
Figure 7: BOD Concentration Distribution Map of Study Area

The distribution of iron magnesium, calcium and sodium in groundwater of the study area are shown in Figures 2 to 5; while the distribution of total coliform bacteria and biochemical oxygen demand in groundwater of the study area are shown in Figures 6 and 7.
