# **Quantitative status of indicator bacterial and Heavy Metal of Groundwater in some Coastal Areas of Akwa Ibom State, Nigeria**

This study evaluates the quality potential of groundwater in coastal areas of Akwa Ibom State, Nigeria. Thirty boreholes were sampled, and analyzed for heavy metals and biological parameters using routine techniques of groundwater studies. The study revealed bacterial contamination of groundwater in the area. Iron ranged from 0.0mg/l to 0.90mg/l; magnesium ranged from <0.01mg/l to 9.88mg/l; calcium ranged from <0.01mg/l to 20.78mg/l; *total coliform* bacteria ranged from 0.27MPN/100ml to 2400.01MPN/100ml; biochemical oxygen demand ranged from 0.1mg/l to 10.02mg/l. Mean BOD and COD were 0.76mg/l and 1.03mg/l respectively; mean *total coliform*, *fecal coliform* and *E-coli* bacteria were 530.65MPN/100ml, 557.24MPN/100ml and 113.17MPN/100ml respectively. The presence of bacterial coliform in the borehole water was attributed to poor waste disposal, surface run-off and perennial flooding in the area. The study showed that groundwater in the area is of poor quality and not suitable for drinking. Therefore, groundwater in the area should be treated to improv

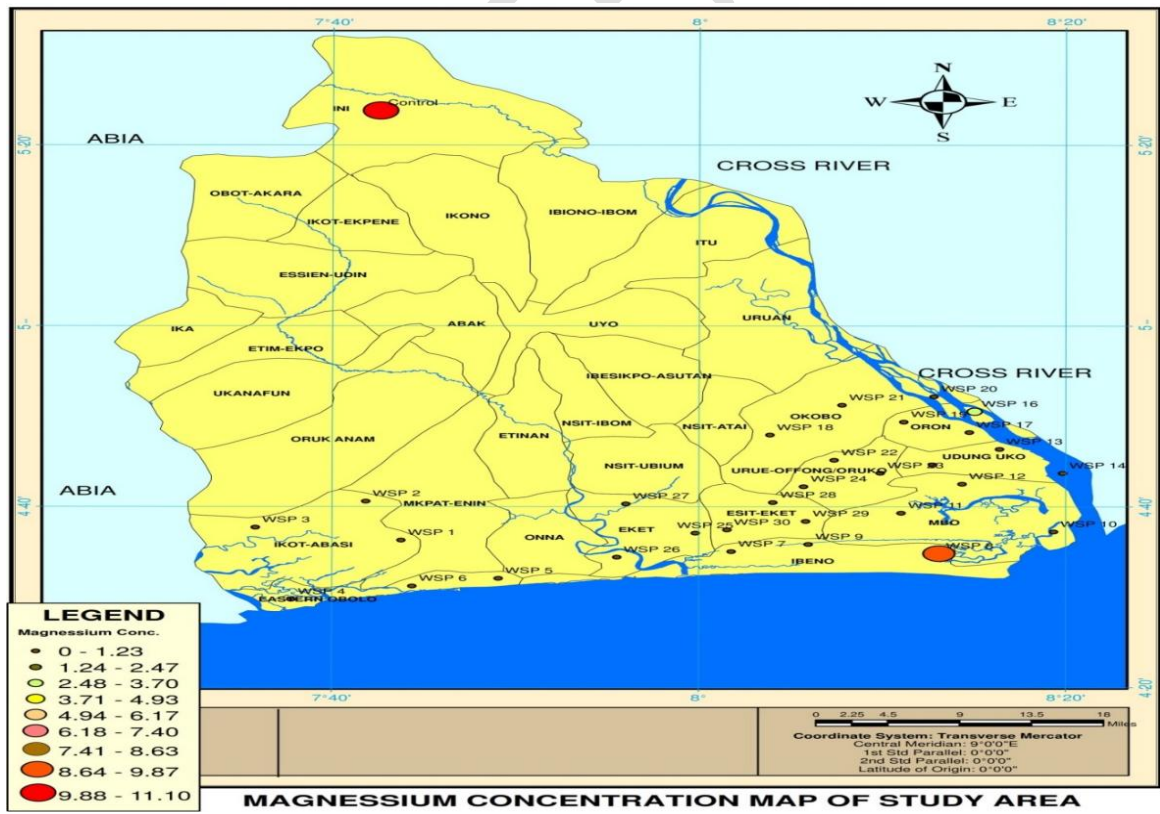
Figure 3: Magnesium Concentration Distribution Map of Study Area

The spatial interpolated values of iron in the groundwater of the study area (shown in Figure 2) ranged from <0.01mg/l to 0.90mg/l. The highest interpolated value of iron was obtained in Eastern Obolo on the eastern part of the area. In a similar study, Beka et al. [9] reported iron concentrations ranging from 0.01mg/l to 8.5mg/l in groundwater in Akwa Ibom State; while [16] reported iron concentration as high as 0.38mg/l in groundwater in Port Harcourt. Again, in a similar study carried out by Nwankwo et al. [17] mean iron concentrations of 0.18 mg/l and 0.168 mg/l were obtained in groundwater in Ghana and Tanzania respectively. The spatial interpolated values of magnesium in groundwater of the study area (shown in Figure 3) ranged from <0.01mg/l to 9.88mg/l, which are below permissible limit. The maximum interpolated value (9.88mg/l) was found in well WSP 8 (Ibeno) on the eastern part of the area. These values agree with the studies by Edet [10] and Sokpuwu [18]. In another related study, Meride, and Ayenew [19] reported an average value of 13.67mg/l for magnesium in groundwater in Wondo Genet campus, Ethiopia.

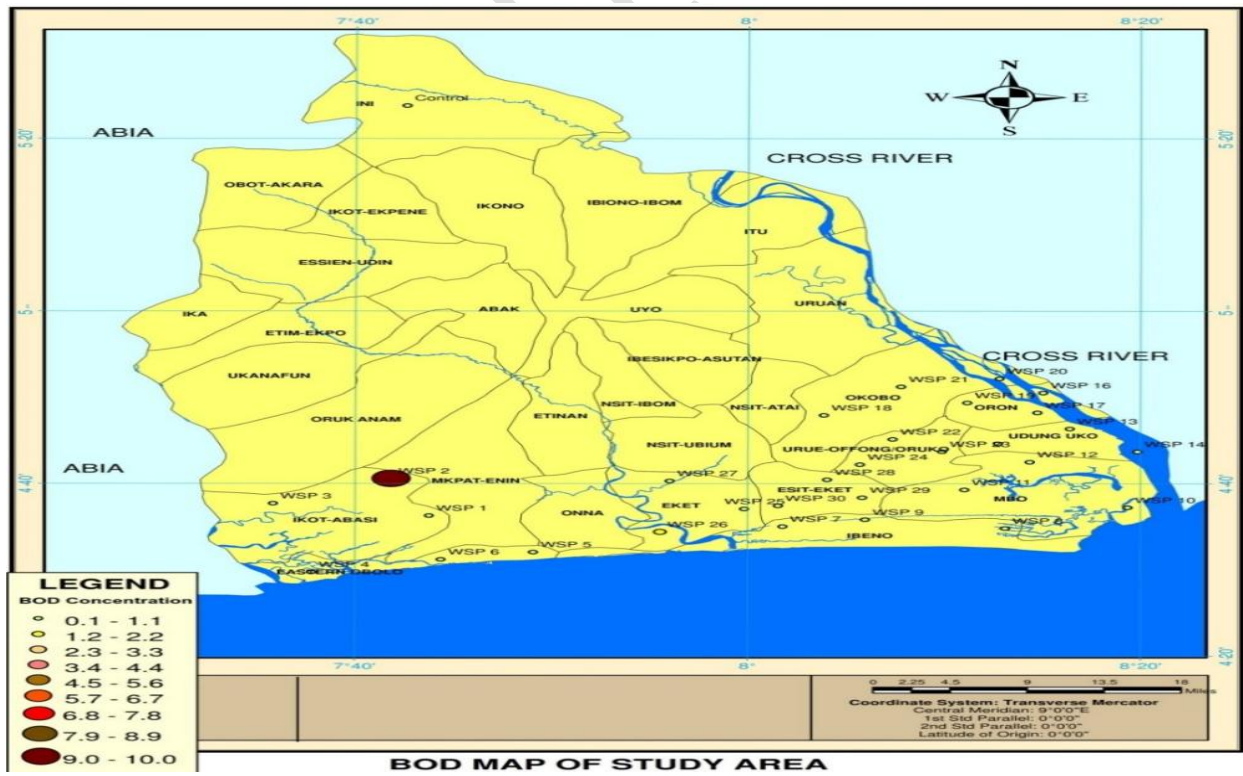
Figure 7: BOD Concentration Distribution Map of Study Area

The distribution of iron magnesium, calcium and sodium in groundwater of the study area are shown in Figures 2 to 5; while the distribution of *total coliform* bacteria and biochemical oxygen demand in groundwater of the study area are shown in Figures 6 and 7.
