# ASSESSMENT OF NEXUS BETWEEN BUILDING CHARACTERISTICS AND CLIMATE CHANGE EXPERIENCES ON HOUSING QUALITIES OF THE RESIDENTS OF AYETORO COMMUNITY, ONDO STATE.

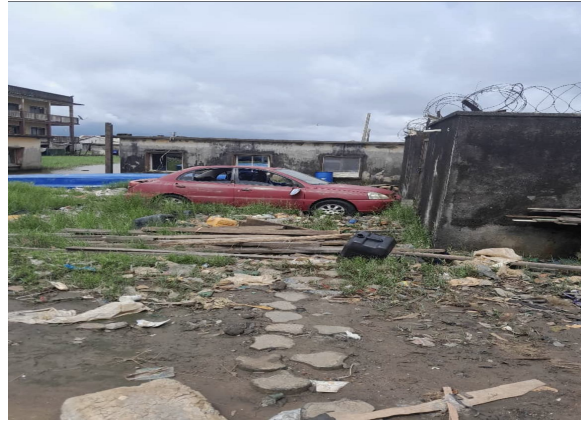
**Figure 1:** Ayetoro impact on climate change in 2023[Source: Work of the researcher].
