Effect of different storage vessels on rainwater harvested from different rooftops: Case study of rainwater harvested in Owerri, Imo State, Nigeria

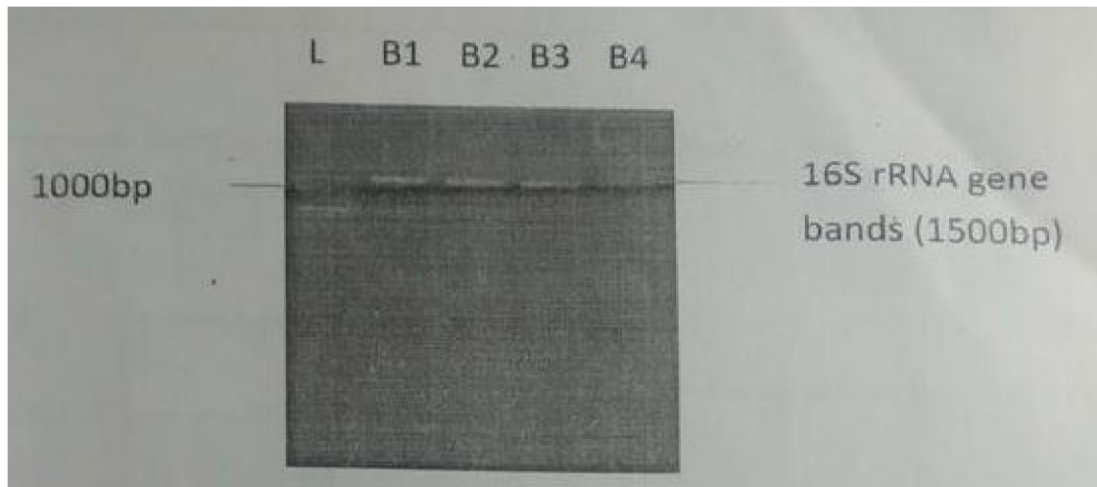
Plate 1: Agarose gel electrophoresis of the 16S rRNA gene of some selected bacterial isolates. Lane B1-B4 represent the 16 rRNA gene bands (1500bp). Lane L represents the 100 bp molecular ladder.

The results of molecular identification study for the bacterial isolates with the 16S rRNA sequence from the isolates produced the exact match with similar sequences from NCBI non-redundant nucleotide database. The phylogenetic placement of the 16S rRNA of the isolates was in agreement with evolutionary distances after computation with jukes-Cantor methods. After the profiling (Plate 2), *E.coli*, *P. aeruginosa*, and *Enterobacter sp.* possessed plasmids and this made them resistant to the antibacterial drugs used.

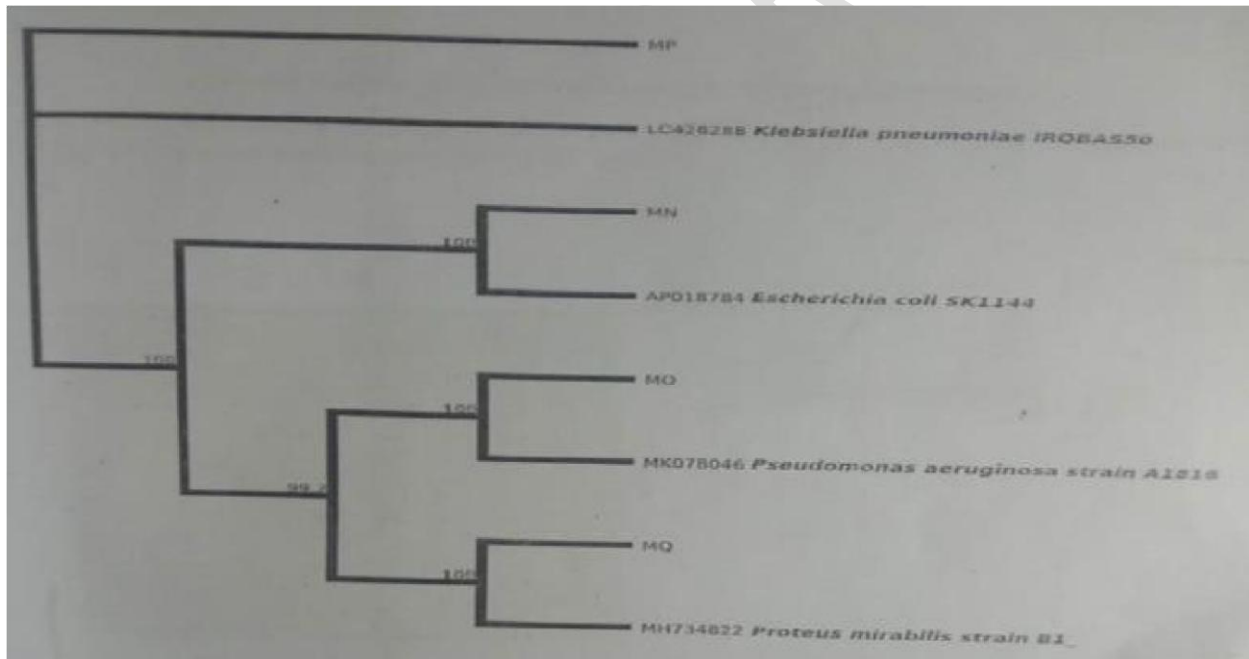
Plate 2: Phylogenetic tree showing the evolutionary distance between the bacterial isolates.

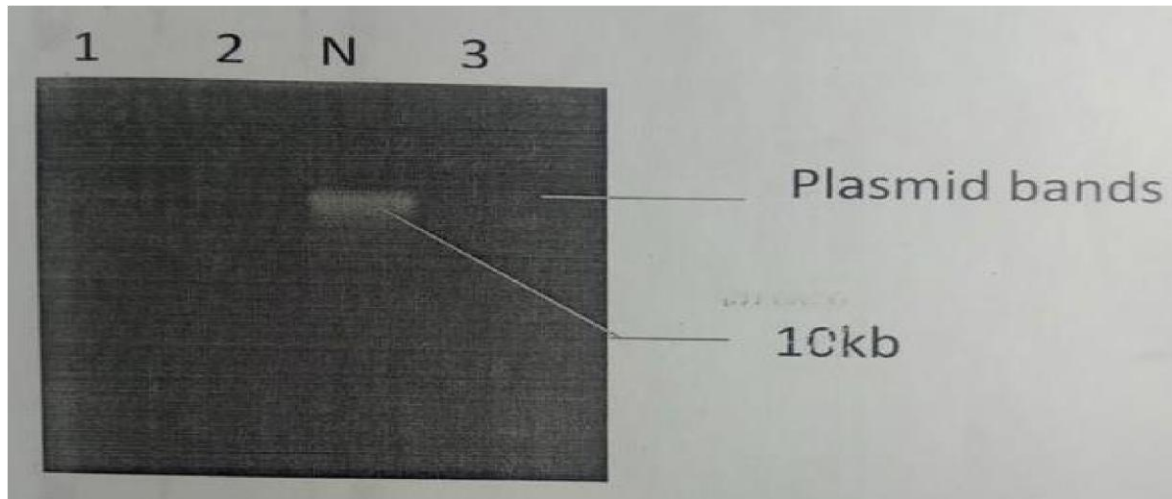
Plate 3: Agarose gelelectrophoresis for the plasmid of the bacterial isolates. Lane N represents a 1 kb molecular ladder.
