# **Atmospheric Corrosion of Al-Zn Coated Steel Sheets Exposed under Marine Environments in Kenya**

## **ABSTRACT**

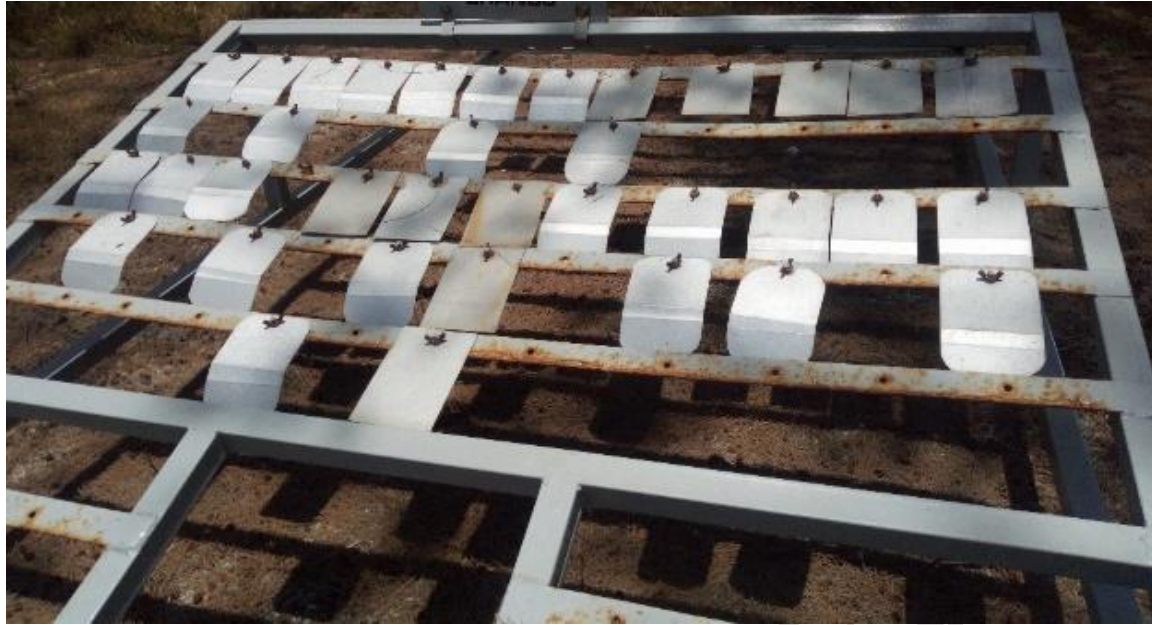
**Figure 2:** A set-up for outdoor exposure of 55% Al-Zn metallic coated sheets at Diani site.

We carried out experiments for a period of 450 days from July 2019 to September 2020. Metallic coated iron sheets (Al-Zn 55%) had mass composition of 55% aluminium, 1.6% silicon and 43% zinc. The sheets were sheared into 130 mm x 190 –mm coupons, punched with coded holes identification and cleaned according to ASTM G1-90 method (ASTM, 1999). The initial coating mass was recorded before exposure to the atmosphere, then the racks were inclined at an angle of 45° facing the sea for a period of 450 days according to ASTM G50-76 (ASTM, 2003). Figure 2 illustrates the racks exposed during experimental period. Representative samples of exposed specimen were collected at intervals of 3 months over the experimental period and analysed to determine losses in coating mass.

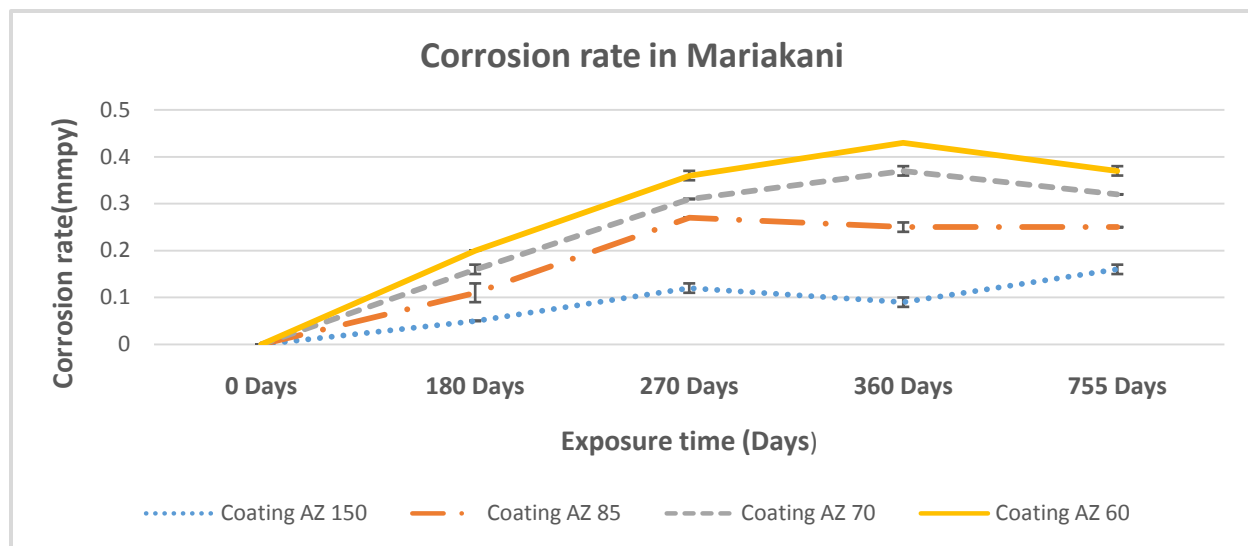
The results revealed strong influence of the mass of coating on the rate of corrosion. Corrosion rate increased from AZ150 < AZ85 < AZ70 < AZ60 suggesting increasing protection of the metallic surface with coating masses (Figure 3). Mariakani site is characterized by industrial marine environment with high sulphur dioxide and nitrogen dioxide levels which could have influenced rate of corrosion. Despite longer distance of the site from the ocean, the site experienced high moisture content which could have enhanced corrosion (Syed, 2006). Corrosion rate was highest during the first year for all the coating masses, and decreased in subsequent years. The trend could be attributed to formation of a protective film slowing down corrosion.

**Figure 3:** Corrosion rate of AZ metallic coated iron sheets in Mariakani

The relatively lower corrosion rates were experienced at Mariakani that were attributed to low chloride levels. Nevertheless, Mariakani site experienced relatively high levels of  $\text{SO}_2$  ( $635 \text{ } \mu\text{g/m}^3$ ) attributable to its location along the Nairobi-Mombasa high way. Sulphur dioxide has been reported to have less effect on stainless steel (H. E. Townsend, 2002) since iron is passivated by sulphate ions and upon saturation the accumulated film of sulphate corrosion products prevent further corrosion. Furthermore, higher rainfall experienced at Mariakani site (114 mm) compared to Diani (96 mm) reduced corrosion rate by washing away the pollutants from the surface (Angel *et al.*, 2015).

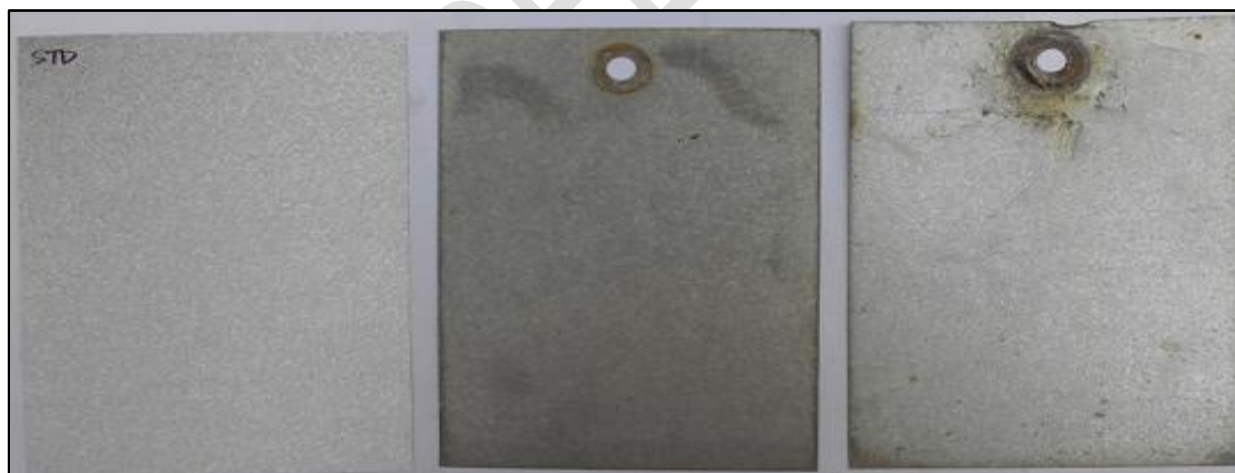
Figure 5 illustrates the visual impression of the sampled specimens S1, S2 and S3 after a 2-year exposure at Diani and Mariakani sites. The specimen exposed at Mariakani site were darker due to exposure to vehicular emissions. The specimen exposed to the environment recorded greyish colouration on the

**Figure 5:** A photograph showing comparison of corroded specimen (AZ 150) at Mariakani and Diani test sites (S1-control specimen, S2- Mariakani specimen and S3- Diani site specimen).
