Case study

Management of severely **decade damaged** primary maxillary anterior teeth: A case series

Aim: The aim of this case series was to illustrate the different posts and core build in severely damaged primary maxillary anterior teeth. So here we presents the case report series of three different post systems that is omega shaped post, prefabricated metal post, composite resin post followed by using varies esthetic crowns.

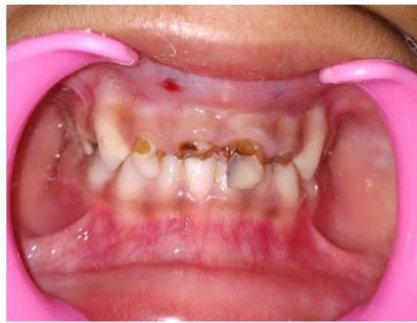
Figure 1. a: Preoperative Intraoral Photograph

Case Report-1: A 3 and half years old male patient has ~~reported~~ referred to the K.D Dental College and Hospital, Mathura in the Department of Pediatric and Preventive Dentistry with a chief complaint of decayed upper front teeth region since 1 year. Patient had no relevant dental and medical history. Both the extra oral and intra oral examination were done. In extra oral examination, no abnormalities were detected while intraoral examination revealed a complete set of primary dentition. It was observed that 54, 52, 51, 61, 62, 64, 74, and 84 were affected by dental caries (Figure 1. a). Intraoral periapical radiographs revealed pulp involvement in respect to 52, 51, 61, and 62. Diet counseling, and oral prophylaxis were done. 54 and 64 were restored with pit and fissure sealent. 74 and 84 were restored with glass ionomer cement. 52, 51, 61, and 62 were grossly decayed & indicated for pulpectomy, followed by omega shaped posts and composite buildups.

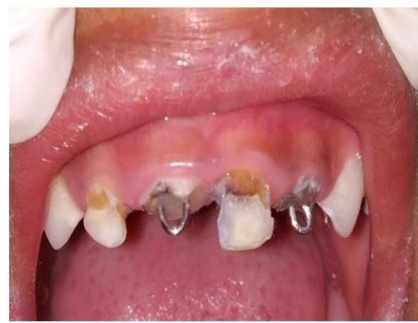
Figure 1. b: Intraoral Photograph after Omega shaped Post placement

NaOCl and normal saline, the root canal was dried using paper points. The canals were obturated with Metapex followed by glass ionomer cement restoration with respect to 52,51,61,62. The Construction of post and core: Omega shaped post was constructed with 0.9 mm stainless steel orthodontics wire. The pulpal ends extended approximately 3mm into the root canal so as to improve the overall retention of the wire and the incisal end or loop of the wire projected 2-3 mm above the remaining root structure. The omega shaped post space was prepared one week after the pulpectomy treatment was completed. The Omega shaped post space was created by removing approximately 3- 4 mm of Metapex material using a thin straight fissure bur. All visible Metapex on the walls of the post space was removed. The prepared post space was then cleaned with saline, air dried drier, and acid etched with 37% phosphoric acid for 15 seconds. This space was rinsed and air dried with oil-free compressed air. A light-cured bonding agent was brushed on the etched surface and uniformly dispersed by a compressed air blast. It was then light cured with for 20 seconds. The omega shaped post was then cured for 20 seconds in order to gain rigidity, before insertion into the post space. Light cured flowable composite resin was then inserted into the canal chamber after the insertion of omega shaped post then cured them together for 60 seconds (Figure 1. b & c). Crowns were reconstructed using PNM (write the meaning of PNM abbreviation) crown. Finishing and polishing were performed using so flex tips after checking the occlusion (Figure 1. d).

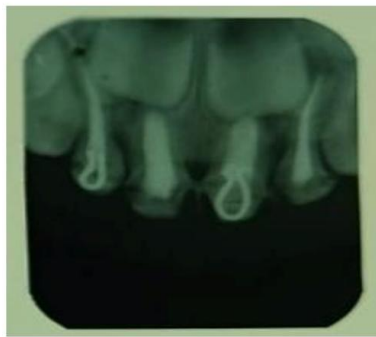
Figure 1. c: IOPAR after Omega shaped Post

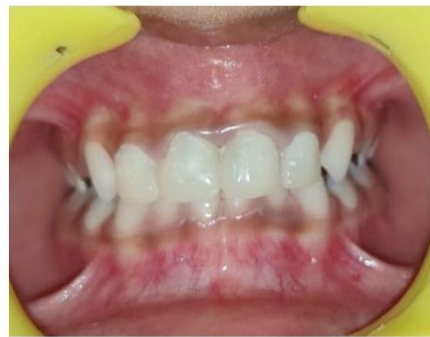
Figure 1. d: Porcelain Non Metal Crown

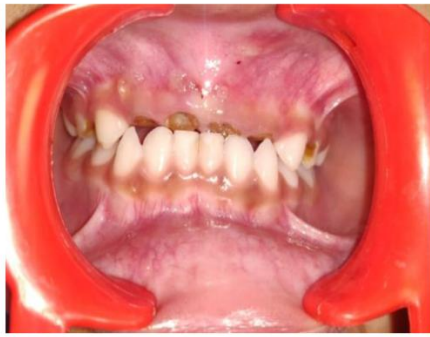
examination revealed a complete set of deciduous dentition. Grossly decayed with respect to 52, 51, 61, 62, (Figure 2 a.). Intraoral periapical radiographs revealed pulp involvement in respect to 52, 51, 61, and 62 with the diagnosis of early childhood caries. Diet analysis, counseling, and oral prophylaxis were done. 52, 51, 61, and 62 were indicated for pulpectomy, followed by prefabricated metal post and core buildup. Rubber dam isolation was performed under LA (write the meaning of LA abbreviation), caries was removed and pulp tissue was extirpated. The canal was prepared under constant irrigation with sodium hypochlorite followed by saline, BMP (write the meaning of BMP abbreviation) was done then, dried with paper points, and obturated with Metapex followed by glass ionomer cement. After a week, three millimeters of the coronal part of the canal was prepared for the replacement of post. Generally, the core length of prefabricated metal posts is 3-4 mm. The sharp four line angles of quadrangle core of the post were then semi-beveled to not exert stress to the root and the post was examined in the prepared canal. Subsequent to occlusion evaluation, 1 mm end of the post which interfered with the occlusion was cut (Figure 2 b.). The post was then cemented into the canal. After initial setting of the cement, etching with 37% phosphoric acid and rinsing, the screws of the post were covered with one layer of flowable composite resin and the coronal restoration was reconstructed incrementally using composite resin (Figure 2 c.). The crown was reconstructed with the Porcelain non metal crown. Finally, the occlusion was adjusted using articulating paper; finishing and polishing was carried out using fine diamond burs (Figure 2 d & e.). The patient and his parents were instructed on proper dietary and hygiene habits and advised to come for regular check-up- in intervals of 6, 12, and 18 months.

Figure 2. a.: Preoperative Intraoral Photograph

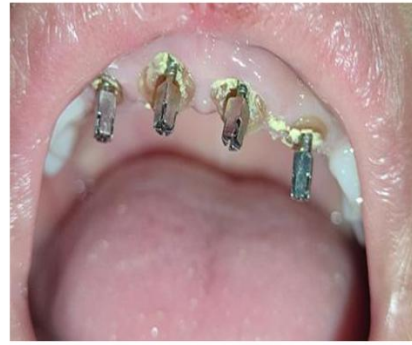
Figure 2. b.: Intraoral Photograph after placing Metal Post

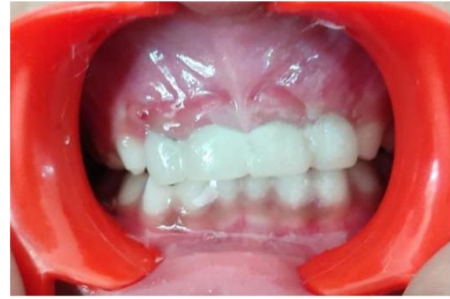
Figure 2. d.: Porcelain Non Metal Crown.

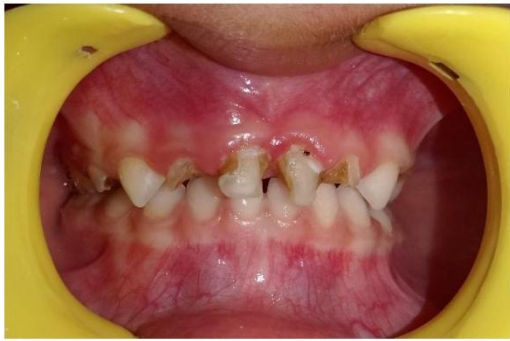
Case Report-3: A 4-year-old male patient ~~reported~~ referred to the K.D. Dental college and hospital in the Department of Pediatric and Preventive Dentistry with a chief complaint of decayed upper anterior teeth. Patient had a history of bottle ~~feeding~~ feeding. Intraoral examination revealed 52, 51, 53, 61, 62, 63, 74, 75, 84, 85, 54, 64 were affected by dental caries (Figure 3 a.). Intraoral periapical radiographs showed pulpal involvement with 53, 62, 63, 54, 64 (Figure 3 b.). Diet analysis, counseling to the parents ~~were~~ was done, 74, 75, 84, 85 were restored with composite and oral prophylaxis were done. 54, 64 indicated for pulpectomy, followed by composite posts. Pulpectomy with metaphex obturation was done ~~it~~ with 53, 62, 63. The post space was prepared 7 days after the pulpectomy. The post space was created by removing approximately 3mm of obturating material using a thin straight fissure bur. The prepared post space was then cleaned with sodium hypochlorite followed by saline, air dried, and acid etched with 37% phosphoric acid at least for 20 seconds. The space was rinsed and air dried followed by application of bonding agent. It was then light cured for 15 seconds. Making of composite post a small amount of packable composite was fabricated as a 3 mm cylindrical post. The post was then cured for 20 seconds in order to gain rigidity, before insertion into the post space (Figure 3 c.). Light cured flowable composite resin was then inserted into the canal chamber after which the composite post was inserted. The composite post ~~were~~ was then cured ~~with~~ together for 60 seconds. The coronal enamel was then etched for 20 seconds, rinsed with water and air dried followed by application of bonding agent which was then light cured. The coronal post was then covered with the flowable composite for core build up, followed by light curing it for 60 seconds,

Figure 3. a: Pre Operative Intraoral Photograph

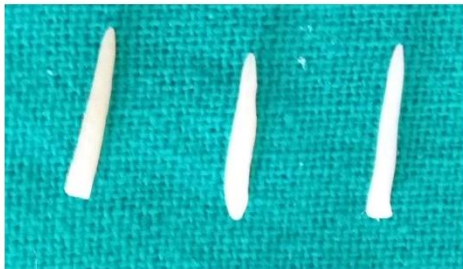
Figure 3. c: Composite Post

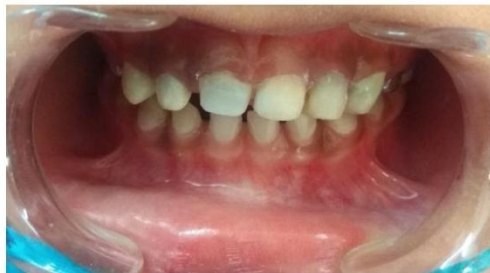
Figure 3. d: Post Operative Photograph

and finally teeth were restored with composite. Finishing and polishing was done.(Figure 3 d.).
